# Effect of X-ray Computed Tomography Scan Noise on **Observation of Internal Defects in**

## a Blade Part Fabricated by Wire Arc Additive Manufacturing

Shinichiro EJIRI, PMP, Nikkiso Co., Ltd., Japan

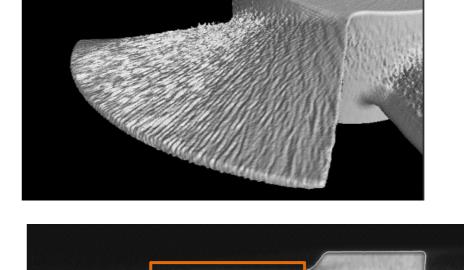
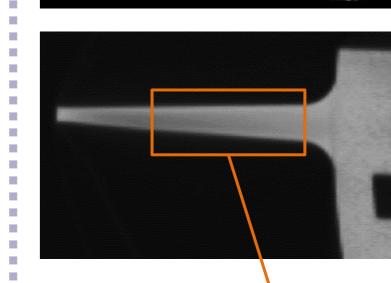
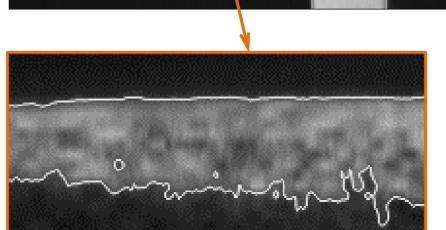
Scan in quadrants,

The scan succeeded with the interior being observable.

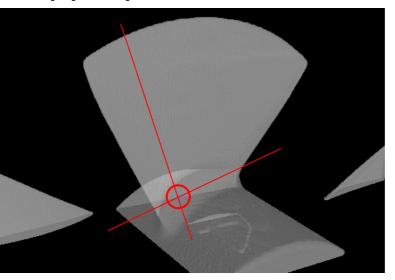
#### Internal defects observation by vertical direction scan

Internal defects in the blades were detected by using appropriate conditions.
