Influence of Surface Treatment on Hydrogen Embrittlement of Commercial Vehicle Seat Slider Bracket

Advanced Technology Group, Centre for Research Engineering and Advanced Technologies (CREAT), UNO Minda Ltd. Pune, Maharashtra, India

Problem statement: Tooth lock was found broken in the failed seat slider assembly.

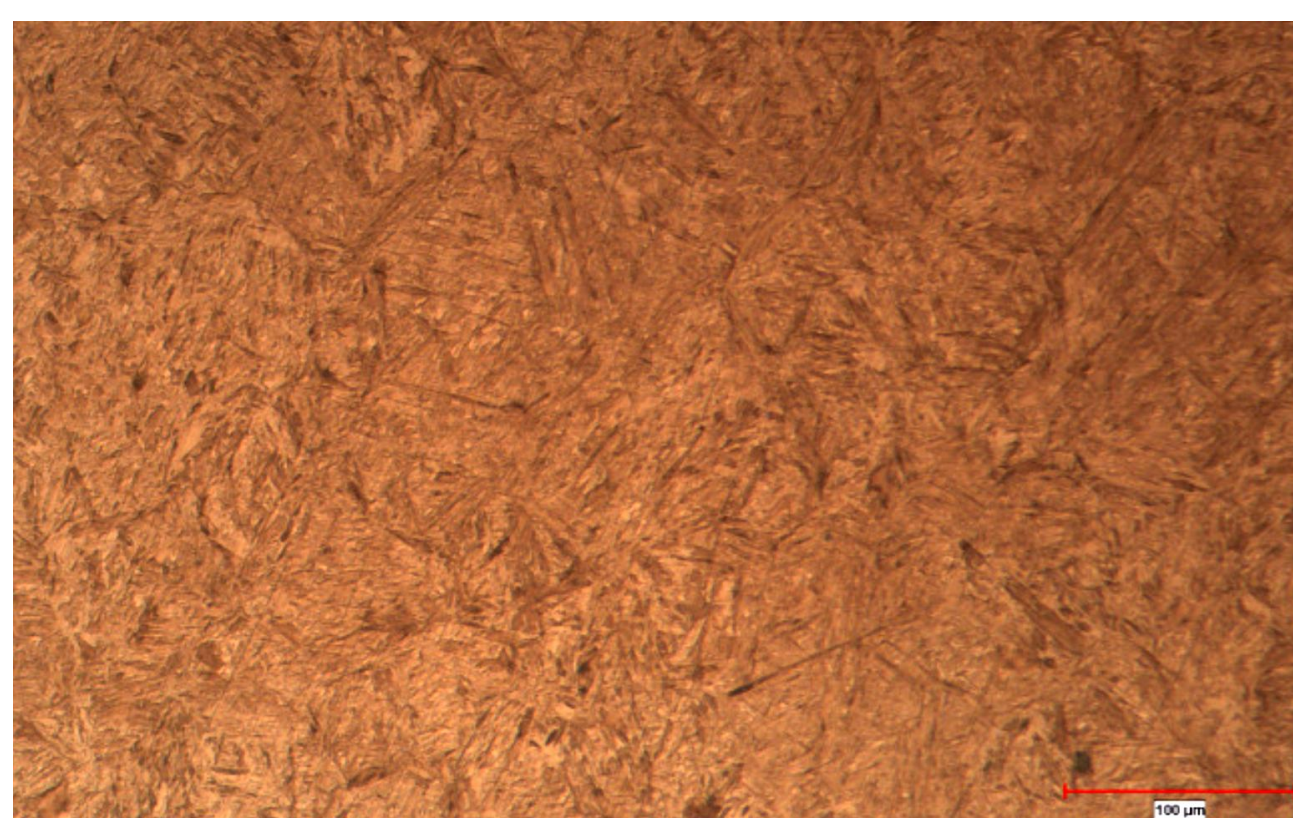
Optical Microstructure

- ❑ The observed microstructure predominantly consists of tempered martensite, characterized by a fine acicular (needle-like) or lath morphology arranged in small packet.
- ❑ The tempered martensite microstructure was observed in both case and core of the failed part.

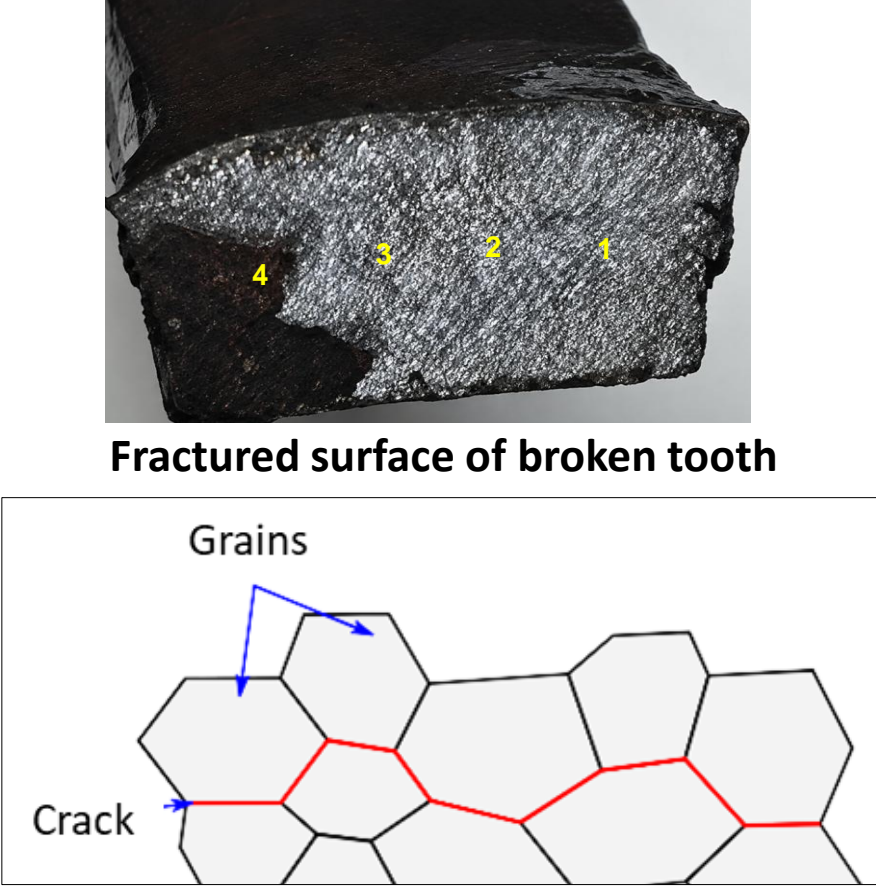
Scanning Electron Microscopy

- ❑ Well defined grain boundary regions, cleavage fracture indicates brittle failure.
- ❑ No crack branching was observed.
- ❑ Intergranular fracture was observed as crack propagated along the grain boundaries.

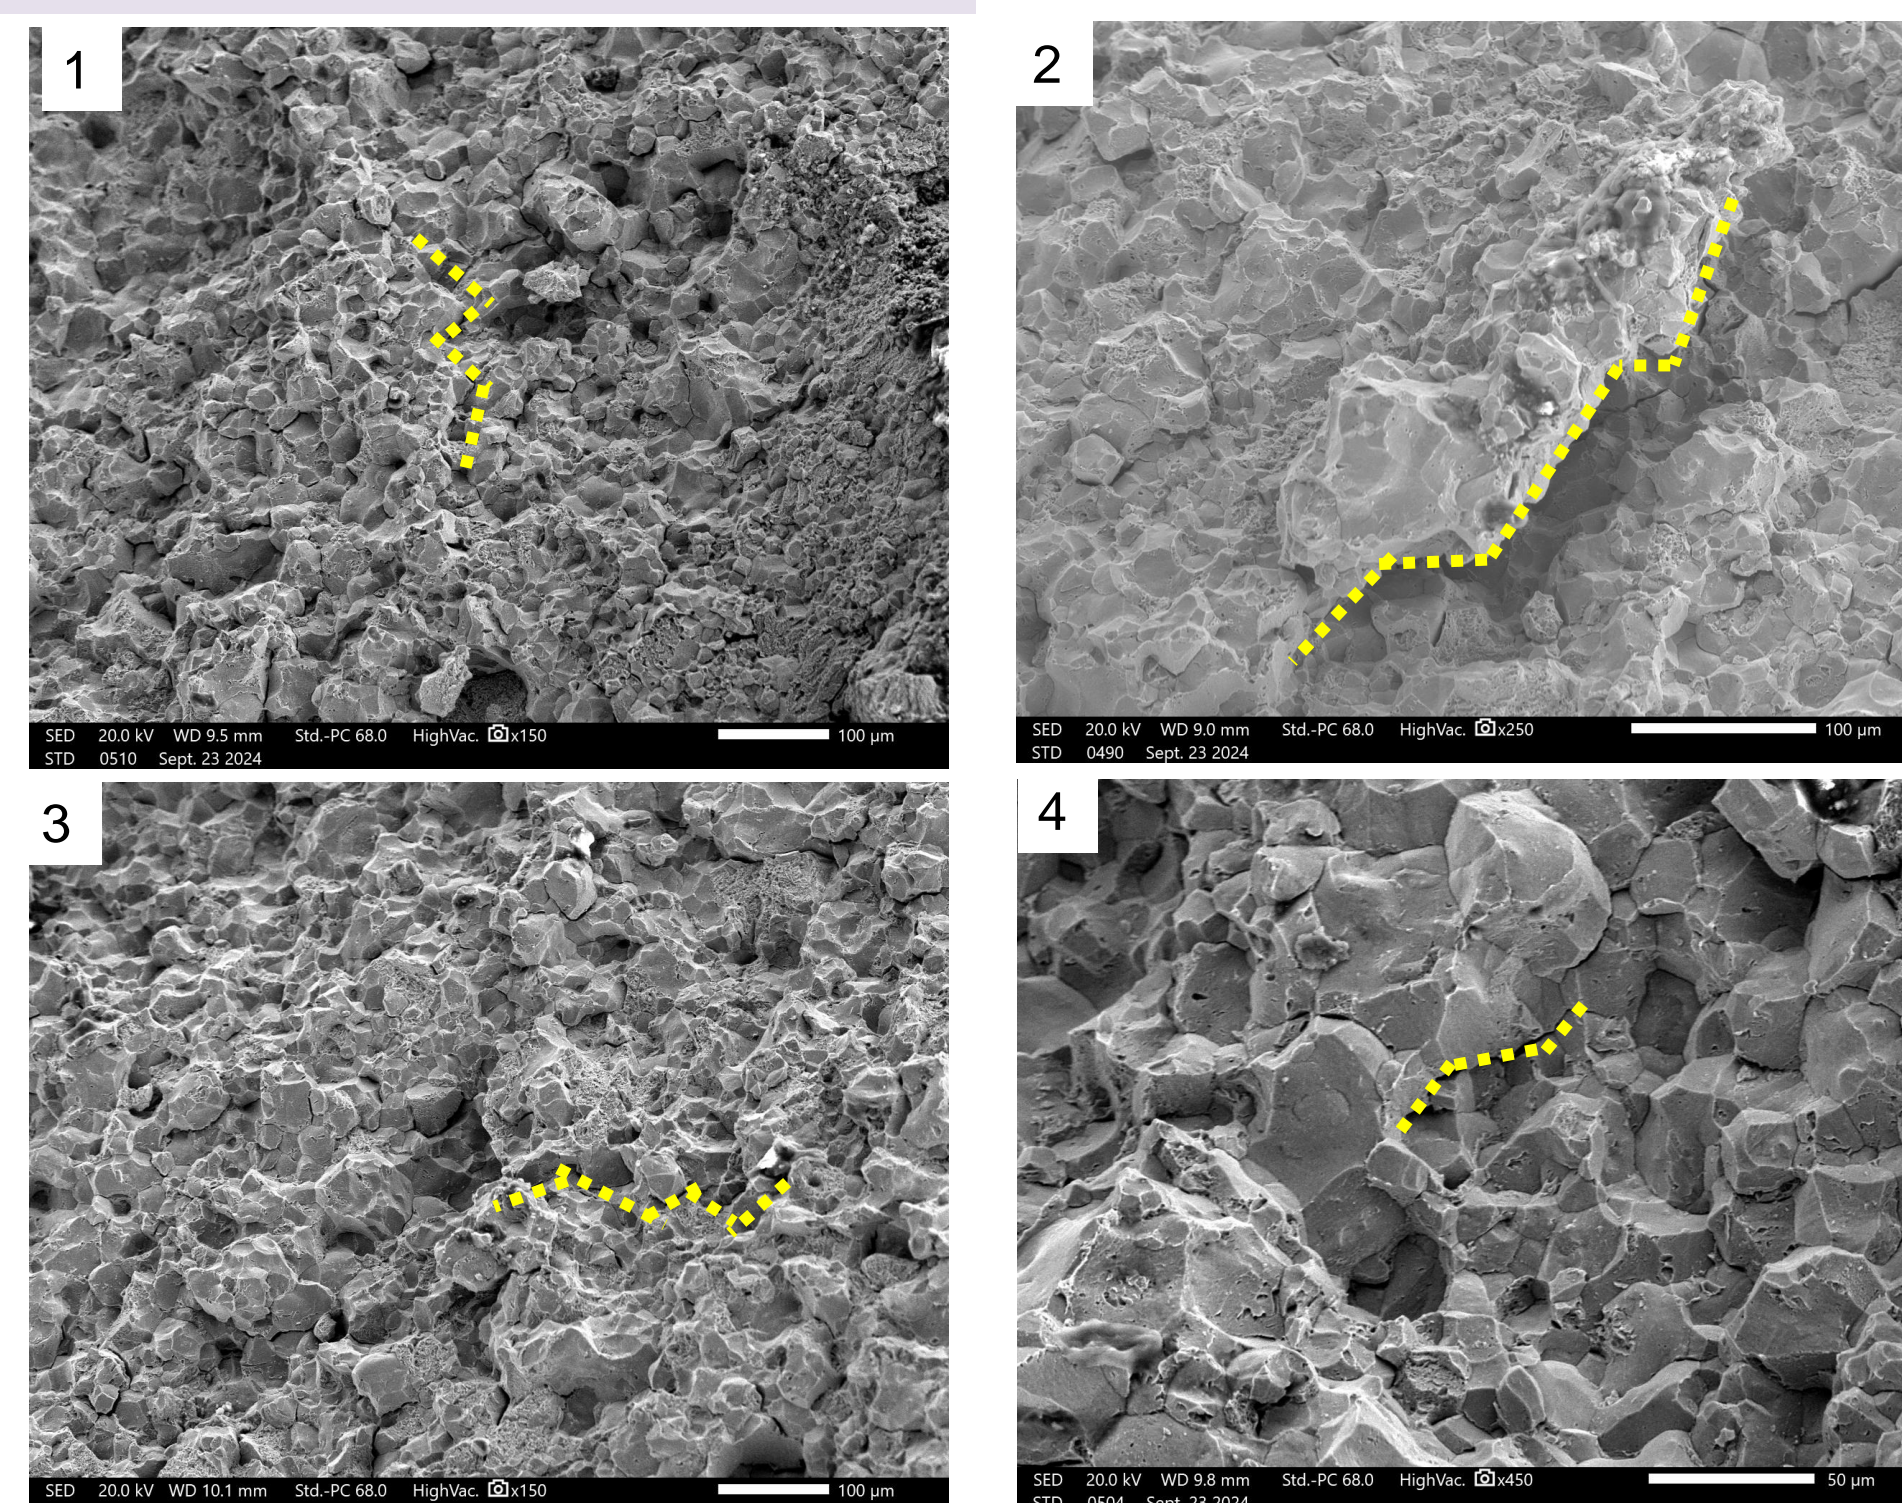
Fractography Analysis

Root Cause: The intergranular fracture tend towards the hydrogen embrittlement susceptibility of tooth lock part of seat slider. This hydrogen embrittlement could be due to hydrogen pickup during heat treatment like carbonitriding or even tempering.

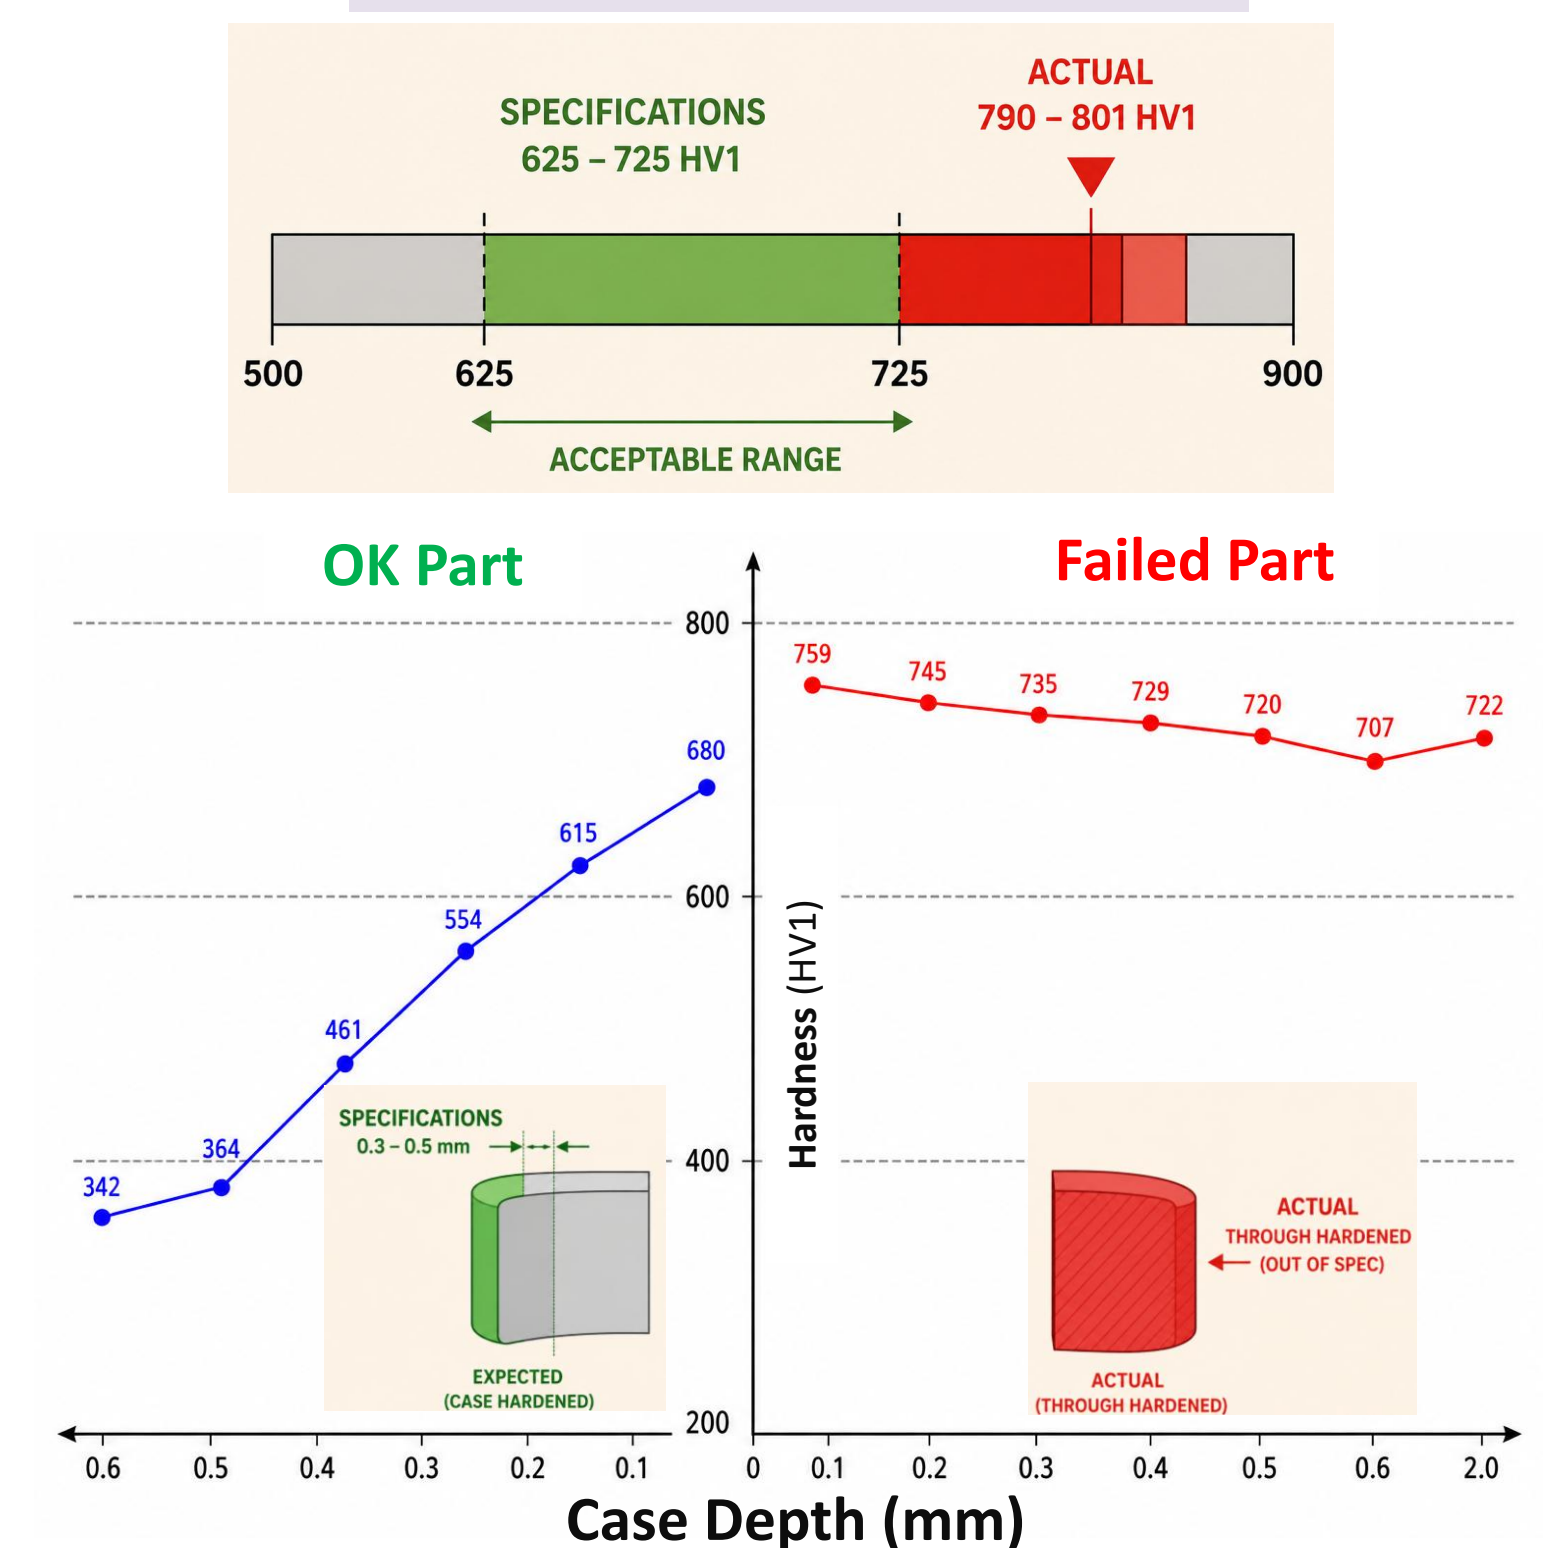
Hardness Analysis

- ✅ Identified root cause: H₂ pick up on the tip of the tooth during hardening treatment
- ✅ Increase in hardness induced during heat treatment, amplified the materials susceptibility to H₂ penetration and subsequent cracking.
- ✅ Corrective actions on heat treatment process, and furnace environment are necessary.
