# Susceptibility to stress-corrosion cracking of long-operated gas pipeline steel in a model soil electrolyte

Department of Welding of Gas and Oil Pipes, E.O. Paton Electric Welding Institute of the National Academy of Sciences of Ukraine  
Kazymyr Malevich Str., 11, Kyiv, Ukraine

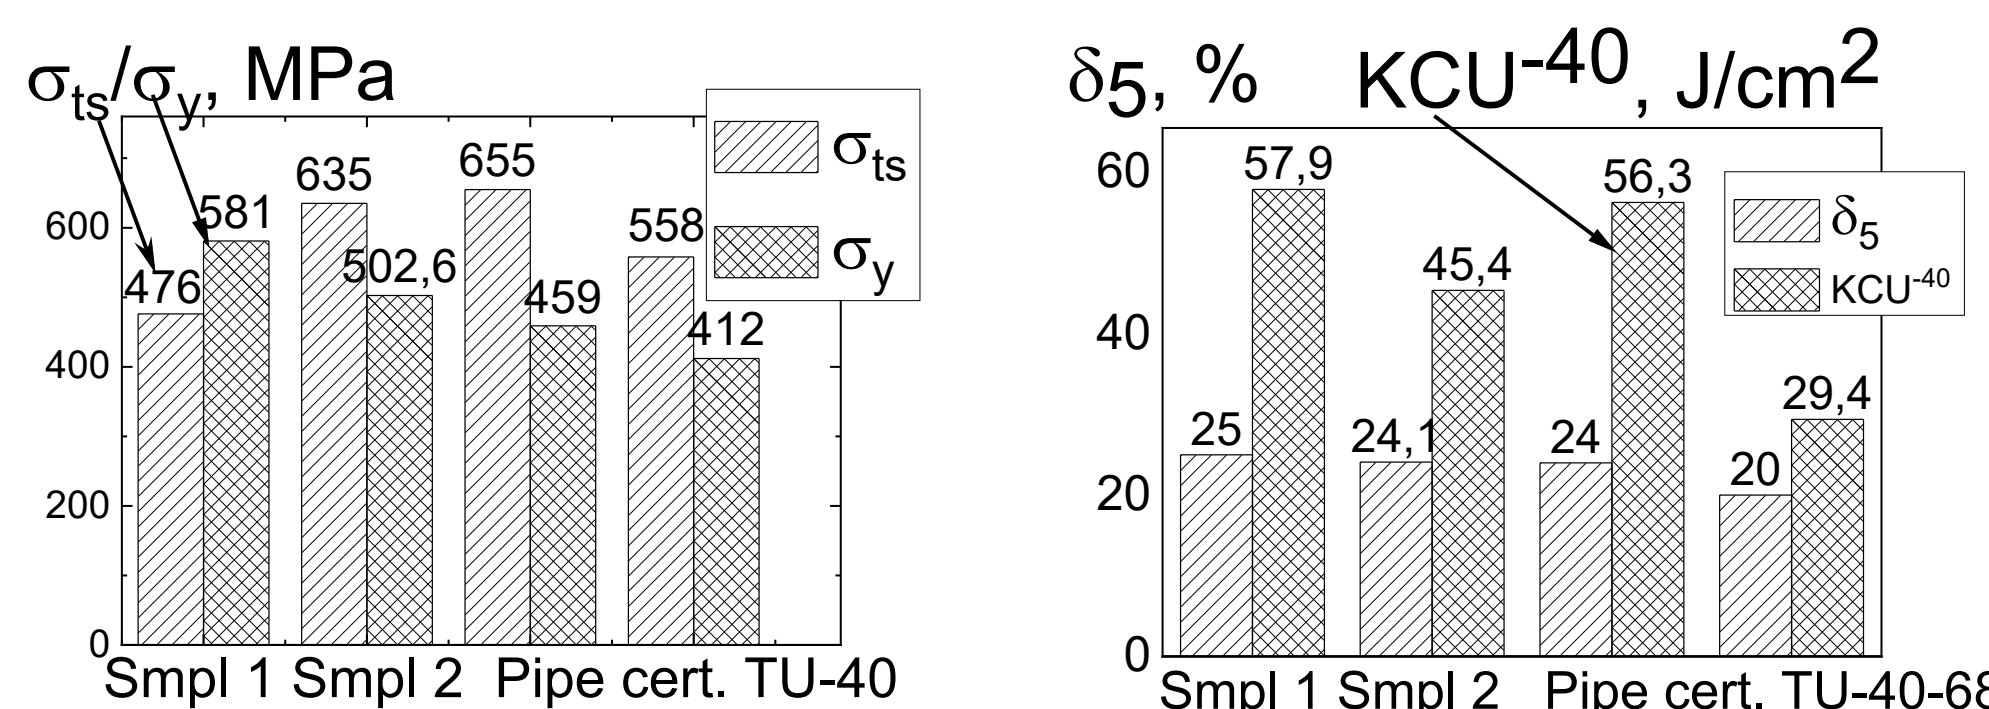
Figure 2. Mechanical properties of the investigated samples in comparison with the pipe certificate data and technical requirements.

The mechanical properties ( $\sigma_{ts}$  and  $\sigma_y$ ) of pipe Sample 2 are slightly higher than those of Sample 1, but remain within the limits specified by the TU-40-68 (Figure 2). Differences were observed in Sample 1 compared with the certificate data: lower tensile strength and higher yield strength. For Sample 2, the tensile strength corresponds to the certificate, while the yield strength is slightly higher. The toughness properties of both pipes, despite deviations from certificate data, are within the TU-40-68 requirements. It can be concluded that after long-term operation, the strength and plasticity of the base metal, both in the intact pipe and in the pipe with a detected damage zone, meet the technical conditions.

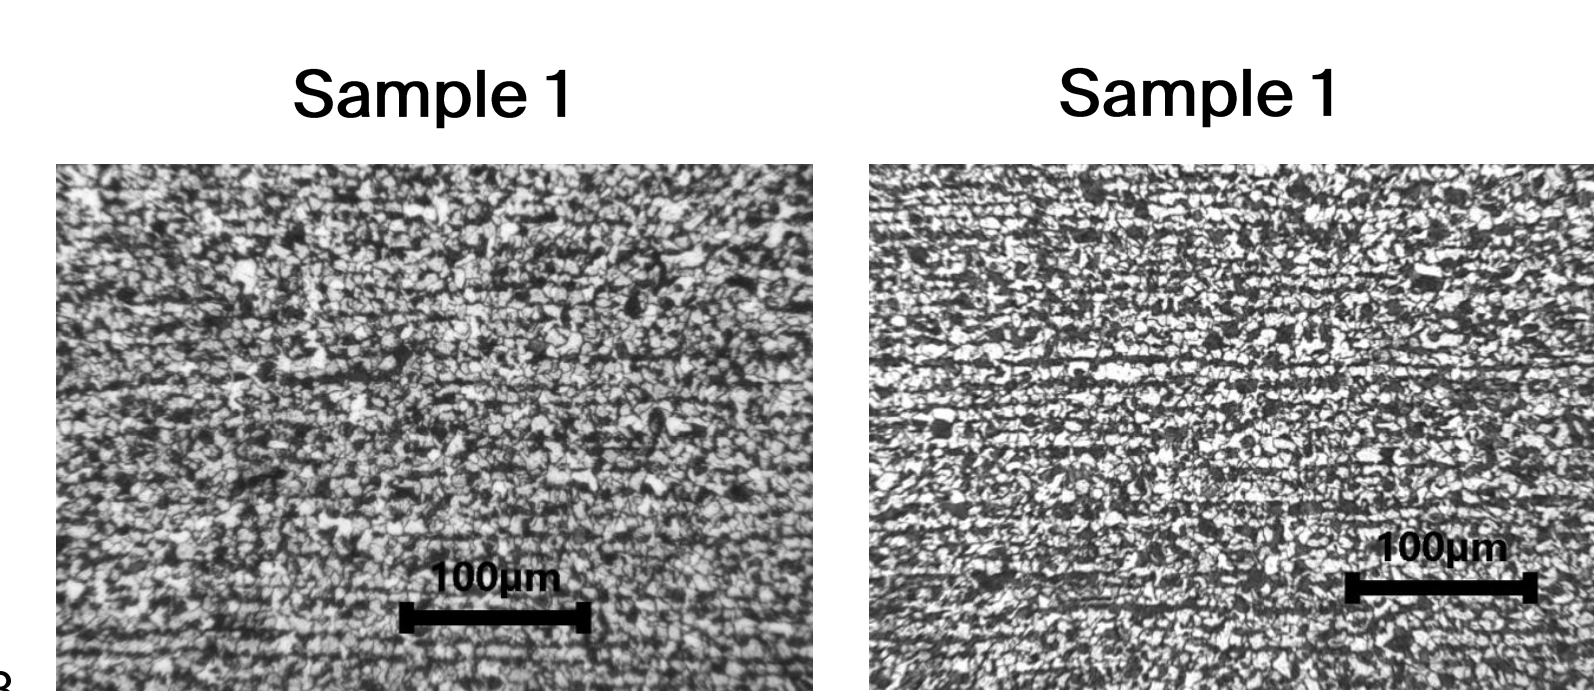
Figure 3. Microstructure of the base metal of the investigated pipes.

The microstructure of Sample 1 and Sample 2 is typical for the steel manufactured in the XX century – ferritic-pearlitic with fine ferrite grains (20-25) microns in size (Figure 3). The share of the pearlite component was (50-60)% and is approximately the same for both pipes.

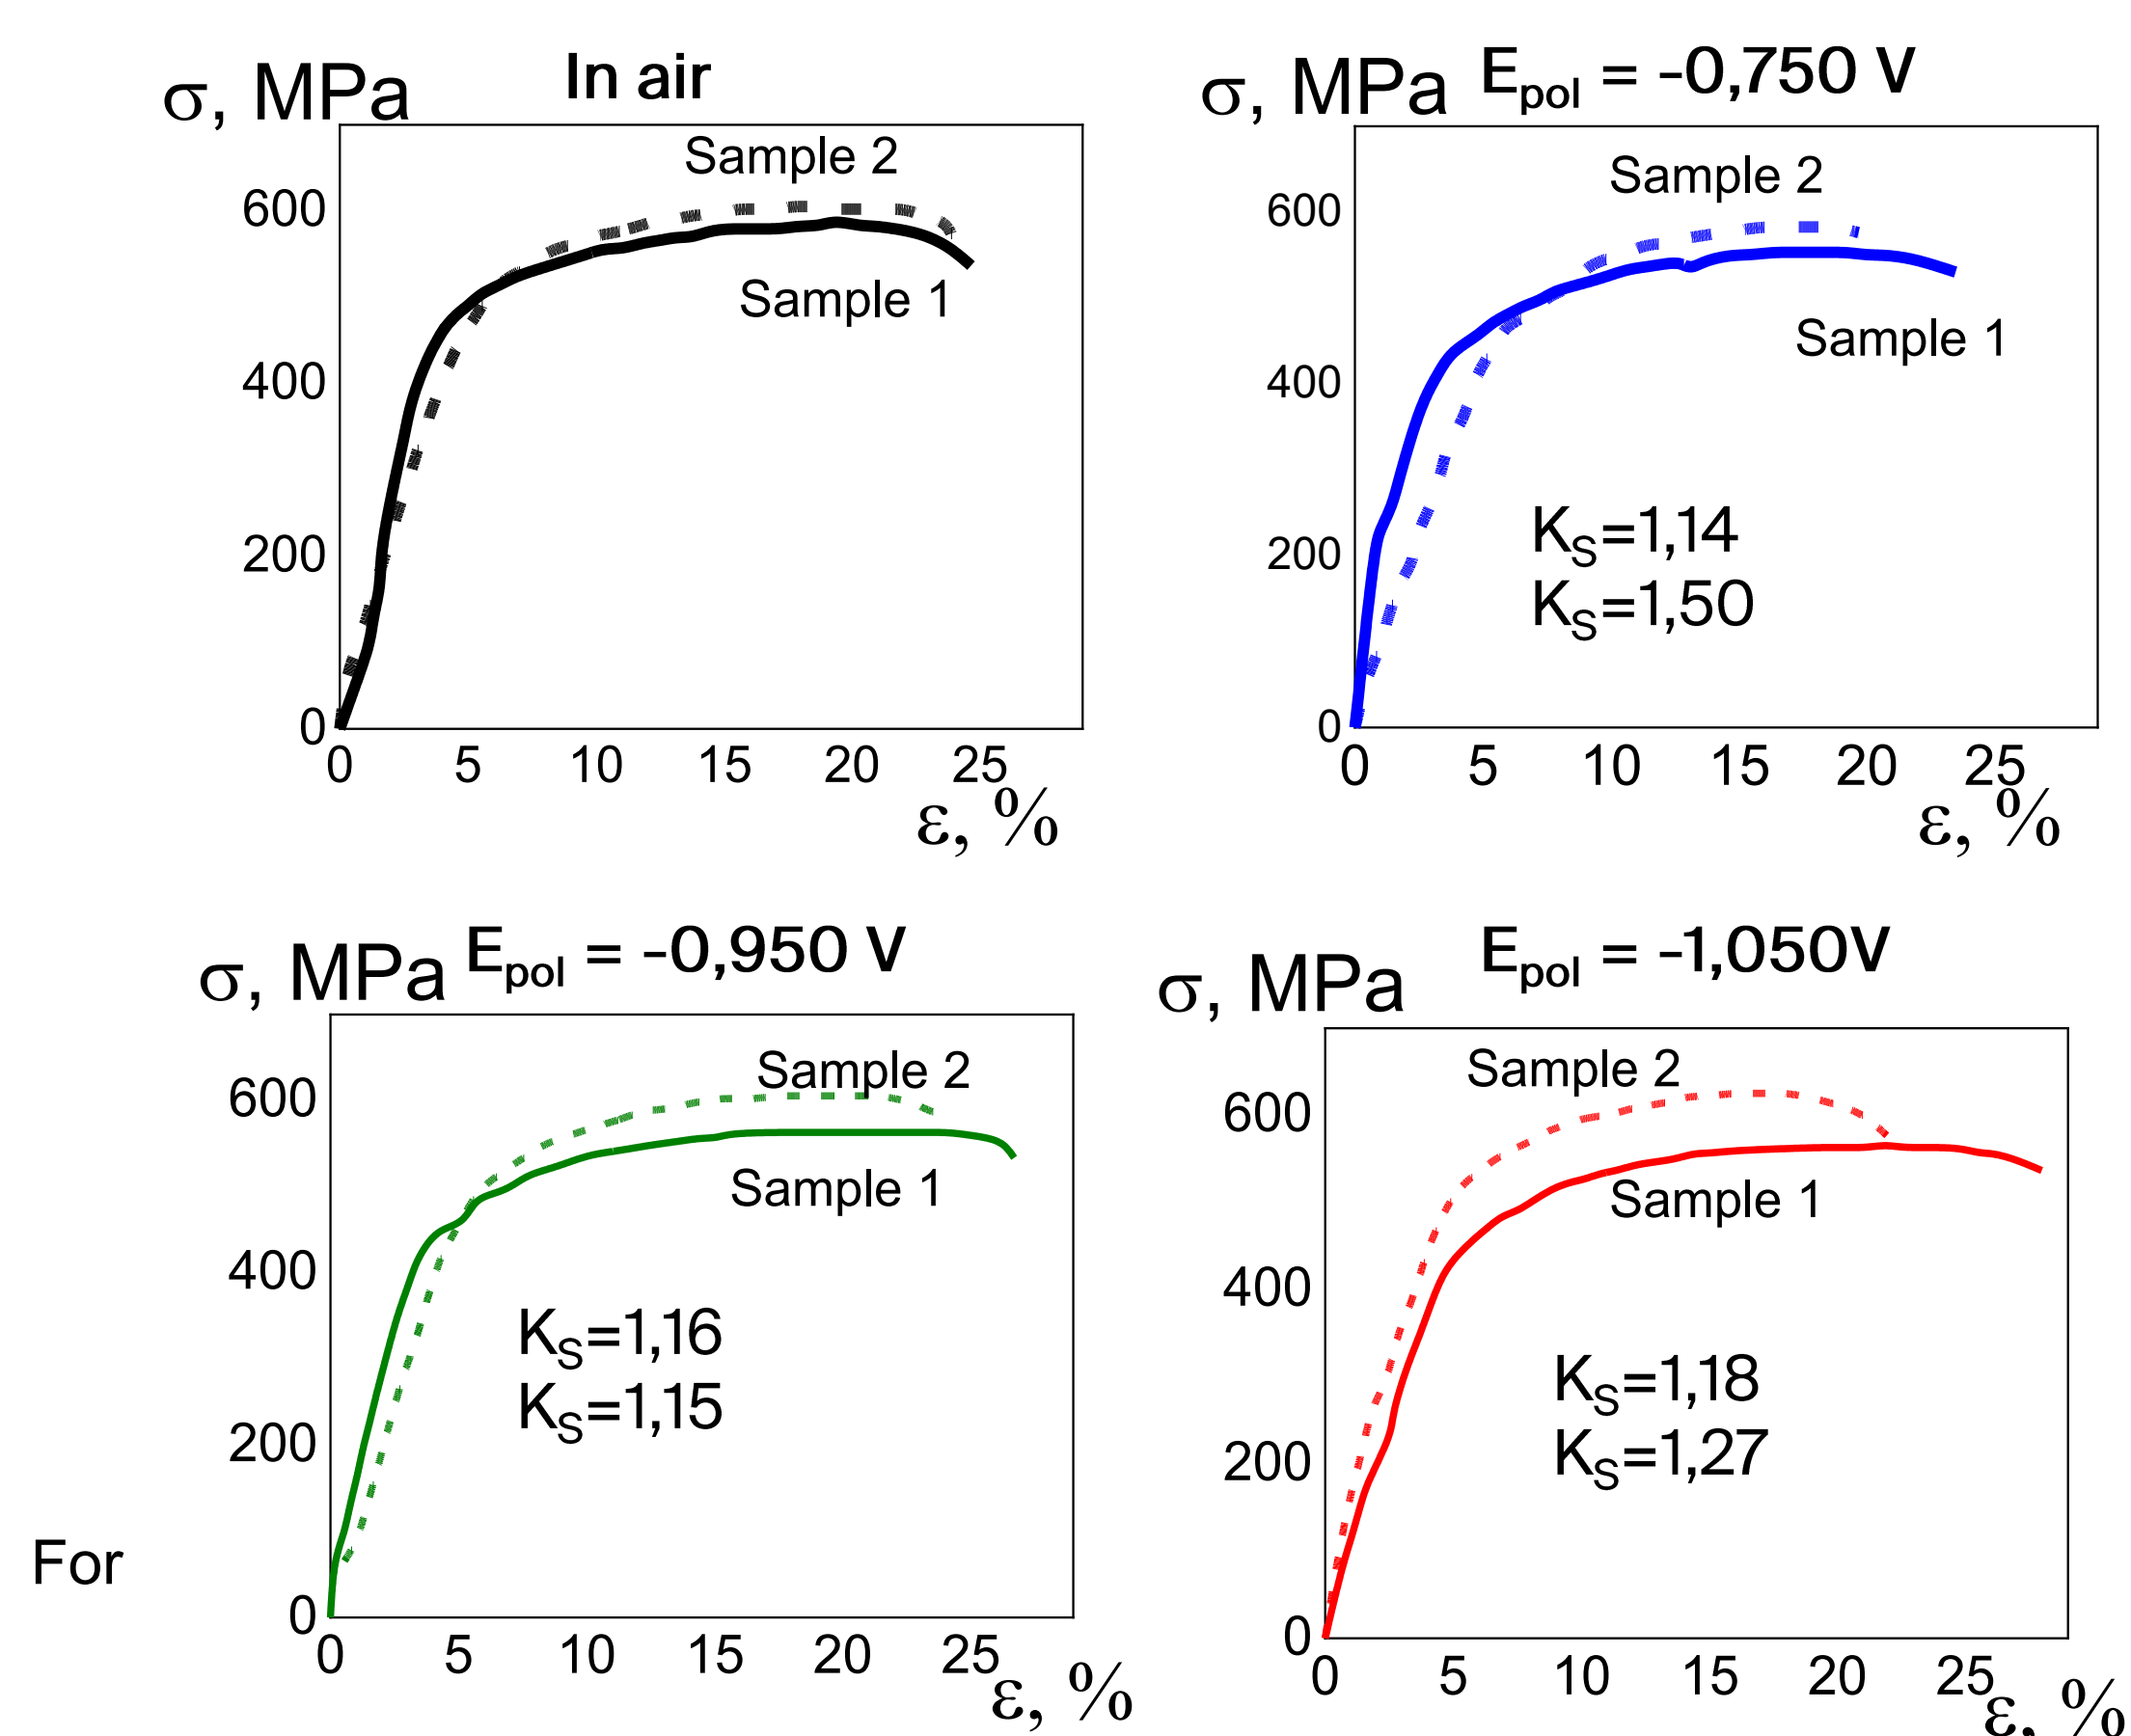
Figure 4. Breaking diagrams of the investigated samples during long-term tensile tests in air and in NS4 solution under conditions of cathodic polarization potentials.

It was found that specimens of damaged pipe demonstrated higher maximum stress, lower relative elongation and relative narrowing at the potential of -1.05 V than specimens from an undamaged pipe (Figure 4). Such patterns may be due to pipe deformation during the accident and the influence of local anodic dissolution.

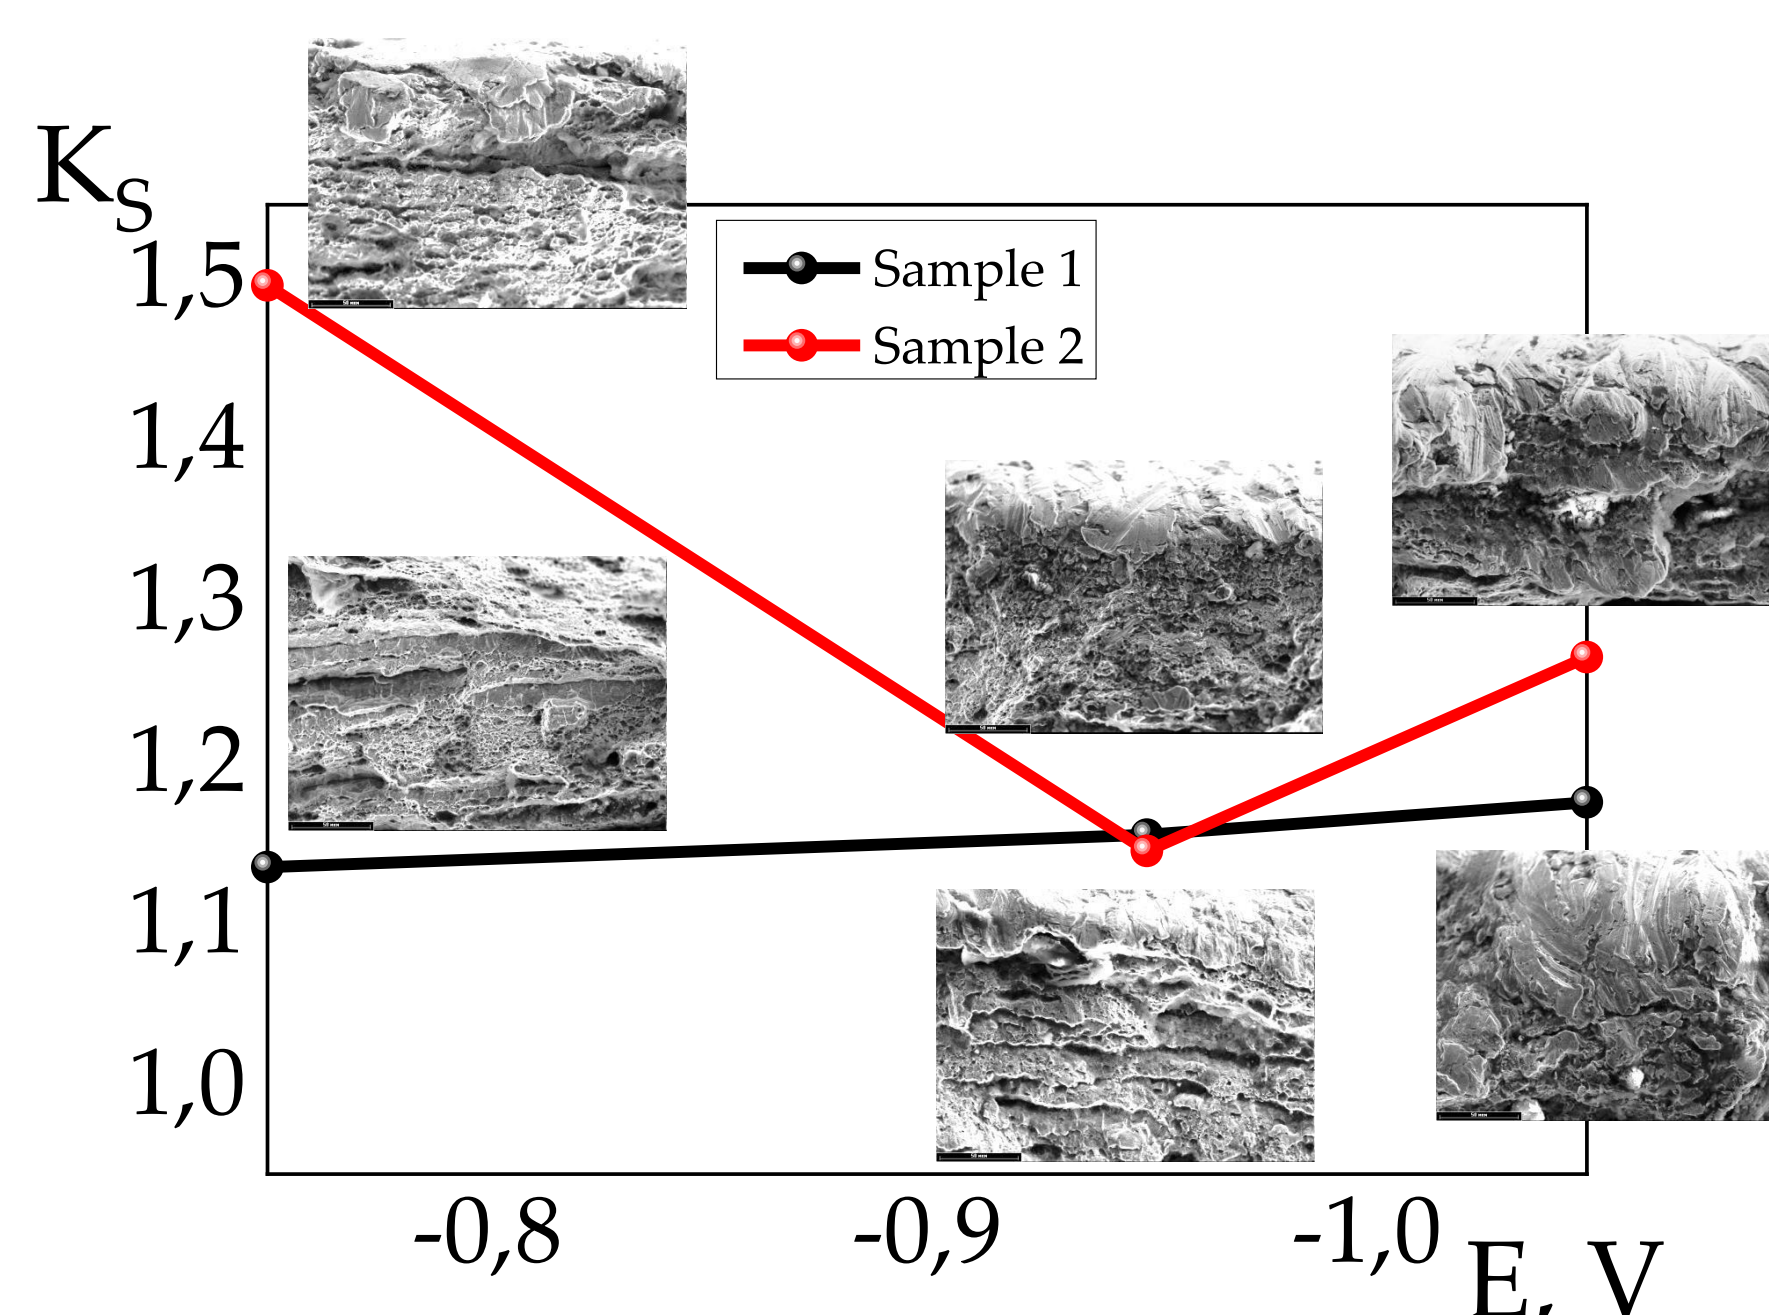
Figure 5. Susceptibility to stress-corrosion cracking of the investigated samples within the range of protective potentials normalized by National Standard 4219 and SEM images of fracture surface.

Susceptibility to stress-corrosion cracking coefficient  $K_S$  for the metal of an undamaged pipe (Sample 1) at the polarization potential range from -0.75 V to -1.05 V (relative to the saturated silver chloride electrode) in NS4 increases from 1.14 to 1.18 (Figure 4, Figure 5). For specimens of damaged pipe (Sample 2), the maximum  $K_S$  value 1.5 is observed at -0.75 V, and it decreases to 1.27 at -1.05 V (Figure 5).

The fracture analysis of both undamaged and damaged pipes under cathodic polarization in the range -0.75 V to -1.05 V demonstrates a progressive increase in brittle features despite the overall ductile fracture mode. In the undamaged pipe (Sample 1), this transition occurs gradually, whereas in the damaged one (Sample 2) the brittle component intensifies more sharply, accompanied by higher  $K_S$  values and a greater presence of faceted fracture surfaces. These findings indicate that prior mechanical damage significantly accelerates susceptibility to stress-corrosion cracking under protective potentials, underscoring the critical role of structural integrity in determining fracture behavior.
