Combined ND techniques for structural assessment: the case of historic Nepali constructions after the 2015 Gorkha earthquake [†]

This study presents an experimental investigation on two Nepali Pagoda temples damaged by the 2015 Gorkha Earthquake, namely Jagannath Temple in Kathmandu Durbar Square and Krishna Temple in Bhaktapur Durbar Square.

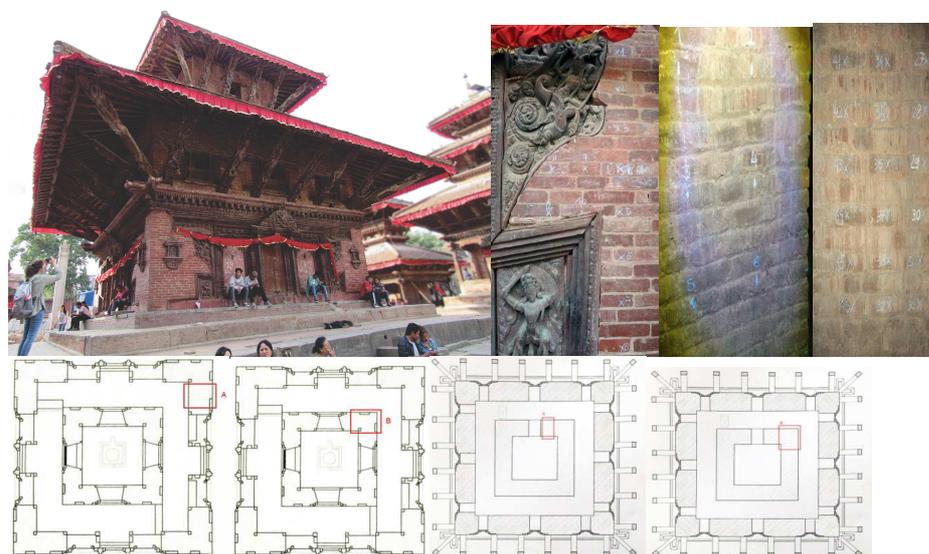
The first historic construction investigated with both STs and AVMs is Jagannath Temple (Figure 1). STs have been applied in four zones, as indicated again in Figure 1. Some results are reported in Table 1 for zone A. Masonry density has been assumed according to [14].

Figure 1. Jagannath Temple, Kathmandu.

In detail, the analysis of the results confirms the effects of damage and its distribution. In particular, it is evident from Table 1 that the zone in correspondence of the first floor appears less damaged than that at the ground floor.

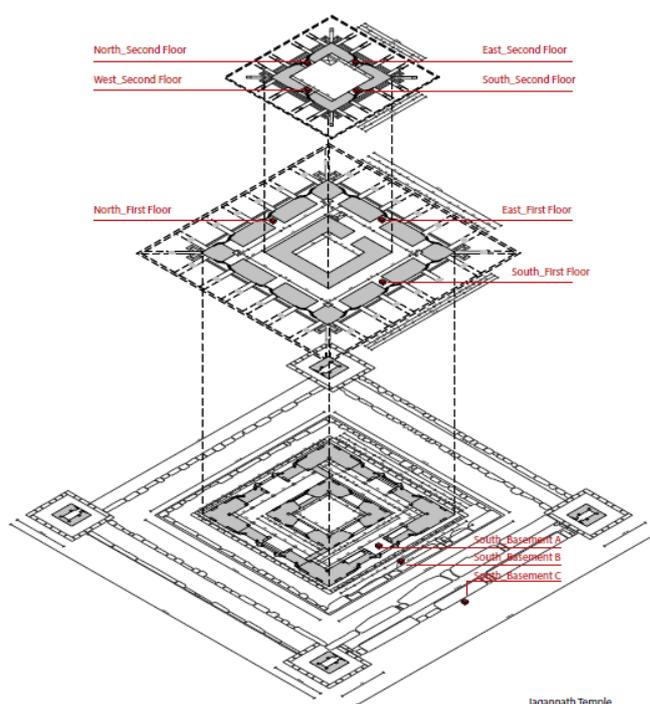
AVMs were accomplished on 23rd October 2016. The measurements on the south basement were accomplished on 29th October 2016. The locations of the velocimeter are shown in Figure 2. The record duration was 16 min for the south basement, 6 min at the north side of first floor and 10 min for the remaining records. The sampling frequency was 128 Hz. The Fourier amplitude spectra of velocity are shown in Figure 3.

Figure 2. Locations of the velocimeter, Jagannath Temple.

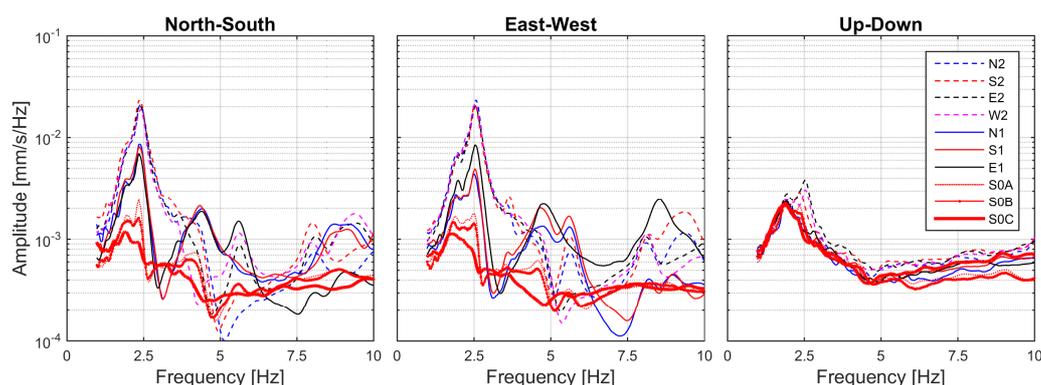
Figure 3. Fourier amplitude spectra of velocity, Jagannath Temple.

The first two frequencies correspond to the fundamental modes along the NS ($f_1 = 2.3$ Hz) and EW ($f_2 = 2.5$ Hz) directions, respectively. Similarly, the third and fourth frequencies correspond to the second modes along the NS ($f_3 = 4.3$ Hz) and EW ($f_4 = 4.7$ Hz) directions, respectively. The fifth frequency ($f_5 = 5.6$ Hz) corresponds to the first torsional mode around the vertical axis, as the N and S walls move along the EW direction, and the E and W wall along the NS direction. Two frequencies follow ($f_6 = 8.1$ Hz, $f_7 = 8.6$ Hz) without clear indications about their modal shape. The eighth frequency ($f_8 = 9.1$ Hz) correspond to the third mode along the NS direction. Finally, the ninth frequency ($f_9 = 9.4$ Hz) corresponds to the second torsional mode around the vertical axis. The measures at the second floor show the typical coupling between the horizontal and the vertical components due to the global bending response of the building. No significant peak was detected at the basement, south side, outside the temple, showing the absence of local amplification effects.

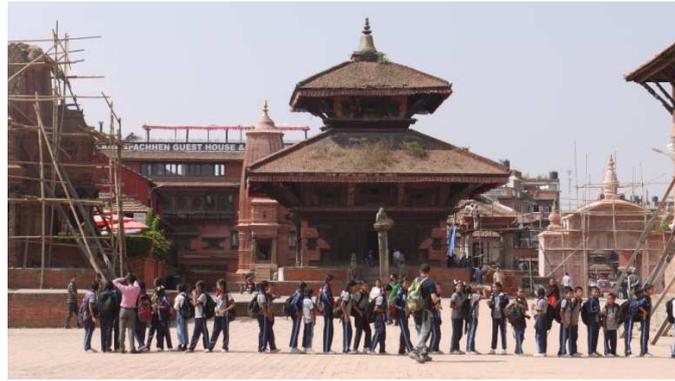
In the case of Krishna Temple (Figure 4), STs, of direct and indirect type, have been applied at the base of the masonry bearing parts, as indicated in Tables 2 and 3.

Figure 4. Krishna Temple, Bhaktapur.

According to well established relations between sonic wave velocity and masonry compactness, Table 2 confirms that the latter is low along both the horizontal and the vertical directions. This is probably due to internal damage and low level of maintenance. Moreover, the very low values of the sonic waves along the vertical direction over short distance (450 mm) highlight the poor mechanical performance of mud mortar joints.

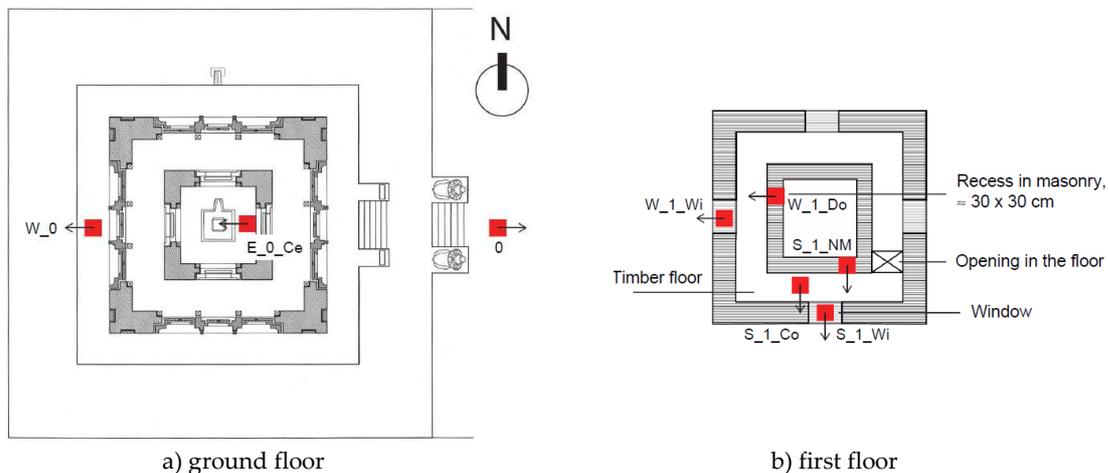
AVMs were accomplished on 24th October 2016. The locations of the velocimeter are shown in Figure 5. The arrows show the instrumental N direction. The duration of each record was 16 min and the sampling frequency 128 Hz. The Fourier amplitude spectra of velocity are shown in Figure 6.

Figure 5. Locations and orientations of the velocimeter, Krishna Temple.

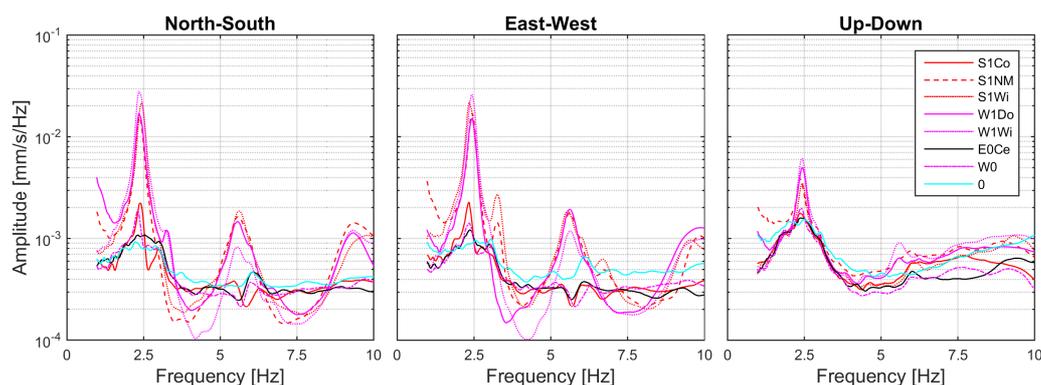
The first two frequencies ($f_1 = 2.3$ Hz, $f_2 = 2.4$ Hz) have mixed components, along the NS and EW directions, possibly with torsion. The third frequency ($f_3 = 3.3$ Hz) corresponds to the first torsional mode around the vertical axis (the S wall moves along the EW direction and the W wall along the NS direction). The fourth frequency ($f_4 = 5.6$ Hz) has mixed components along the NS and EW directions. The fifth frequency ($f_5 = 6.1$ Hz) corresponds to the free-field and the basement, showing local amplification effects. Finally, the last three frequencies ($f_6 = 6.5$ Hz, $f_7 = 9.4$ Hz, $f_8 = 9.8$ Hz) have again mixed components along the NS and EW directions. Coupling between the horizontal and the vertical components can be found at the first floor.

Figure 6. Fourier amplitude spectra of velocity, Krishna Temple.
