Mapping and Detecting Influences of Vegetation Cover on Runoff and Torrents in Khartoum State, Sudan

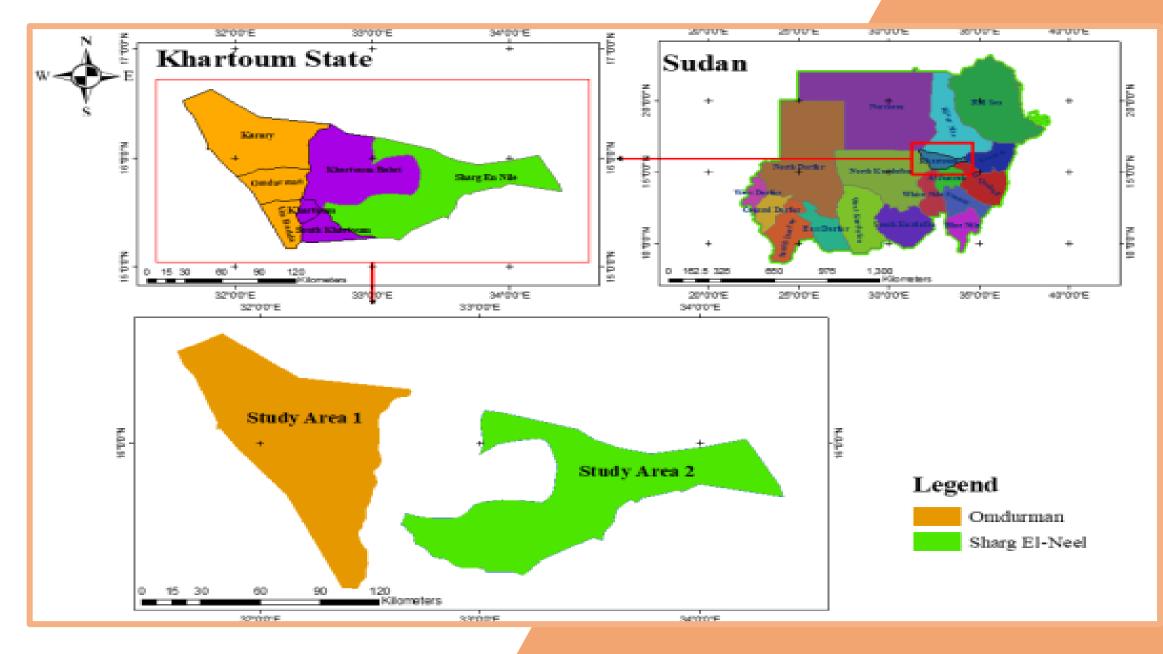
Fig.1: Map of the Study Area

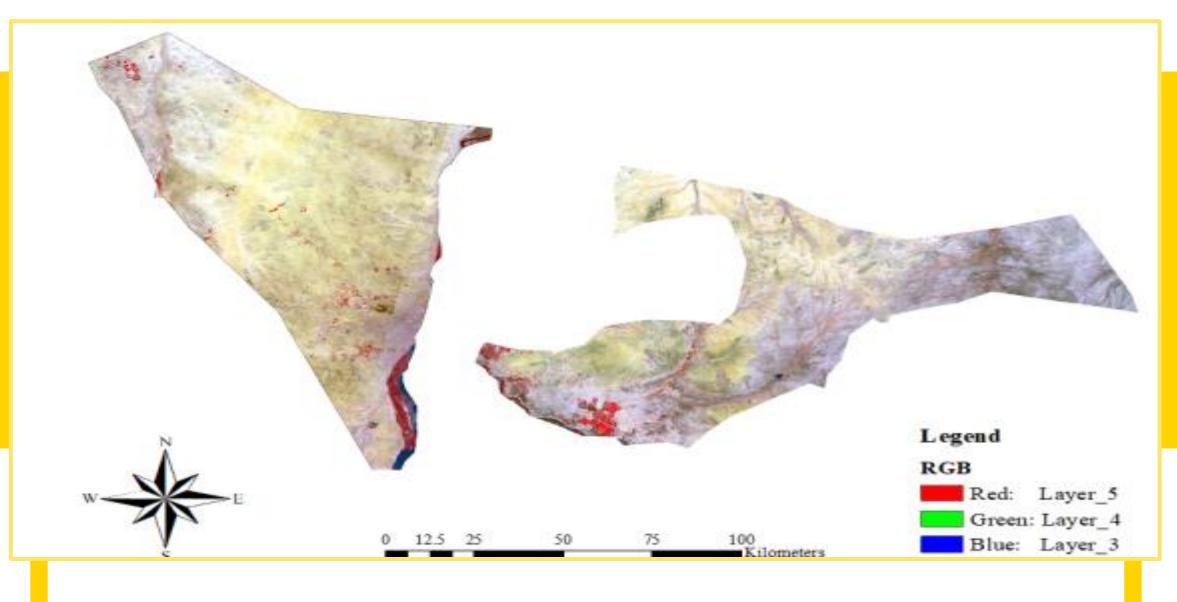
Fig.2: Landsat Images of the Study Area

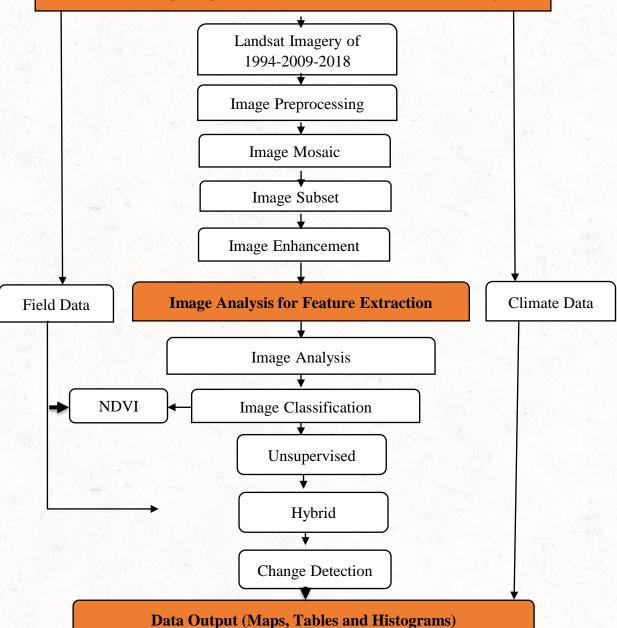
Fig.4: Flow diagram for the Data Analysis

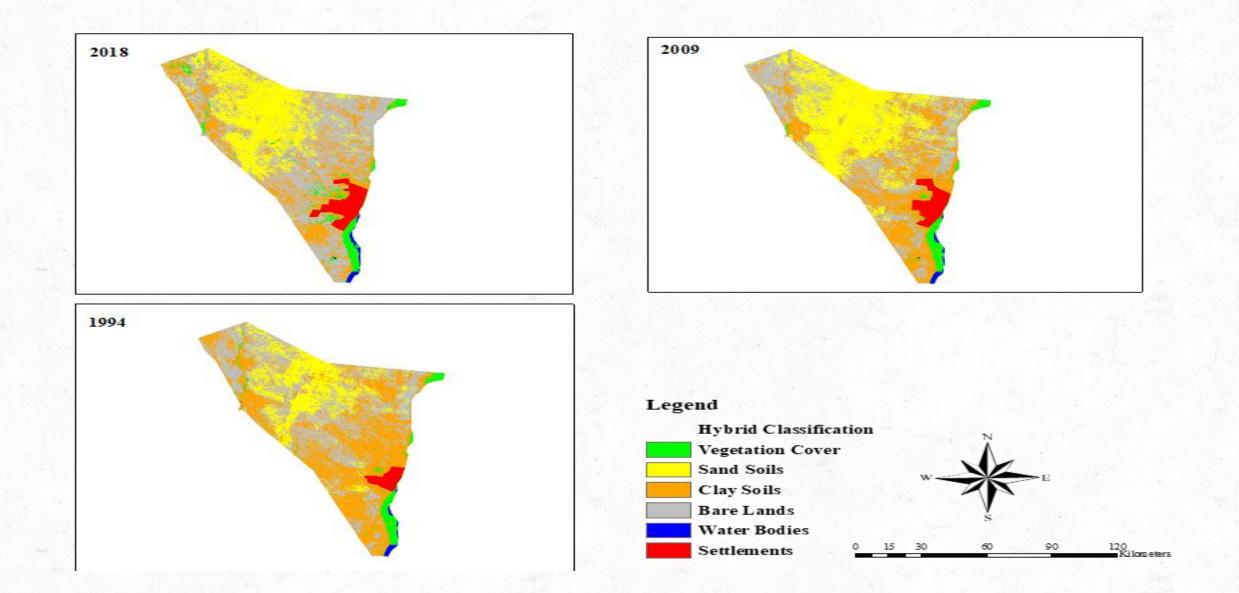
Fig.5: LULC Classification of Omdurman Area Over 1994, 2009 and 2018

Table1: Changes in the LULC Areas of Omdurman Over 1994, 2009 and 2018

Years	1994		2009		2018		LULC Changes		
LULC classes	(ha)	(%)	(ha)	(%)	(ha)	(%)	1994-2009	2009-2018	1994-2018
Vegetation Cover	24906.7	3.2	23600.9	3.1	32603.8	4.2	-130508	9002.9	7697.1
Sandy Soils	143586	18.6	269468	34.9	213382	27.6	125882	-56086	69 <mark>796</mark>
Clay Soils	310723	40.2	213652	27.6	163485	21.2	-97071	-50167	-147248
Bare Lands	274053	35.5	231619	30	321493	41.6	-42434	89874	47440
Water Bodies	3710.16	0.5	4185.99	0.5	5213.7	0.7	475.83	1027.71	1503.54
Settlements	15943.4	2.1	30396.1	3.9	36745.2	4.8	14452.7	6349.1	20801.8

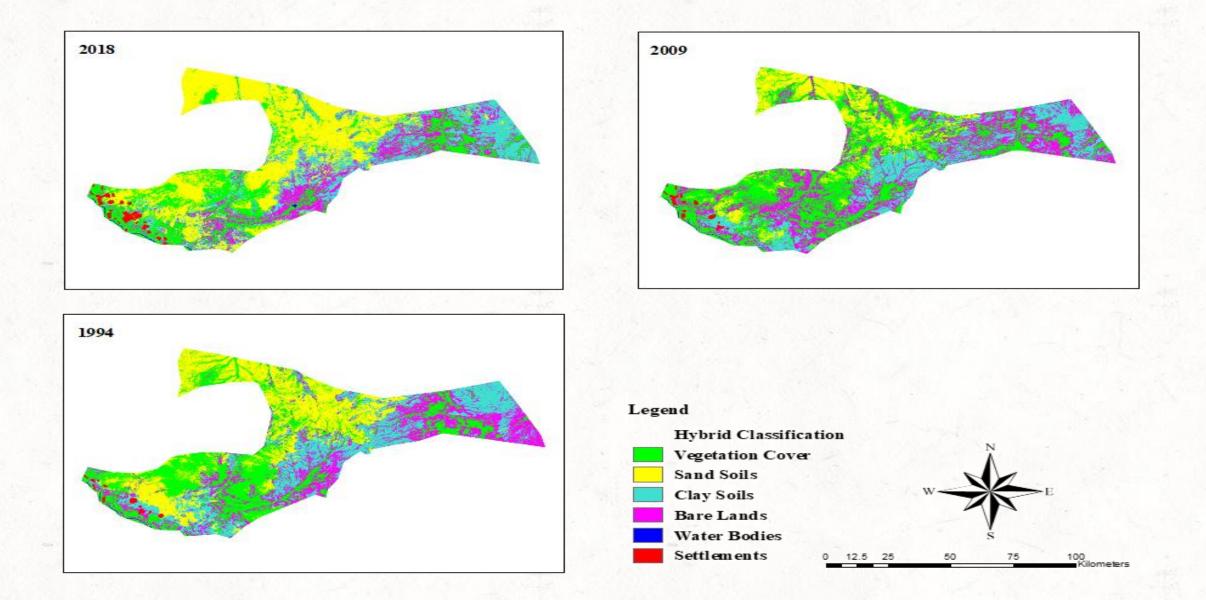
Fig.6: LULC Classification of Sharg El-Neel Area Over 1994, 2009 and 2018

Table 3: Changes in the LULC Areas of Sharg El-Neel Over 1994, 2009 and 2018

Years	1994		2009		2018		LULC Changes		
LULC classes	(ha)	(%)	(ha)	(%)	(ha)	(%)	1994-2009	2009-2018	1994-2018
Vegetation Cover	227801	31.4	299937	41.3	179520	24.7	72136	-120417	-48281
Sandy Soils	190838	26.3	107722	14.8	277683	38.3	-83116	169961	86845
Clay Soils	162326	22.4	132216	18.2	154744	21.3	-30110	22528	-7582
Bare Lands	140614	19.4	180933	24.9	102980	14.2	40319	-77953	-37634
Settlements	849.06	0.1	675.45	0.1	1364.67	0.2	-173.61	689.22	515.61
Water bodies	3310.47	0.5	4255.02	0.6	9446.58	1.3	944.55	5191.56	6136.11

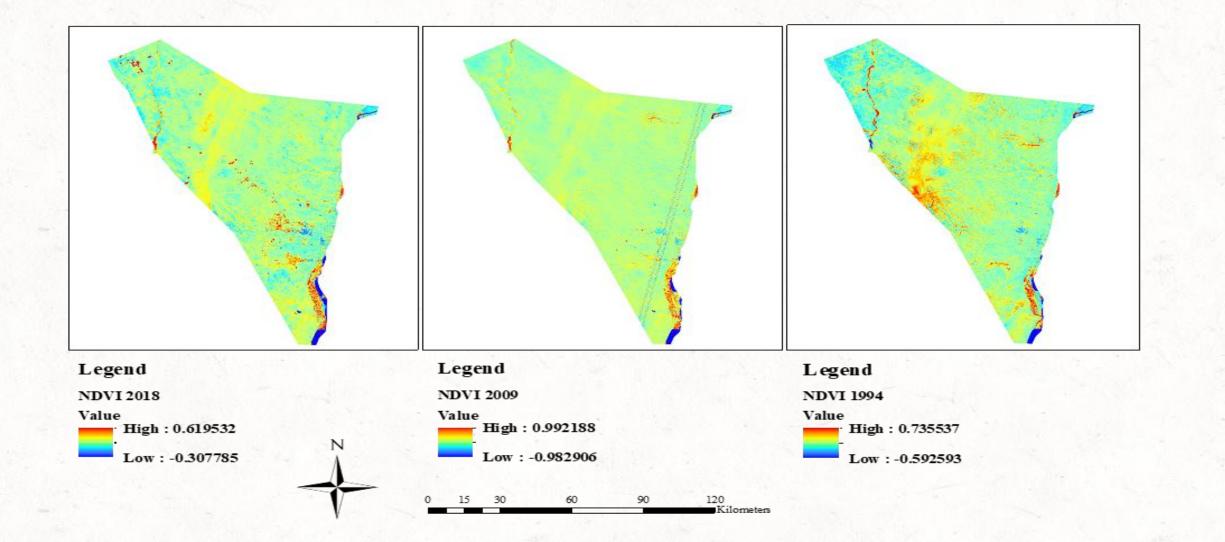
Fig.7: NDVI Value of Omdurman for the Year 1994-2009 and 2018

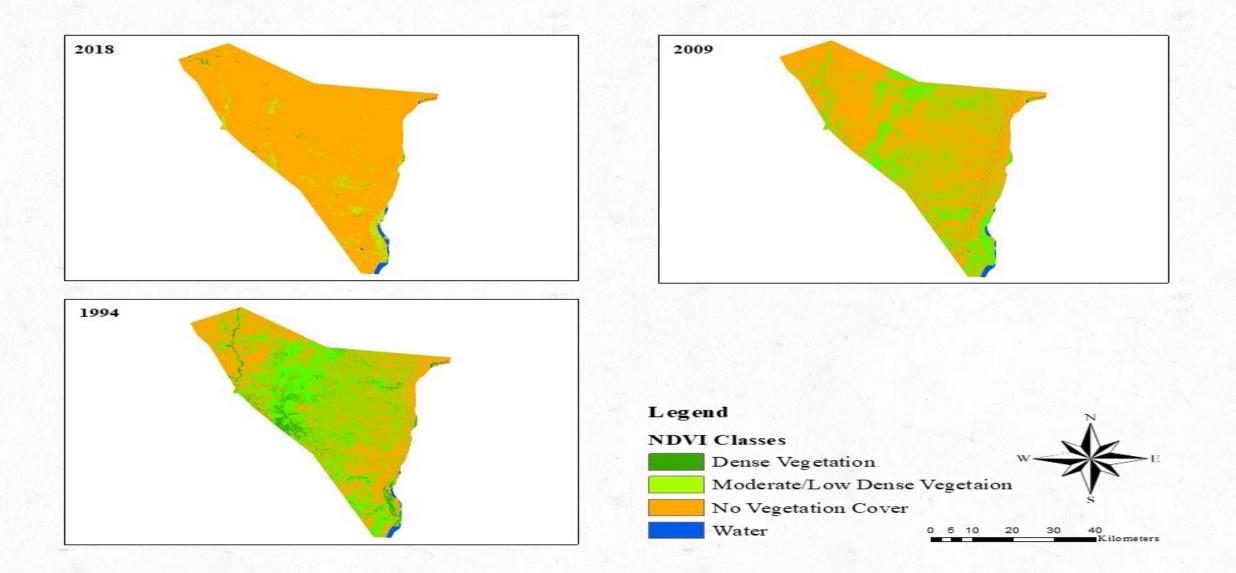
Fig.8: NDVI Classes of the Images Omdurman for the Years 1994, 2009 and 2018.

Table 2: Area of NDVI Value of Omdurman for the Years 1994, 2009 and 2018

Years	1994	2009	2018
NDVI Classes	(ha)	(ha)	(ha)
Dense Vegetation	69517.2	12259.1	15979
Moderate/Low Dense Vegetation	288962	307603	408569
No Vegetation Cover	339328	341005	342117
Water	4903.02	51220.89	6257.7

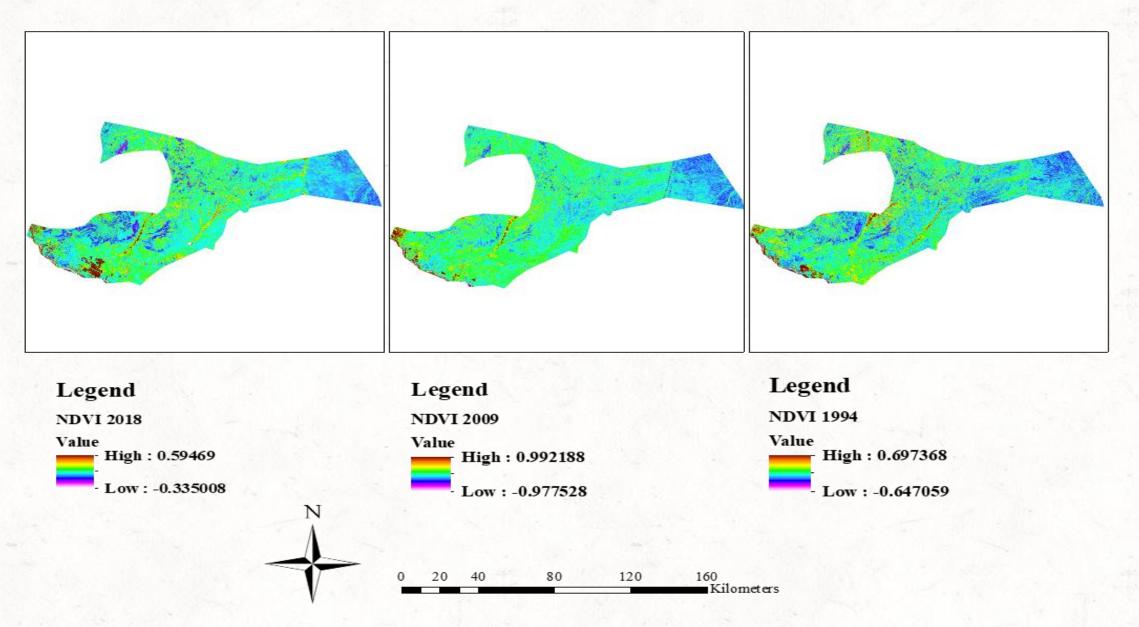
Fig.9: NDVI Images of 1994-2009 and 2018 of Sharg El-Neel Study Area

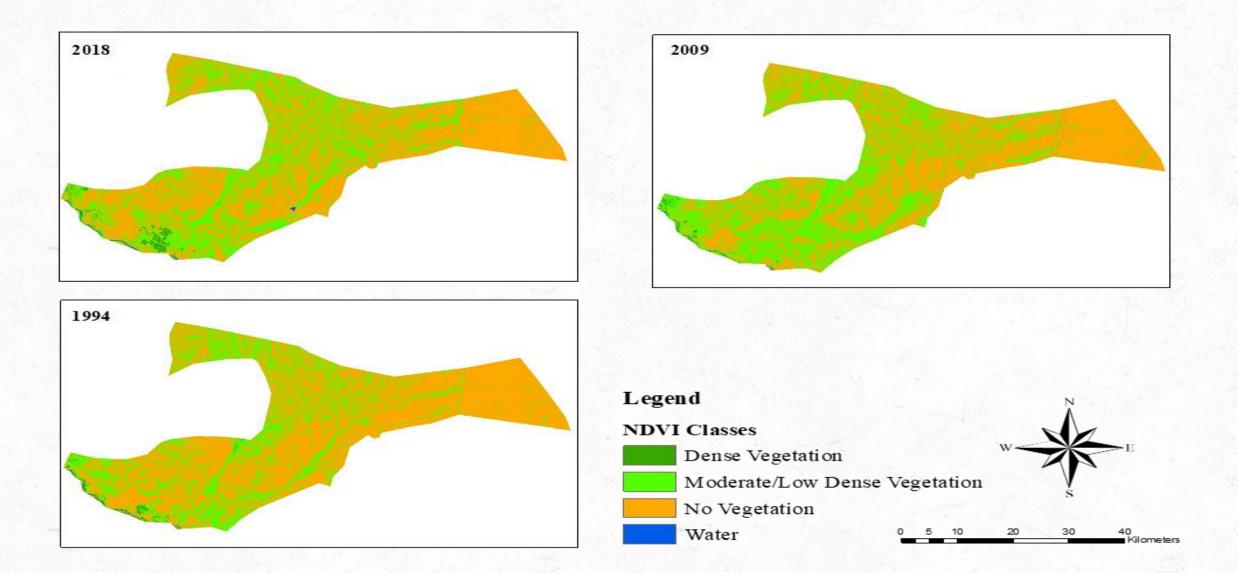
Fig.10: NDVI Classes of the Images of Sharg El-Neel for the Years 1994, 2009 and 2018

Table 4: Area of NDVI of Sharg El-Neel for the Years 1994, 2009 and 2018

Years	1994	2009	2018
NDVI Classes	(ha)	(ha)	(ha)
Dense Vegetation	14707.6	10214.9	82338.1
Moderate/Low Dense Vegetation	241468	170533	339635
No Vegetation Cover	411294	413021	176119
Water	58268.6	34663.8	30928
