# Surface-mounted smart PZT sensors for monitoring damage using EMI-based multi-sensing technique

Aditya Parpe and Jothi Saravanan Thiyagarajan

School of Infrastructure,

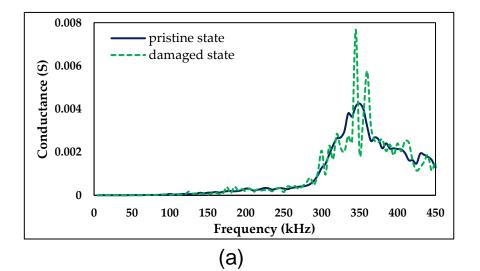
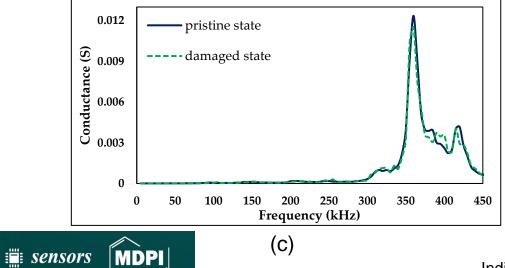
Concrete beam with multiple surface-mounted SSUs: Damage monitoring

SSU 1 SSU 1 B - 100 mm H - 100 mm L - 1000 mm

- Damage: crack of length 20 mm.
- External loading: load impactor
  ✓ 10 kN

SSU No.	1	2	3
Distance from impactor (mm)	310	110	250
Distance from crack location (mm)	70	120	480

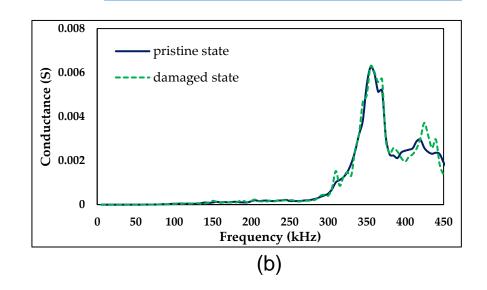
Conductance signatures obtained from (a) SSU-1; (b) SSU-2; (c) SSU-3 for the damaged concrete beam.

Conductance signatures are obtained from each SSUs at different states.

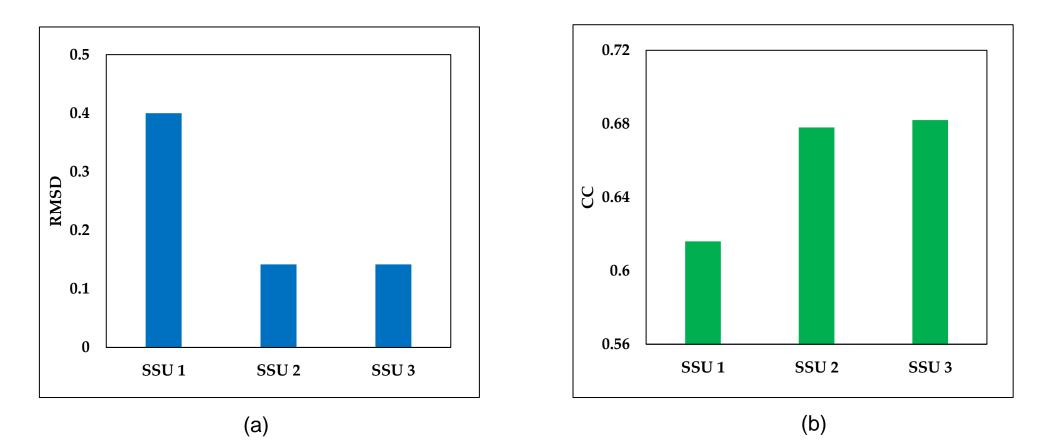
Various statistical metrics (a) RMSD; (b) CC evaluated for each SSU.

- 1. Methodology for damage detection-
  - ✓ The sensors are harmonically excited in the high-frequency range.
  - ✓ Obtaining conductance signatures at different states and comparing them.
  - Evaluating statistical metrics (namely root mean square deviation and correlation coefficient) for better understanding of trend of signatures.

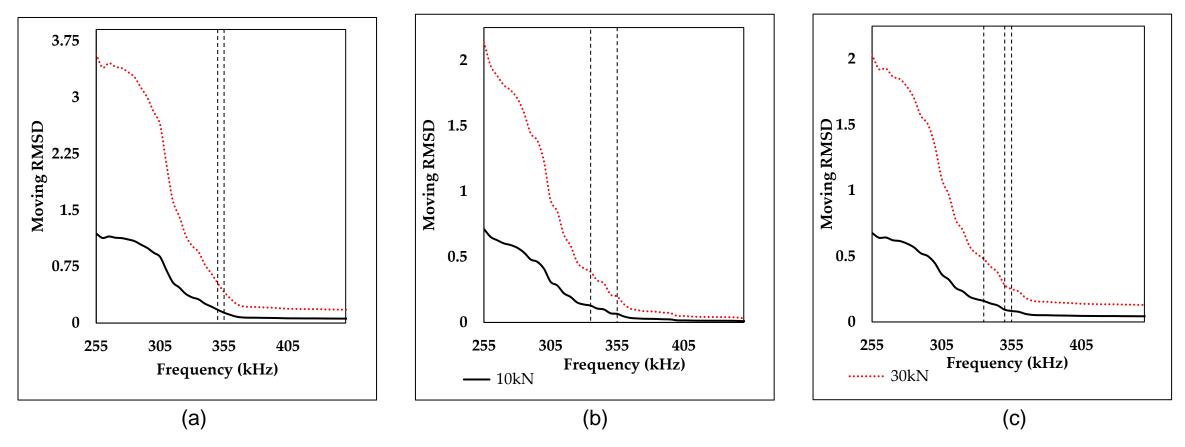
Moving RMSD plots for the combination (a) SSU 2-3; (b) SSU 1-3; (c) SSU 1-2-3 under different loading.

- 2. Methodology for damage localization-
  - The group of sensors are assumed to be in parallel connection.
  - MISO mode is preferred to obtain multiplexed signatures of particular combination.
  - ✓ Three combinations: SSU2-3, SSU1-3 and SSU1-2-3.
  - Evaluating dynamic metrics (namely moving RMSD and moving CC) for localization.
  - The magnitude of moving RMSD and moving CC.

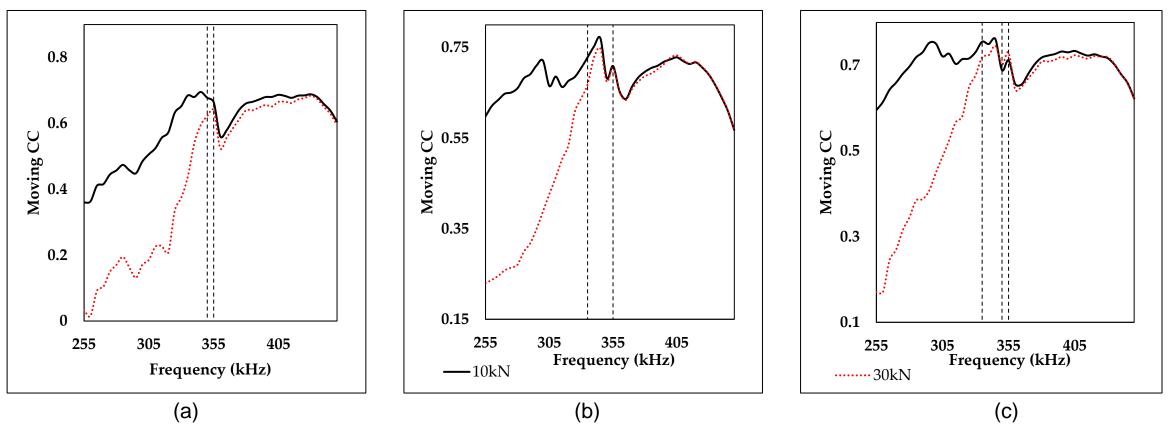
Moving CC plots for the combination (a) SSU 2-3; (b) SSU 1-3; (c) SSU 1-2-3 under different loading.

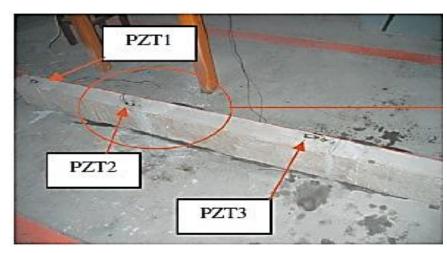
- Plain concrete beam: (100 x 200 x 2000) mm<sup>3</sup>
- Three similar type of PZT sensors
- Damage: crack induced at different location
  ✓ Case I: 10 mm long crack
  - ✓ Case II: 28 mm long crack

PZT No.	1	2	3
Distance from first crack (mm)	75	580	1390
Distance from second crack (mm)	723	68	742

Concrete beam with multiple surface-mounted SSUs: Damage monitoring

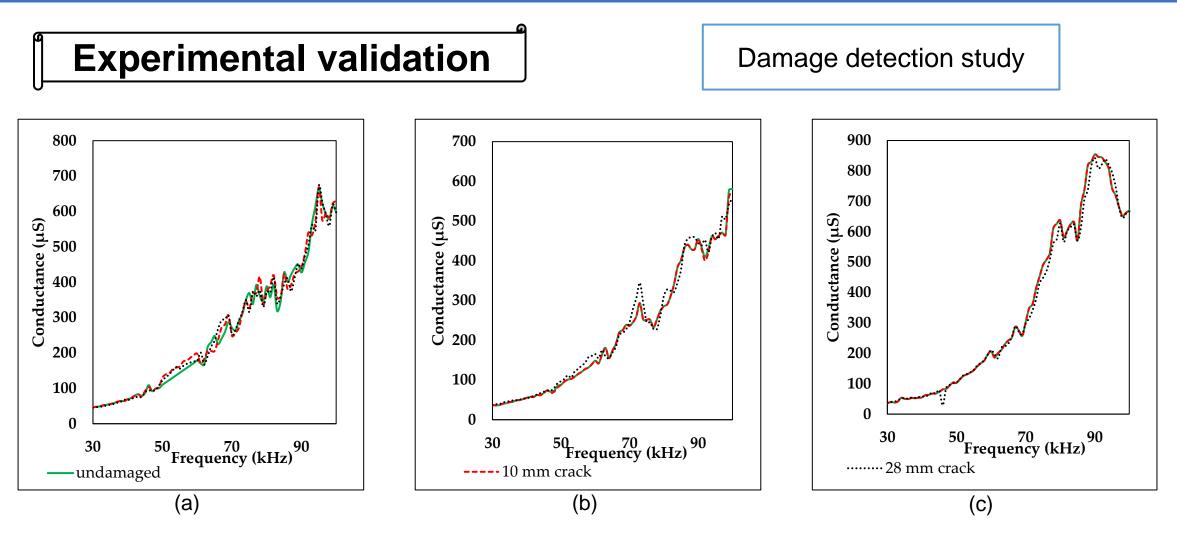
Conductance variations measured for (a) PZT-1; (b) PZT-2; (c) PZT-3 bonded to concrete beam.

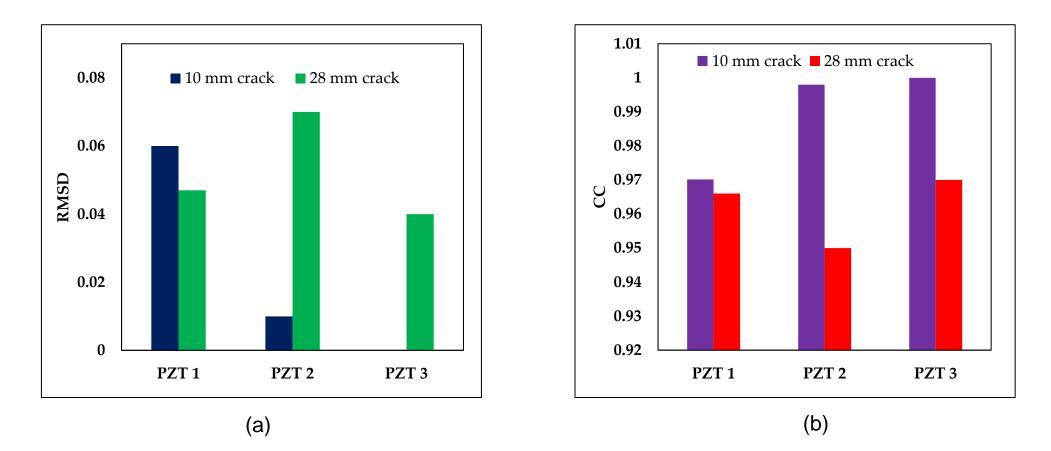
Statistical metrics (a) RMSD; (b) CC evaluated for various PZT sensors.

- The trend of experimental results shows a good correlation with the numerical results.
- Surface-mounted SSUs are working well in the concrete structures.
- The proposal of the multi-sensing technique on the surface-mounted PZT sensors is recommended for effective SHM.
- The studies based upon damage detection and localization have been performed.
