Experimental Analysis of Piezoelectric Transducers for Impedance-Based Structural Health Monitoring

Vinicius A. D. de Almeida, Fabricio G. Baptista *, Lucas C. Mendes and Danilo E. Budoya

**Department of Electrical Engineering
Faculdade de Engenharia de Bauru
UNESP – Univ Estadual Paulista**

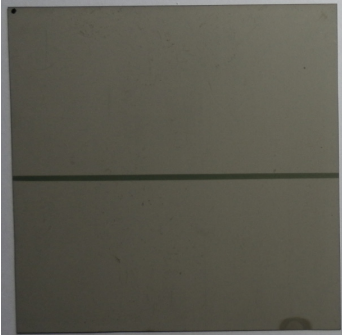
PZT (lead zirconate titanate) piezoceramic

Type: 5H

Size: 15 x 15 x 0.267 mm

MFC (macro-fiber composite)

Type: M2814-P2

Size: 37 x 18 mm

Piezoelectric diaphragm – “Buzzer”

Size: 27 mm (external diameter)

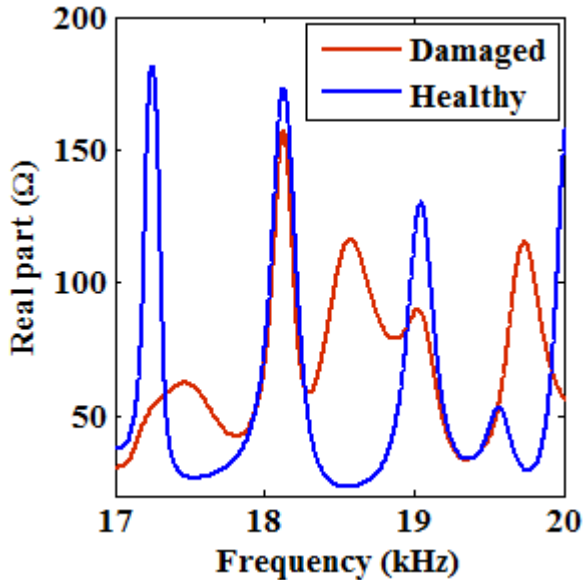
- Comparison of two electrical impedance signatures: **healthy condition** and **damaged condition**
- We used the real part of the electrical impedance

RMSD

Root mean square deviation

$$RMSD = \sum_{k=\omega_l}^{\omega_F} \sqrt{\frac{[Z_{E,D}(k) - Z_{E,H}(k)]^2}{Z_{E,H}^2(k)}}$$

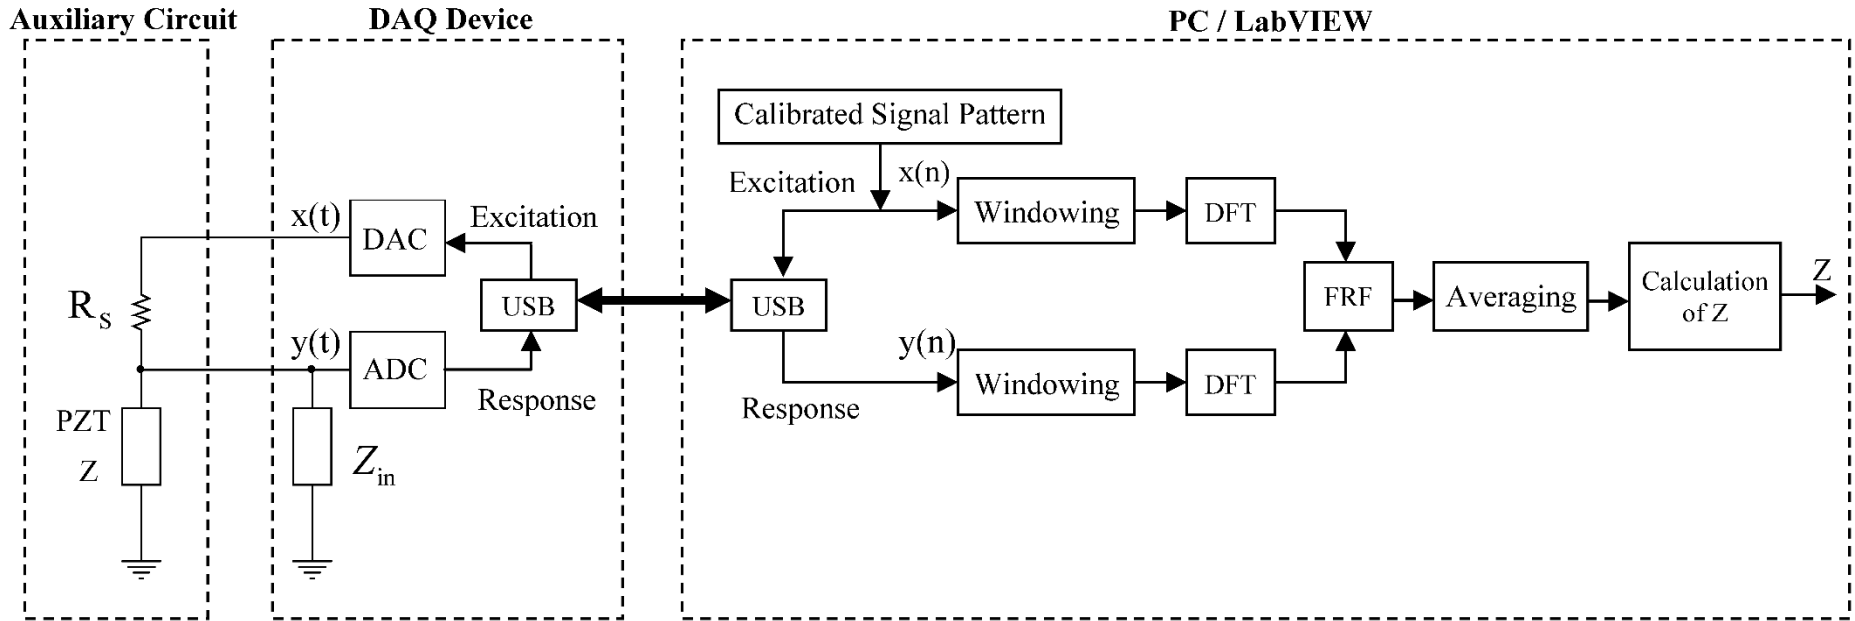
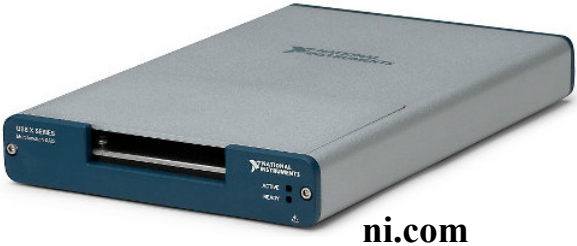
Measurement System

NI USB-6361

Configuration

- Sampling rate: **2 MS/s**
- Excitation voltage: **1 V**
- Frequency range: **0 – 500 kHz**
- Frequency step: **2 Hz**

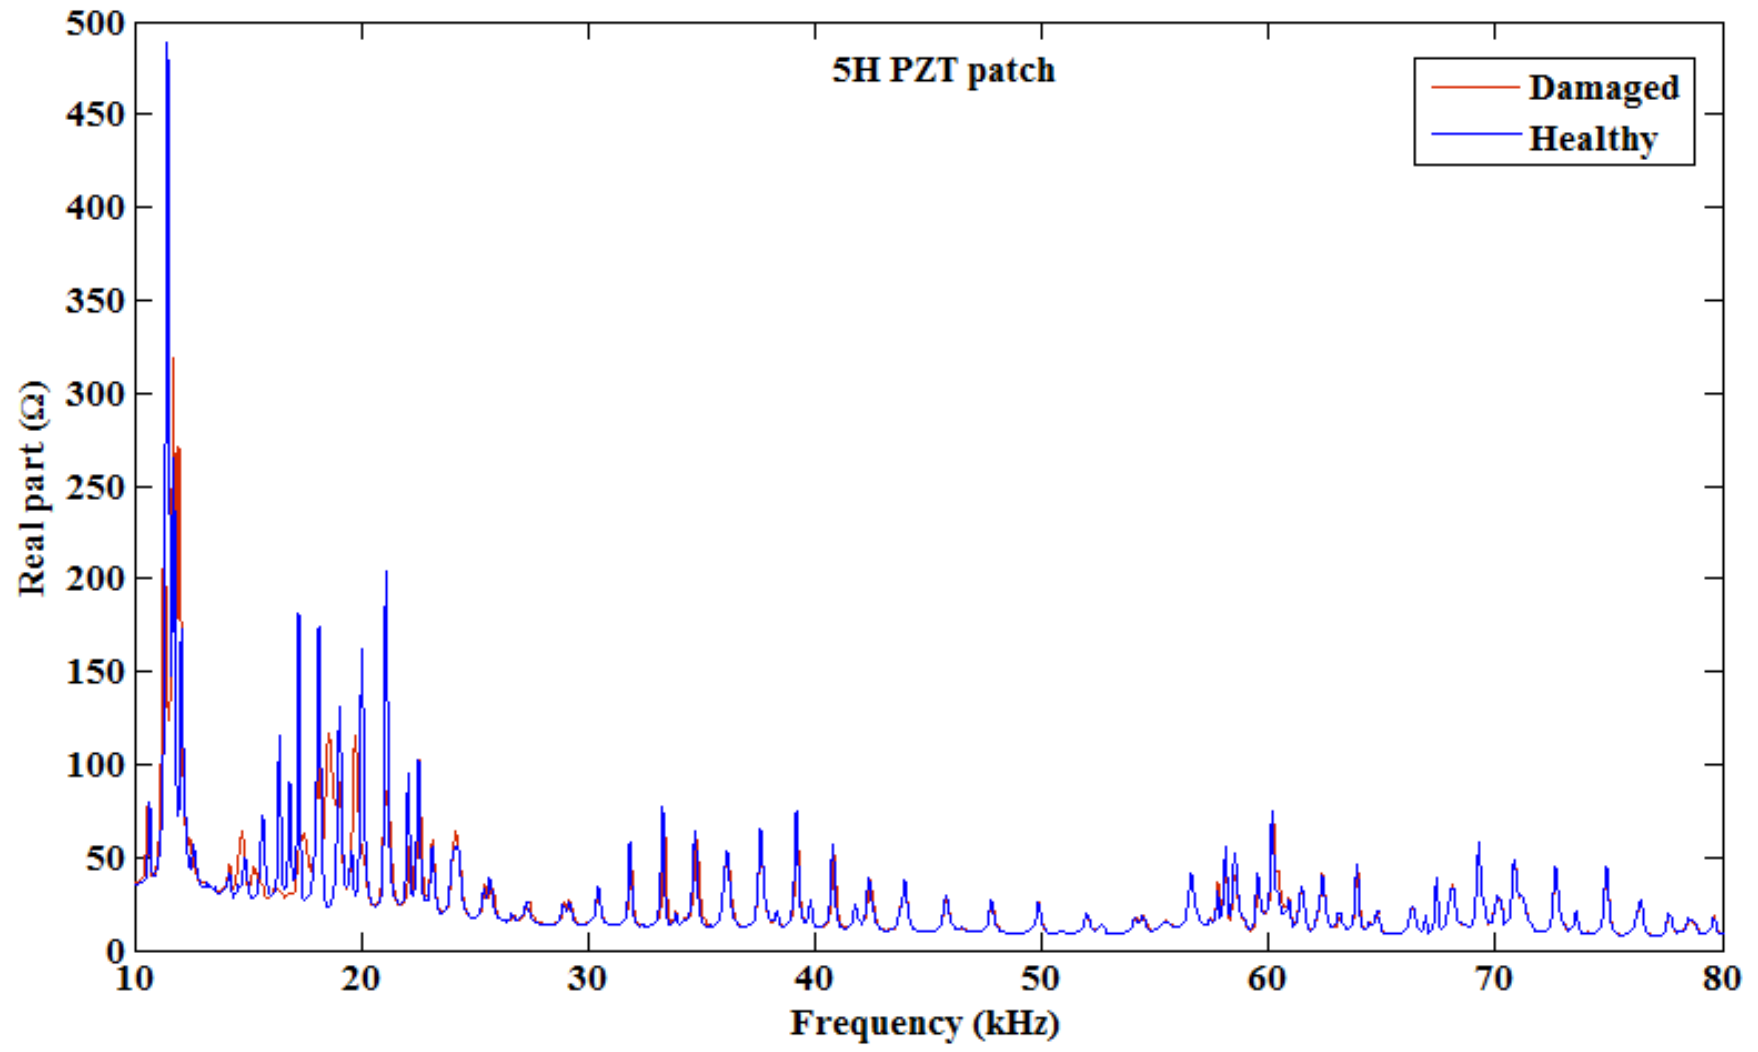
Results – Impedance Signatures – 5H PZT patch

- There are resonance peaks in the signatures related to the natural frequencies of the structures;
- Structural damage (nut) causes variations in frequency and amplitude in these peaks, which can be quantified by indices of damage;
- The peaks are more significant at low frequencies and tend to decrease as the frequency increases;
- The **PZT patch** has provided impedance signatures with higher amplitude;
- Impedance signatures with lower amplitude were obtained using the **MFC transducer**;
- The **piezoelectric diaphragm** provided impedance signatures with intermediate amplitude between the other two transducers.

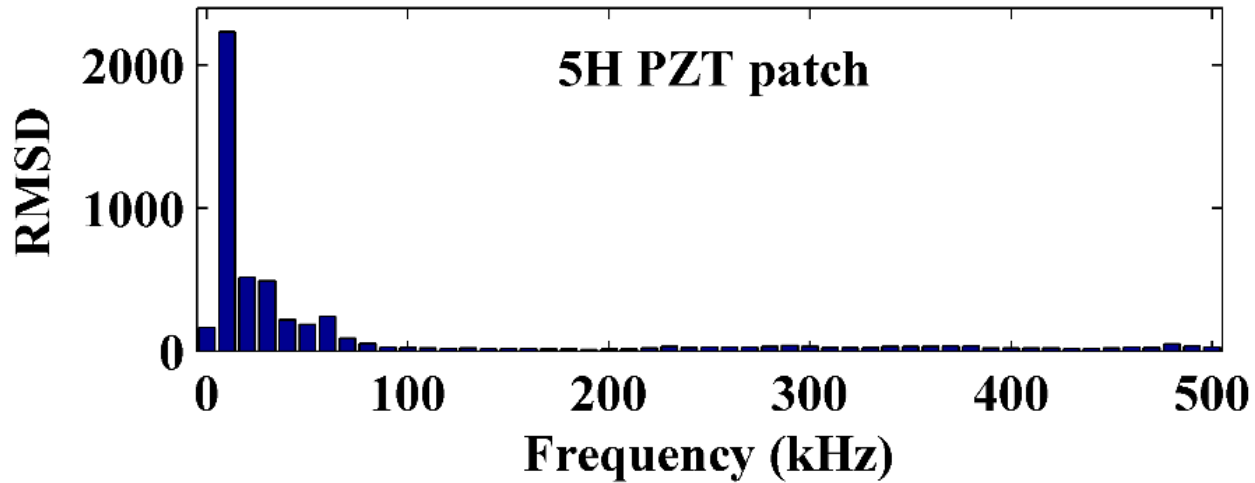
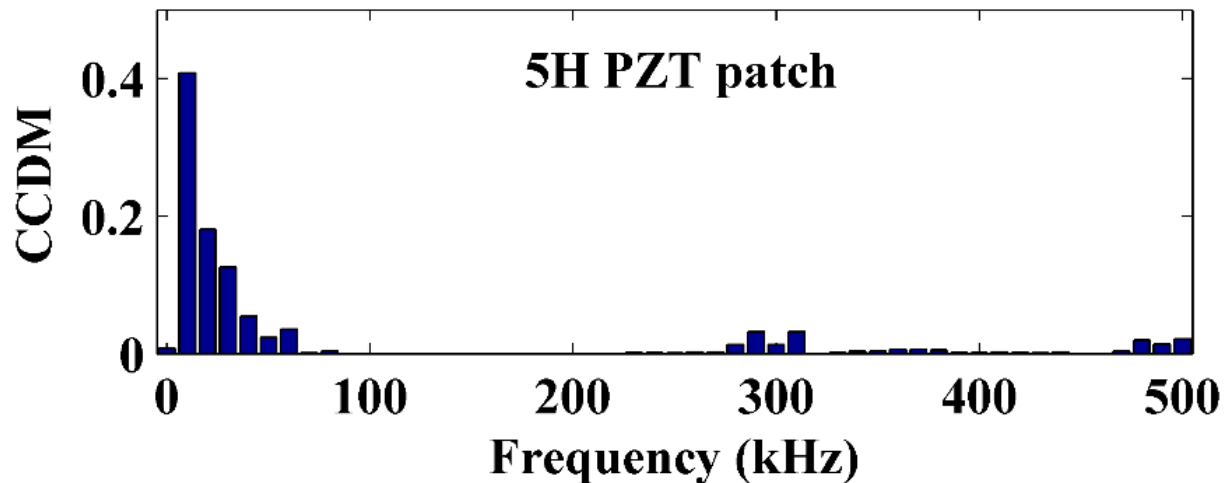
Results – Damage Indices – 5H PZT Patch

- The **PZT patch** and the **diaphragm** provided the highest indices for low frequencies around approximately 10-70 kHz;
- The **MFC transducer** provided higher indices at high frequencies;
- The **piezoelectric diaphragm** showed a reasonable sensitivity to detect damage, although the indices were lower compared to other transducers. However, this device has the advantage of having a very low cost.
