Water Leaks Detecting by Thermographic Image Analysis, In Laboratory Tests

Keywords: water distribution systems; water leaks; lab tests; Thermographic image analysis

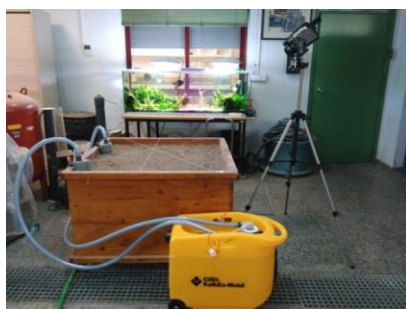
Figure 1. The laboratory model working with the Thermographic camera.

The physical model is a simple box, with dimensions 100x100x70 cms, filled with earth material similar to the filler, that let us to imitate the working conditions of a pipe in a WDS. Two conditions were simulated: (1) a gravity condition and (2) a pressure condition with a closed re-circulating water circuit, both first working without leak and after with leak. Notice that the second condition was the most representative for the aim of this paper. For this reason, just the results for the second experiment are shown.

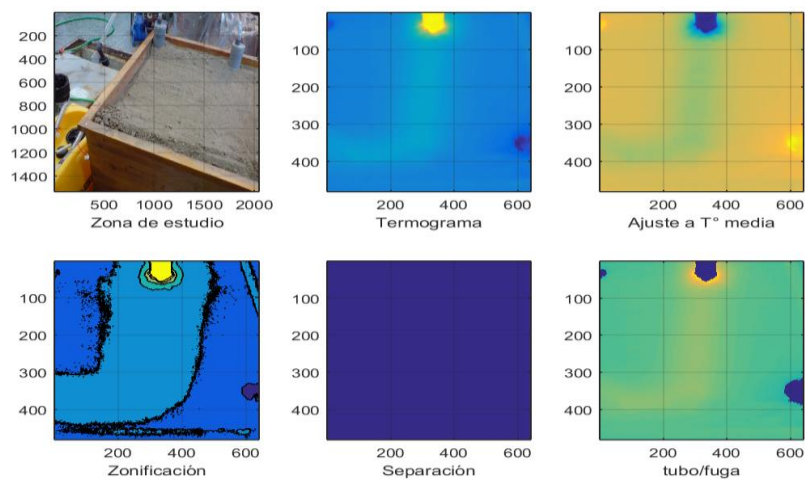
Figure 3. Termogram results with MATLAB algorithms. Test ID: Mr-4.

Notes: The pipe is able to observe once the image has been processed. The Otsu's method can't isolate the pipe region. The rest of the processes can isolate the studies' zones and delimitate the contour of the pipe. The pipe has not leak.

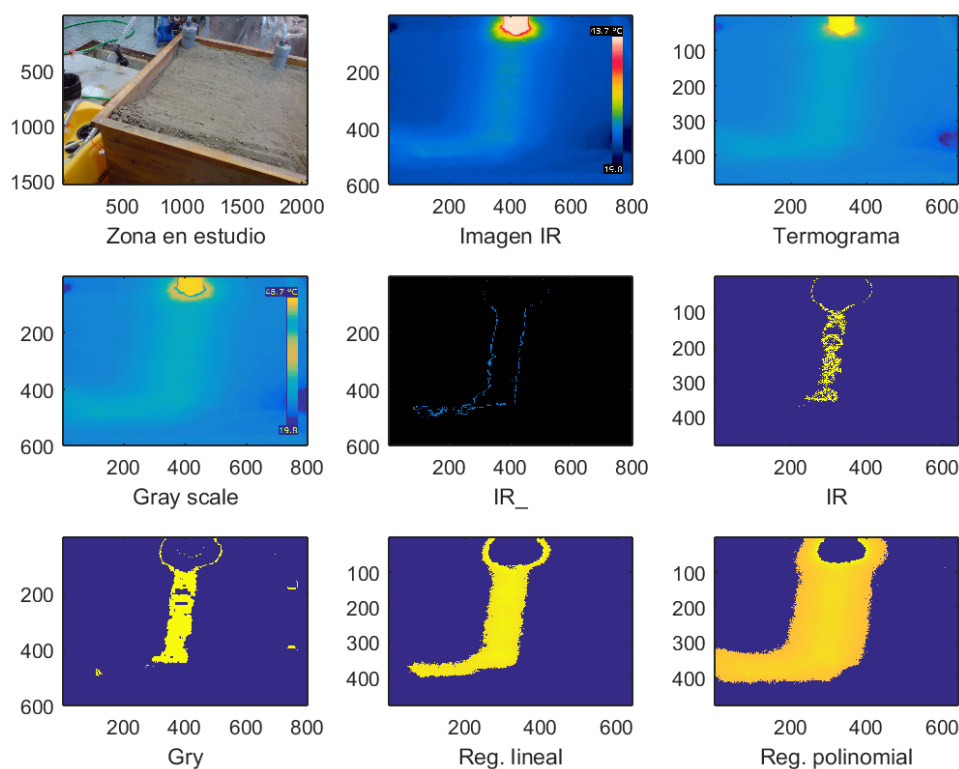
Figure 6. Image results with MATLAB algorithms. Test ID: Mr-4.

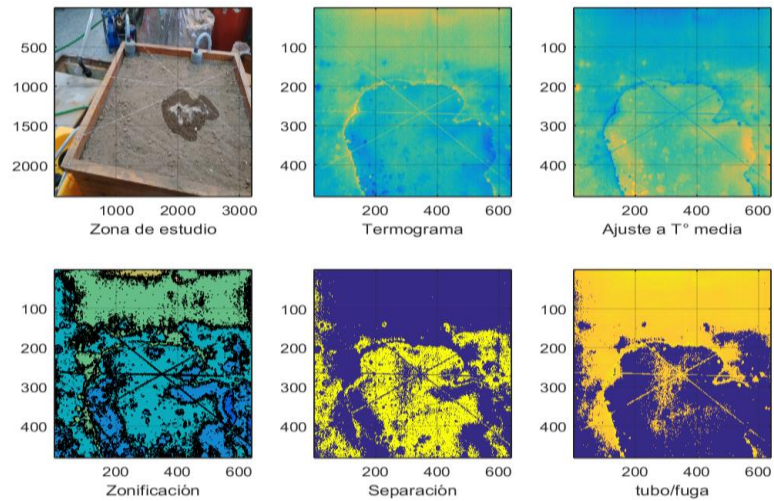
Figure 9. Termogram results with MATLAB algorithms. Test ID: Mr-4.

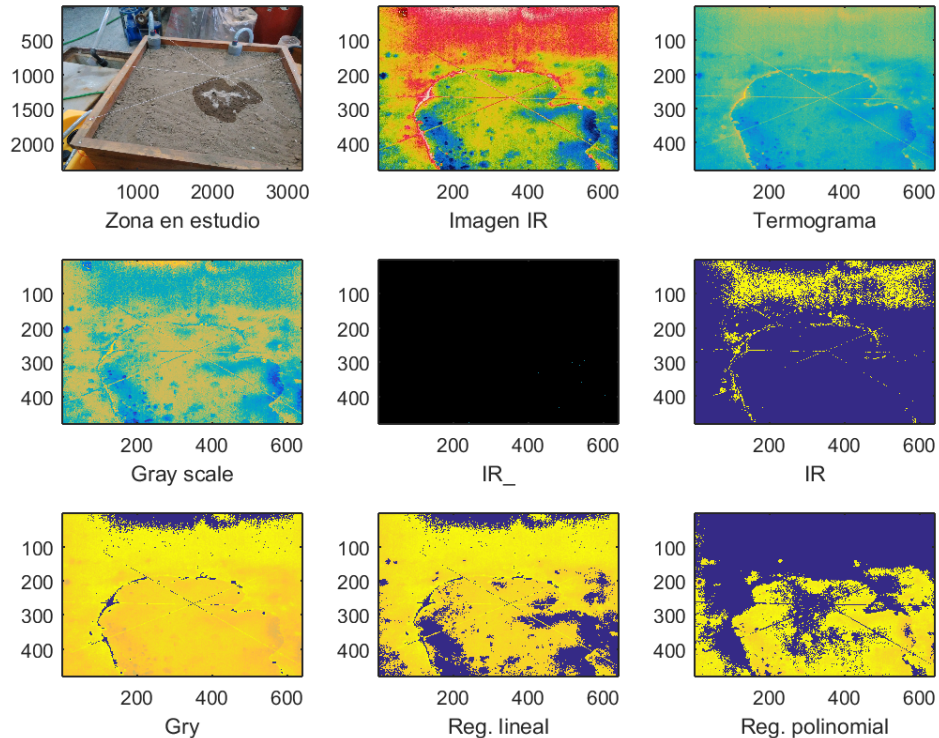
Figure 10. Image results with MATLAB algorithms. Test ID: Mrf-2.

Notes: The visual inspection shows clearly the contour of the leak. On this test was notice that the time of leak developed was faster that the take of the image, For the size of the model and the pressure of the leak is necessary a more potent infrared camera. Due the imidiatly leak developed was not possible to get more information, just the contours of the change of temperature of the water and the material were the pipa lays. The processes were very different; however the isolate of the study zone can be appreciated very well.
