Corrosion properties of biodegradable AZ31 and ZK60 magnesium alloys: in-situ study

**1st Corrosion and Materials Degradation Web Conference
17/05/2021 - 19/05/2021**

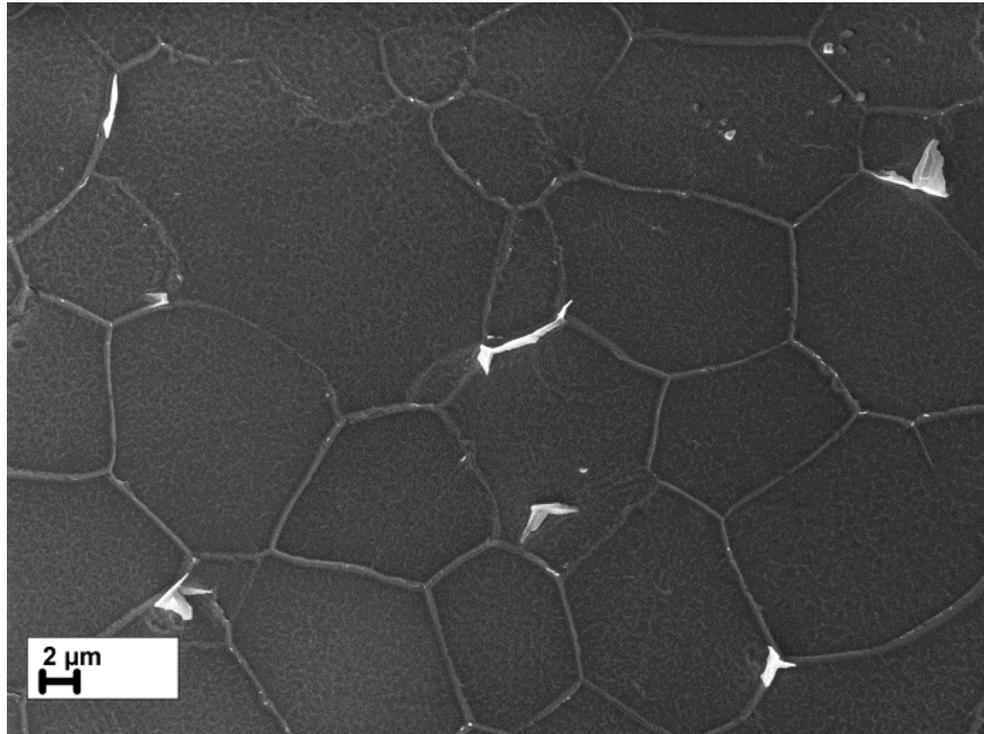
SEM

Hot-rolled AZ31 alloy:

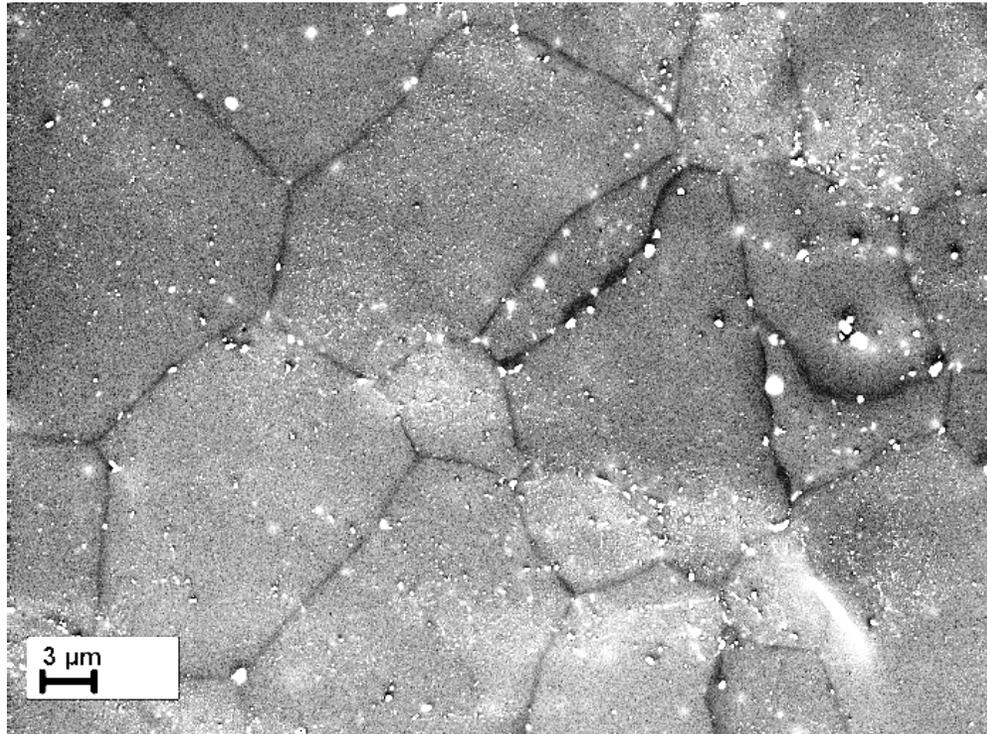
SEM

Extruded ZK60 alloy:

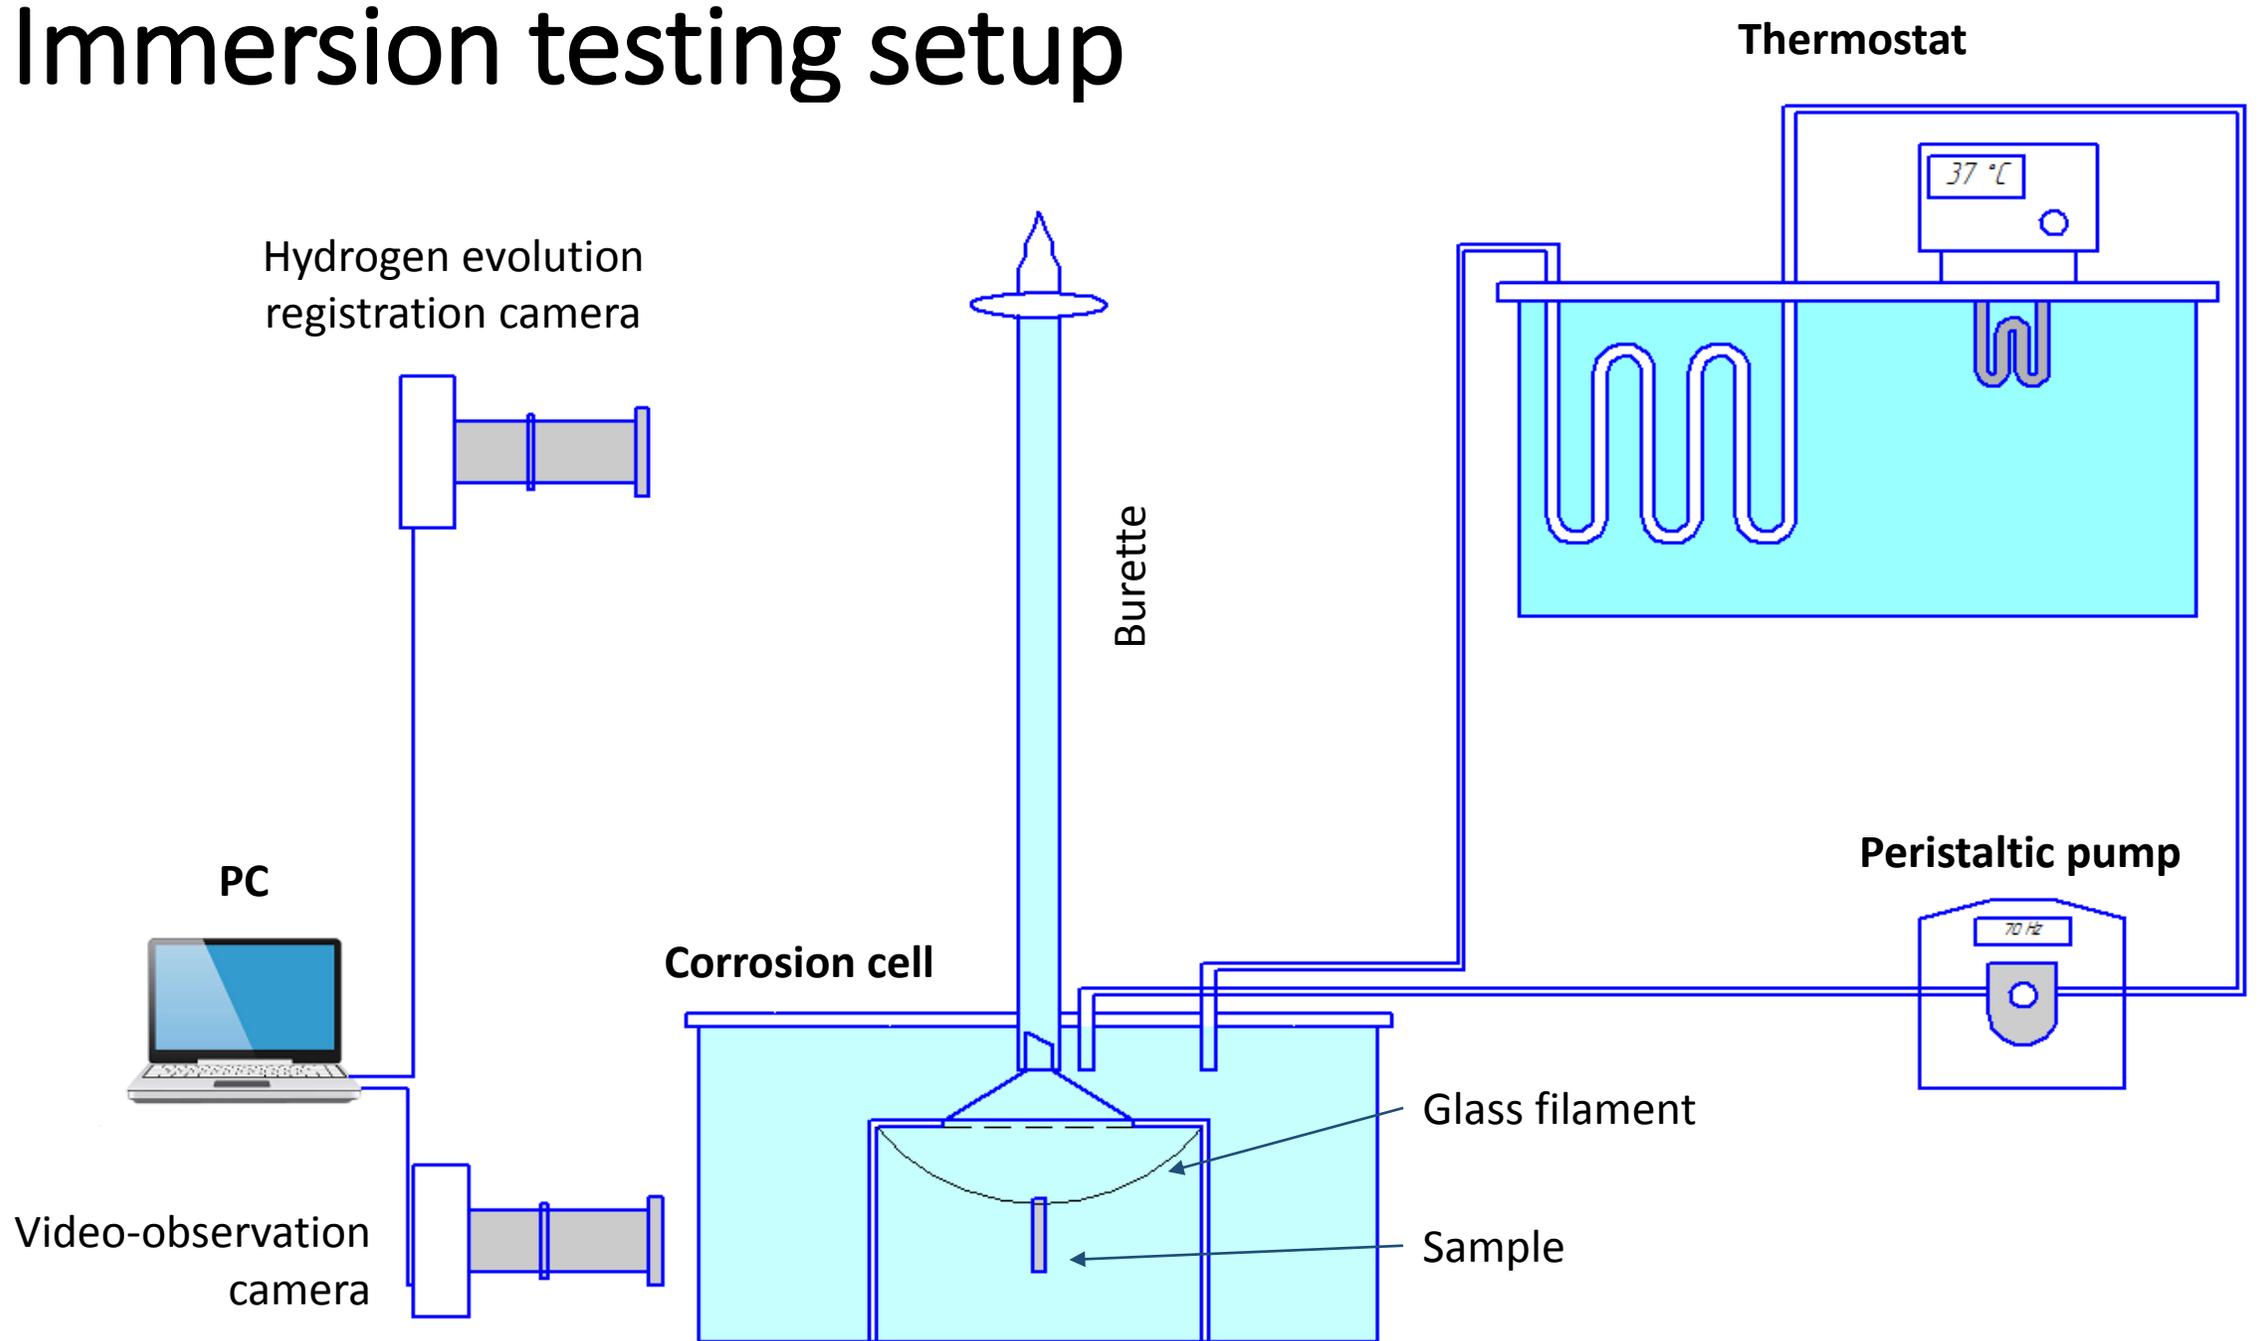
Immersion testing setup

- 120 hours
- Temperature 37 °C
- In 0.9% NaCl aqueous solution
- Circulation of corrosion media
- Real-time video-observation
- Hydrogen evolution monitoring (every hour)
- pH measurement (twice per day)

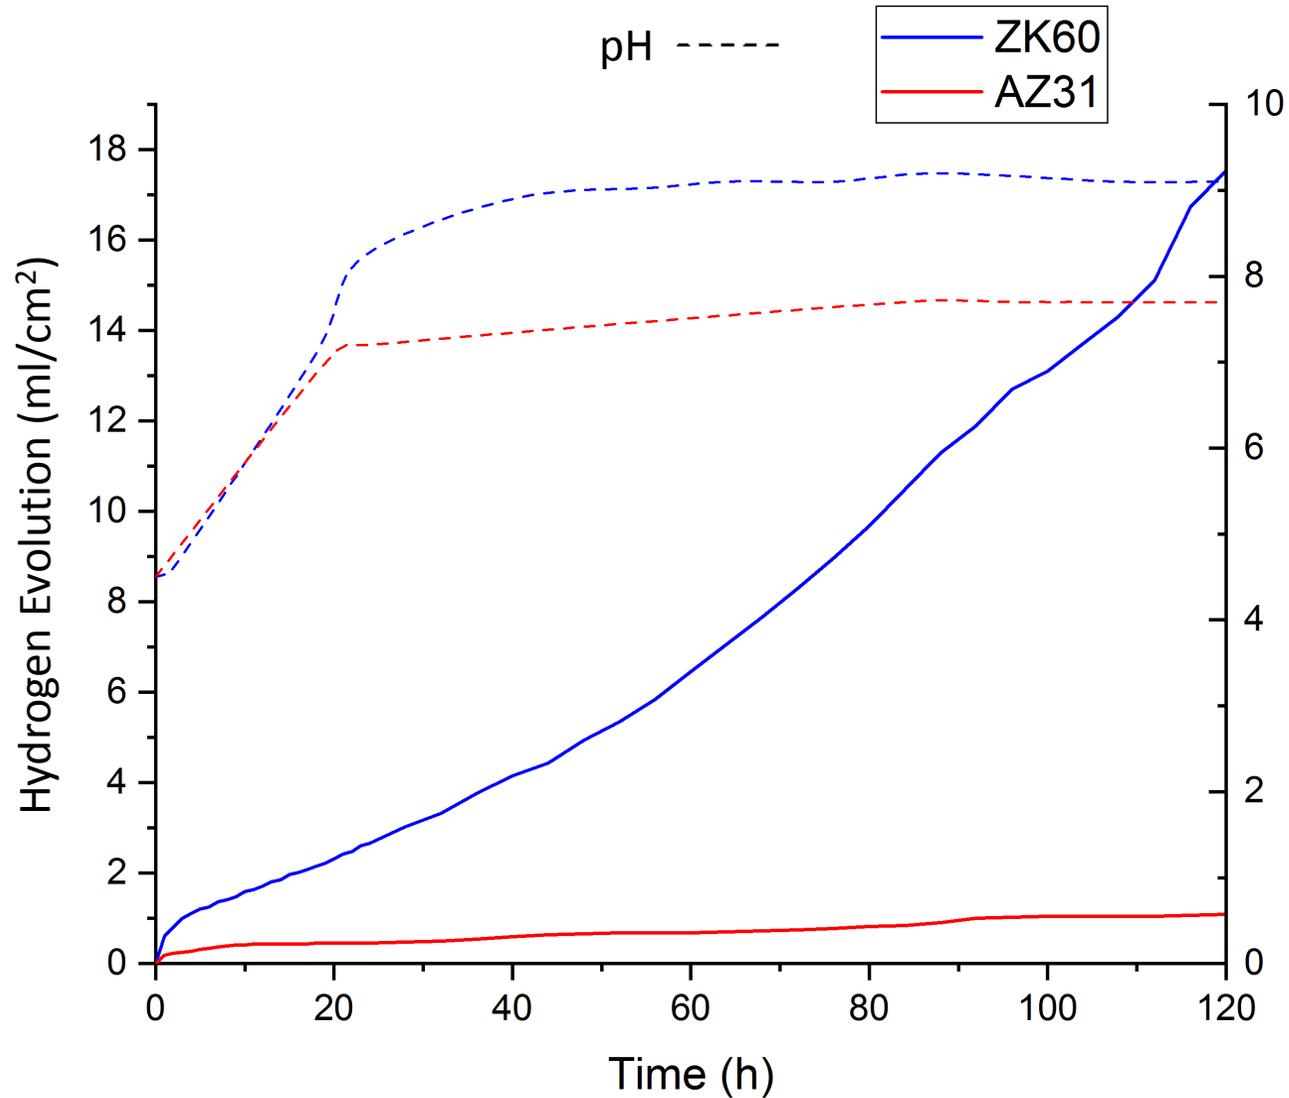
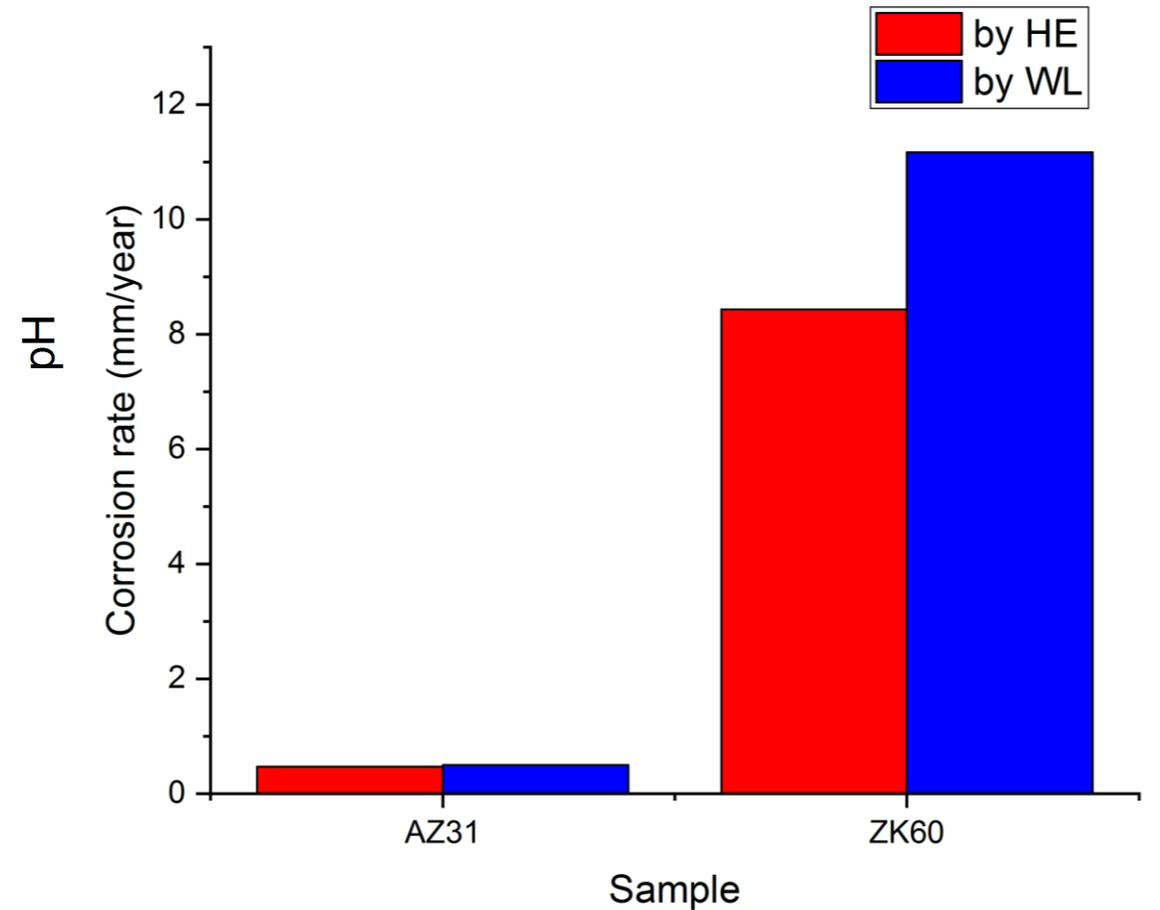
Results: corrosion rate

- Extruded ZK60 alloy possesses much less corrosion resistance in comparison with the hot-rolled AZ31 alloy.
- The corrosion rate of AZ31 alloy is nearly constant during the test, while ZK60 demonstrate increasing corrosion rate as is indicated by parabolic-like shape of hydrogen evolution curve.
- The corrosion rate of the both alloys is featured by the steep increase in the first 6 hours of immersion test. It is supposed to be due to formation of the magnesium hydroxide protection surface film.
- The discrepancy between the results of the hydrogen evolution and weight loss methods can arise due to fall off of the metal particles from the sample during corrosion process.

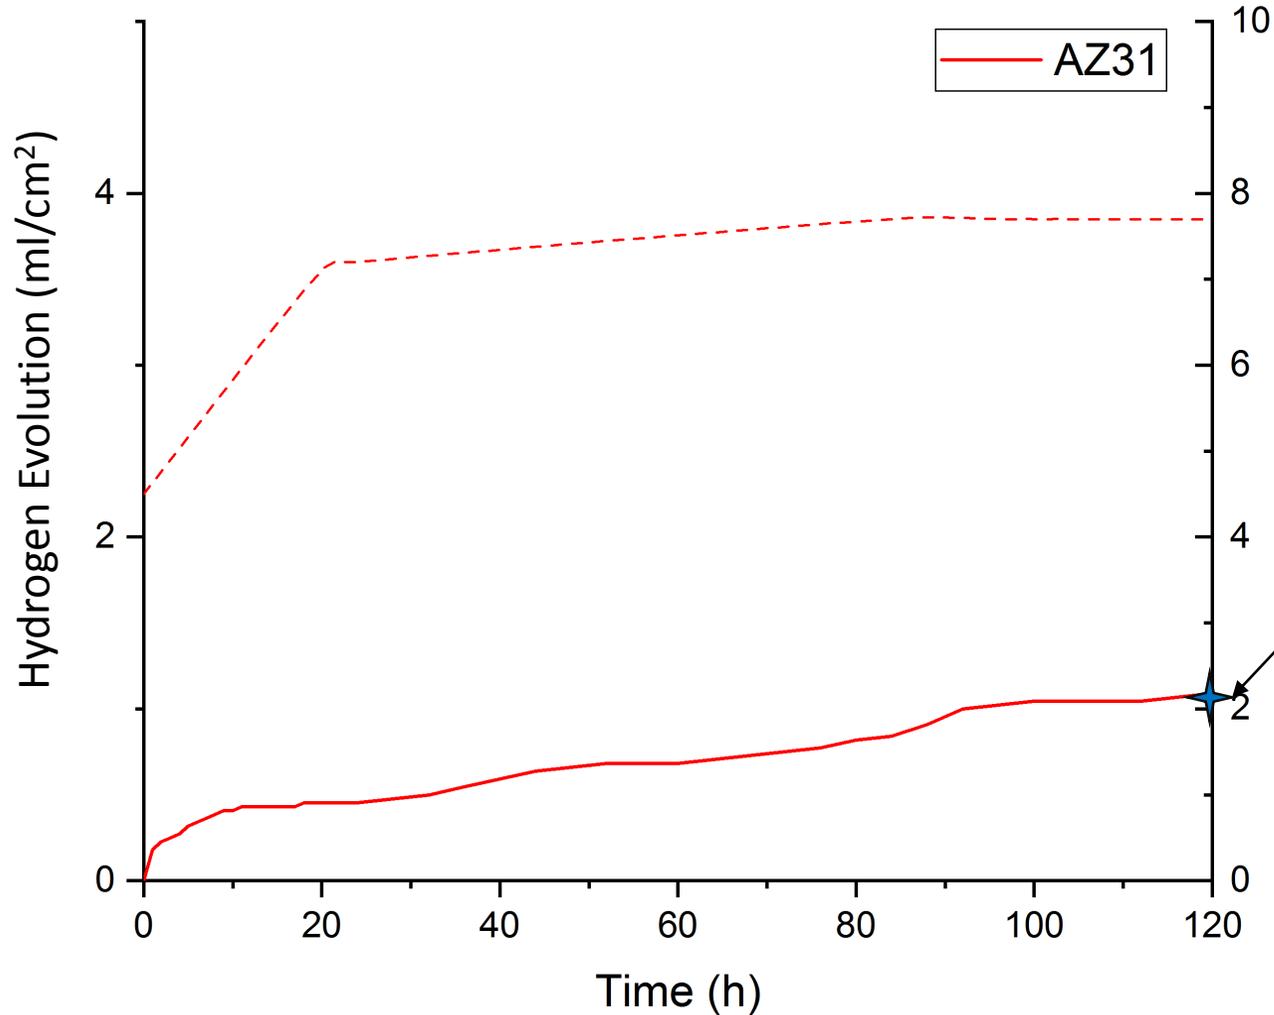
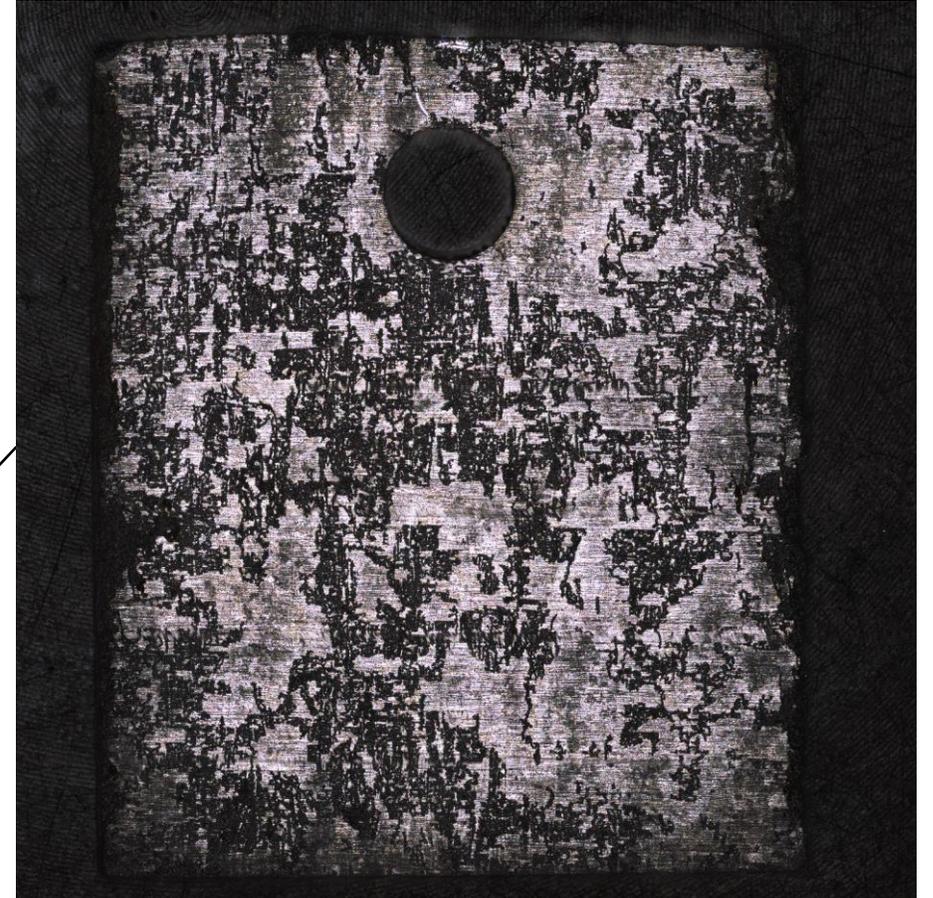
120 hours (without corrosion products)

- Extruded ZK60 alloy is prone to the severe pitting corrosion
- Metal particles fall off from the ZK60 sample during corrosion process
- Hot-rolled AZ31 exhibits increased susceptibility to the filiform corrosion
- In the both alloys, the samples' edges are damaged to the greater extent

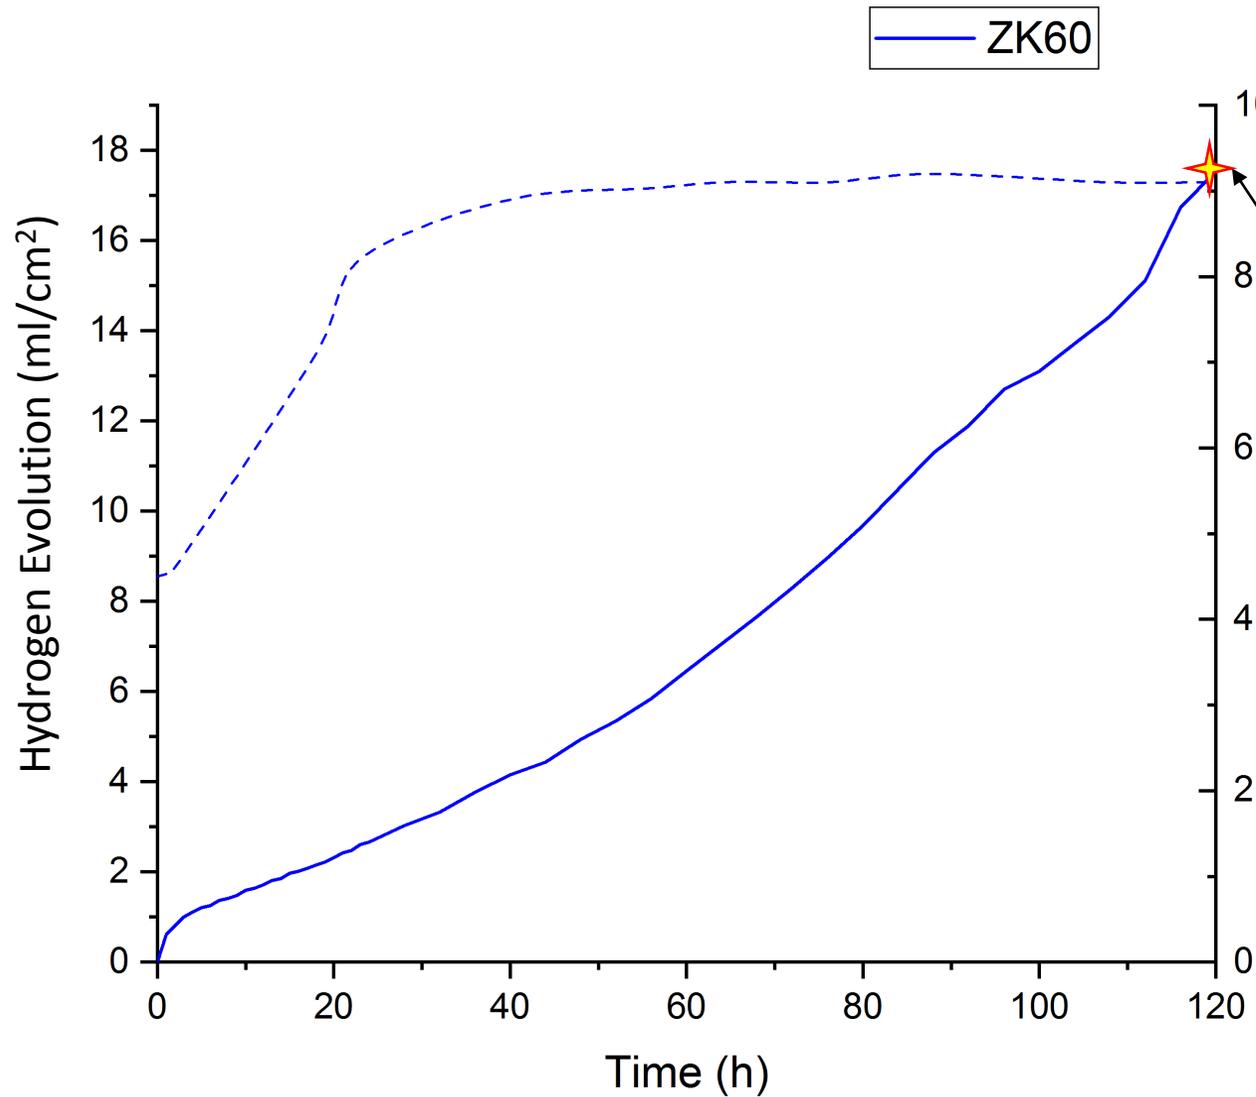
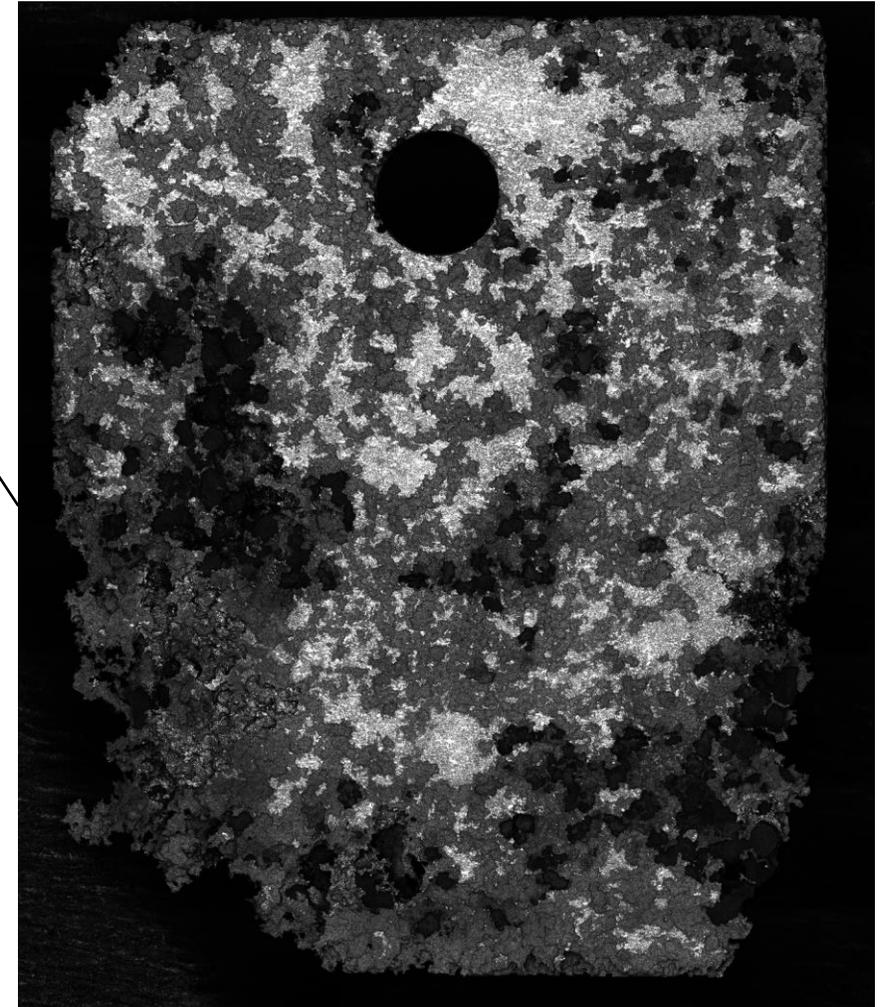
120 hours (without corrosion products)

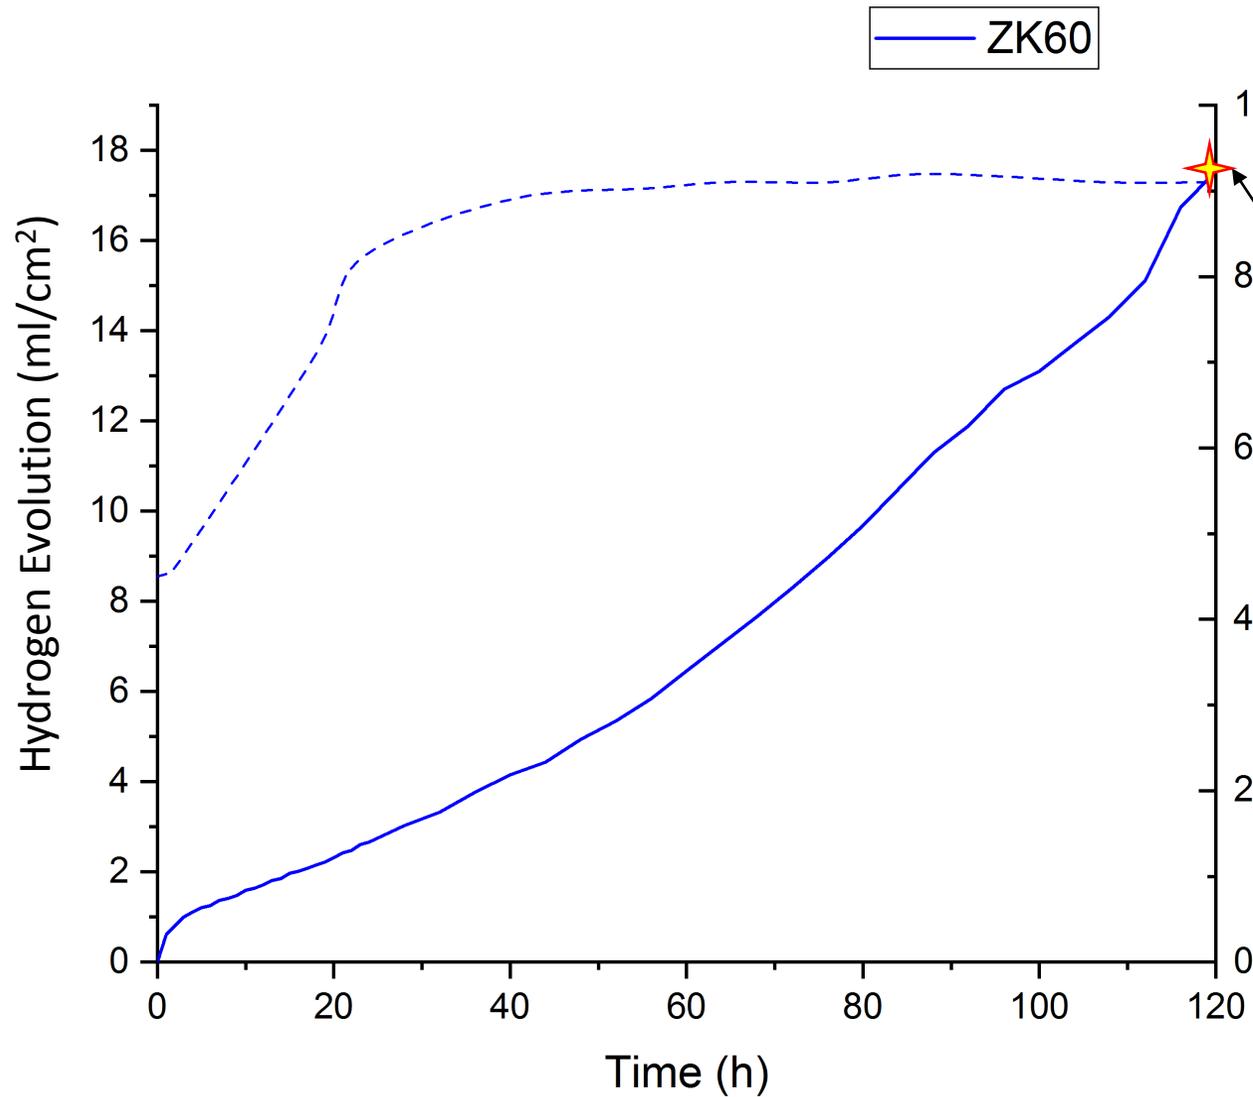
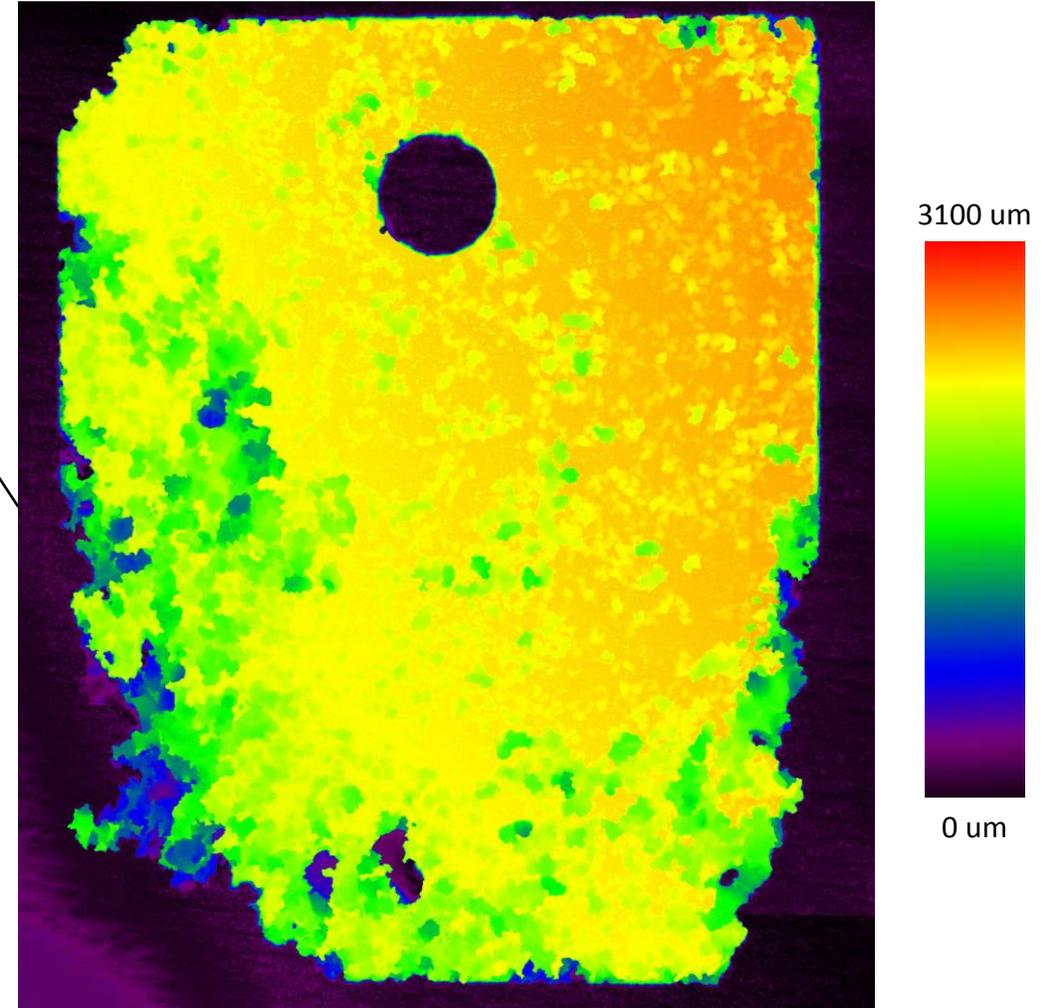
120 hours (height map, CLSM)
