Ecological evaluation of the Douro estuary: considering microplastics in ecological framework

Samuel Fernandes Santos¹, Luis R. Vieira^{1,2}, Isabel Iglesias², Sandra Nogueira^{1,2}, Garry F. Kett², Isabel Sousa Pinto^{1,2}, Sara C. Antunes^{1,2}

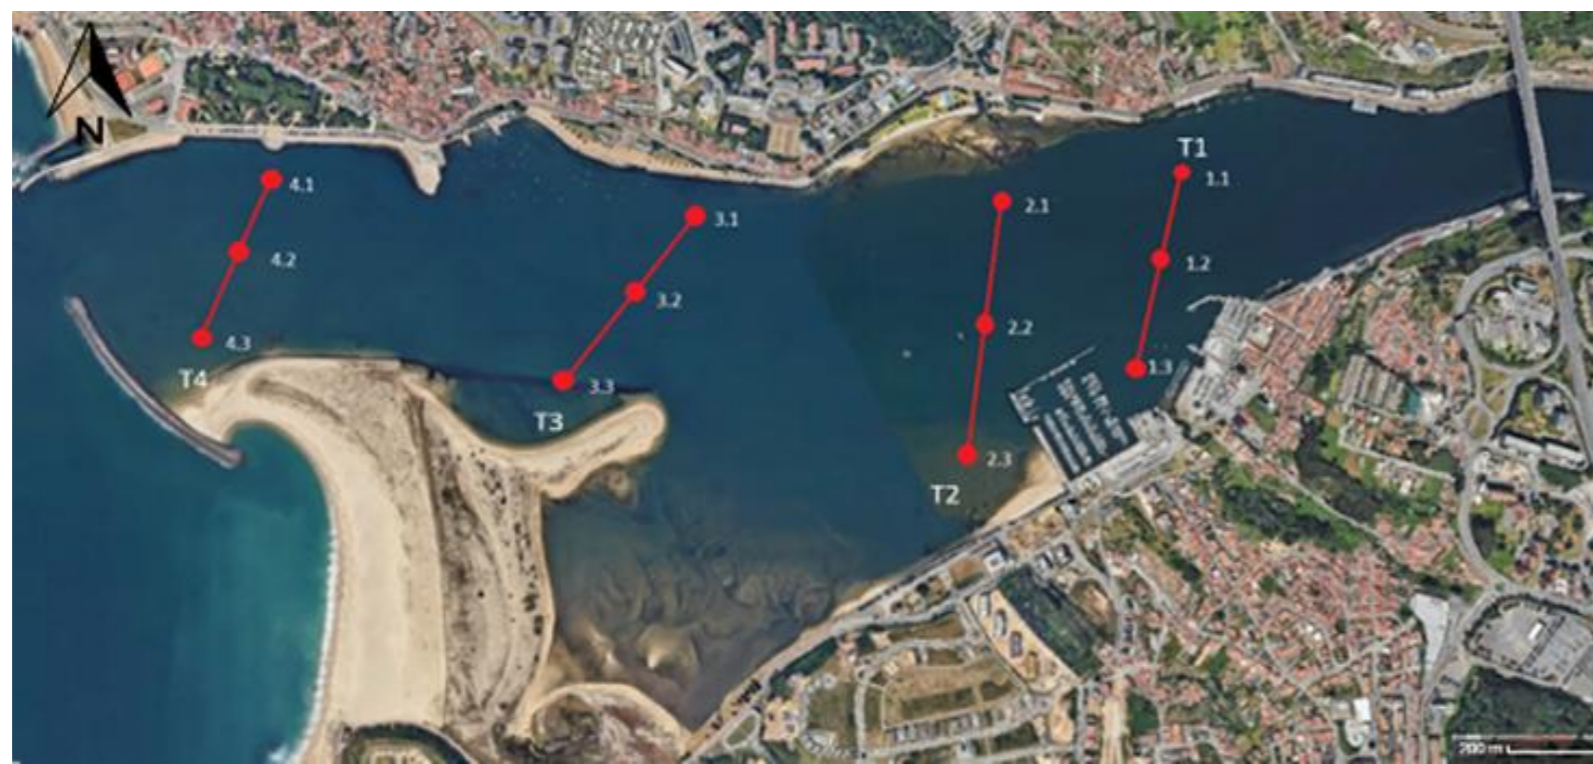
4 transects (T), each comprising 3 sites, were established in the lower Douro estuary.

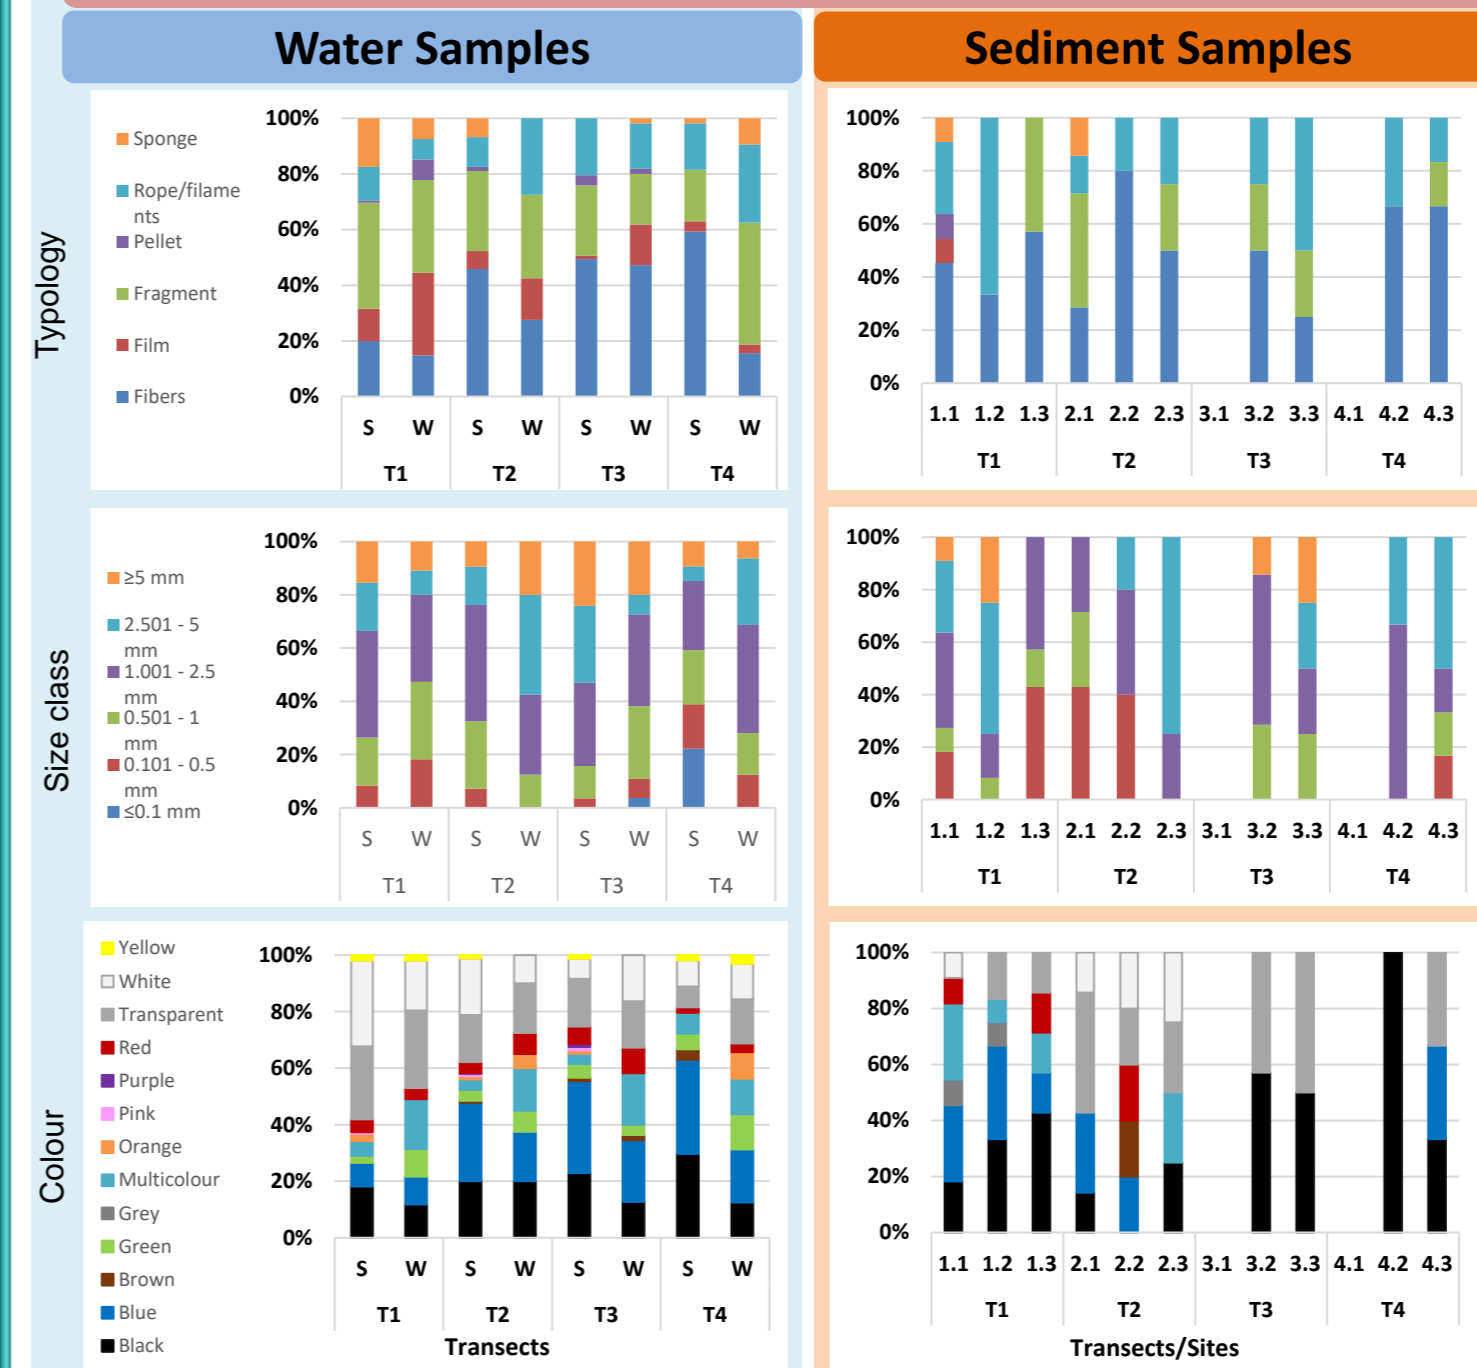
MP Summer 2024

Highest MP/m³ and MP/Kg values were found in transects T1 and T2, and respective sites

- Possible pollution sources: Afurada Marina and in the WWTP discharge area

Total MP's found in the Douro estuary:

Water samples: 9.03 MP/m³

Sediment samples: 1650 MP/kg

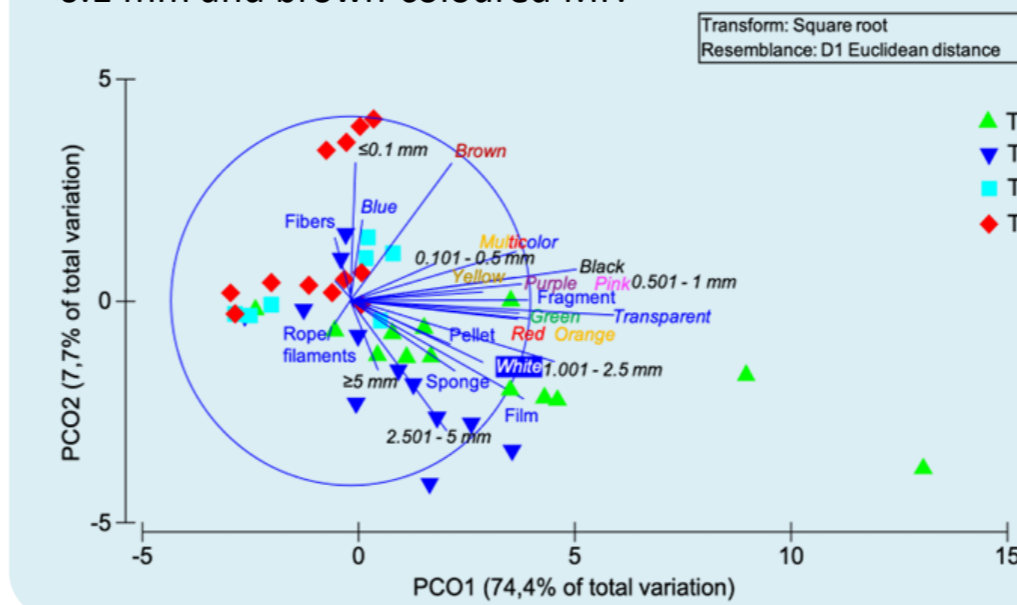
PCO Analysis of MP

T1 (affected by diverse pollution inputs): high diversity, predominantly associated with films and white MP's;

T2 (combined pressures and higher hydrodynamic exposure): dominated by fibers, with size classes of [2.501 - 5] mm and >5 mm;

T3 (combined pressures and higher hydrodynamic exposure): mainly blue and fibers;

T4 (combined pressures and higher hydrodynamic exposure): size class <0.1 mm and brown-coloured MP.

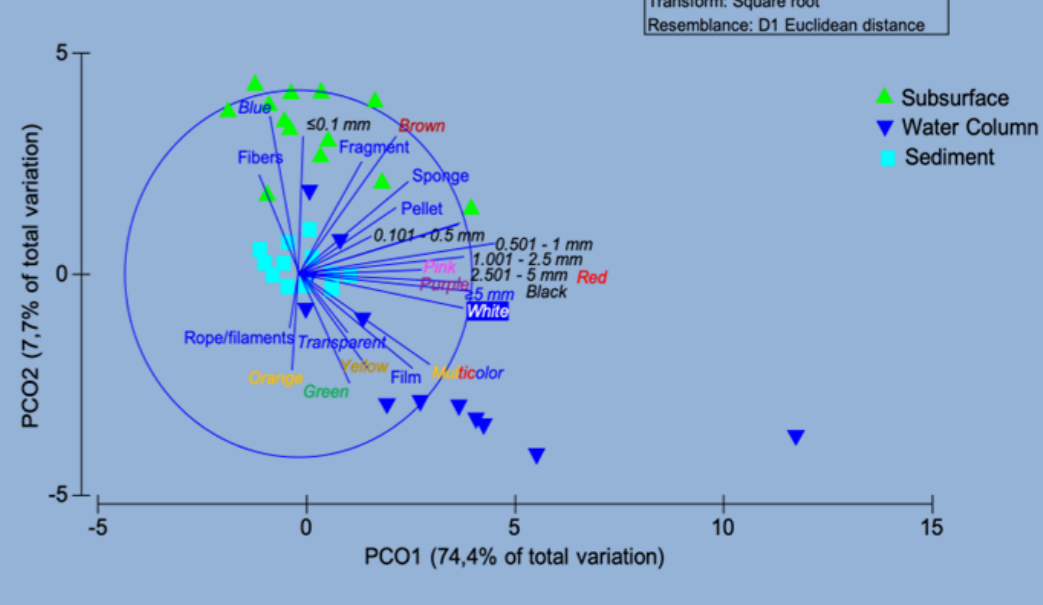
Subsurface: dominated by smaller particles (<0.1 mm) and blue fibers;

Water column: larger particles and films;

Sediment: no clear relation with any MP's characteristics
