Proceeding Paper

# Irregular Temperature Variation Effects on Damage Detection Based on Impedance Measurement from Piezoelectric Transducers <sup>†</sup>

Felipe Augusto Barnabé and Fabricio Guimarães Baptista \*

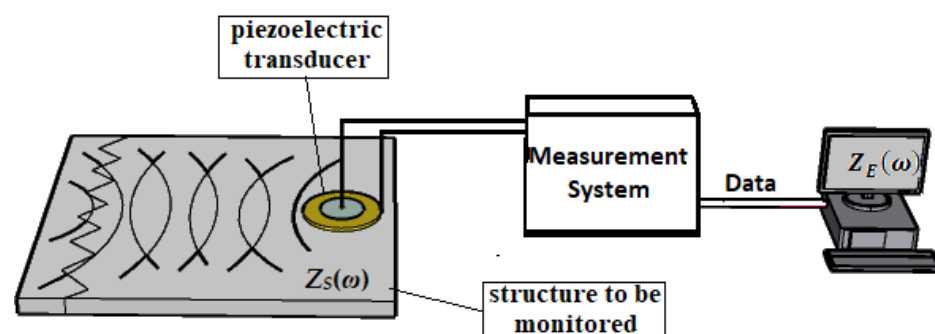
The basic principle of the EMI technique is presented in Figure 1, in which a piezoelectric transducer is fixed, by means of a high stiffness adhesive, on the structure to be monitored with mechanical impedance  $Z_S(\omega)$  and has its electrical impedance  $Z_E(\omega)$  measured by a system with angular frequency ( $\omega$ ) which varies within an appropriate range, which is normally above 30 kHz to minimize the effects of external vibrations.

Figure 1. Application of the EMI method.

Due to the piezoelectric effect, a relation is established between the mechanical impedance  $Z_S(\omega)$  of the structure and the electrical impedance  $Z_E(\omega)$  of the transducer. For a simplified analysis, a one-dimensional electromechanical model [12] can be developed to relate these two quantities:

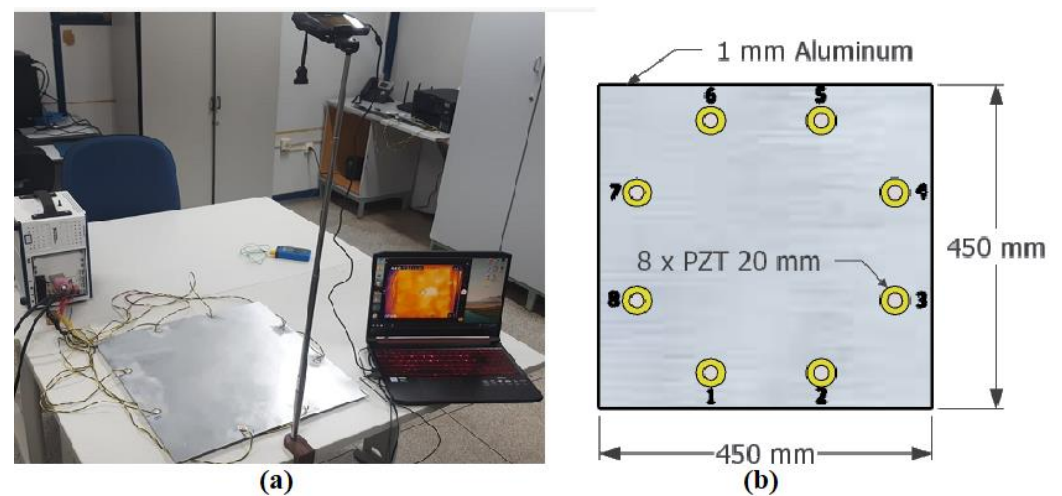
Eight piezoelectric diaphragms were placed in the aluminum structure using cyanoacrylate adhesive, forming a network of transducers. Figure 2a,b show the experimental arrangement in the laboratory and the placement of the piezoelectric transducers on the aluminum plate, respectively.

**Figure 2.** (a) Experimental setup. (b) Structure and position of the piezoelectric transducers.

Experimental tests were carried out to analyze the effects of temperature in uniform and irregular distribution in different points of the host structure using a 450 mm x 450 mm x 1 mm aluminum plate. To produce heating, a thermal blower was used, which is a tool that has already been successfully applied in other works and can heat the structure with temperature ranging from 25 °C to 120 °C. To perform the temperature measurement, a FLIR C2-X thermal camera connected to a laptop was used, which made it possible to accurately measure and control the uniform and irregular temperature distribution.

step and frequency range to excite the transducers and simultaneously samples the response signals. The DAQ device is based on the NI-PXIe-1071 chassis with PXIE-5413 arbitrary waveform generator and PXIE-5105 8-channel oscilloscope. Control of the DAQ device as well as signal processing were performed using LabVIEW software.

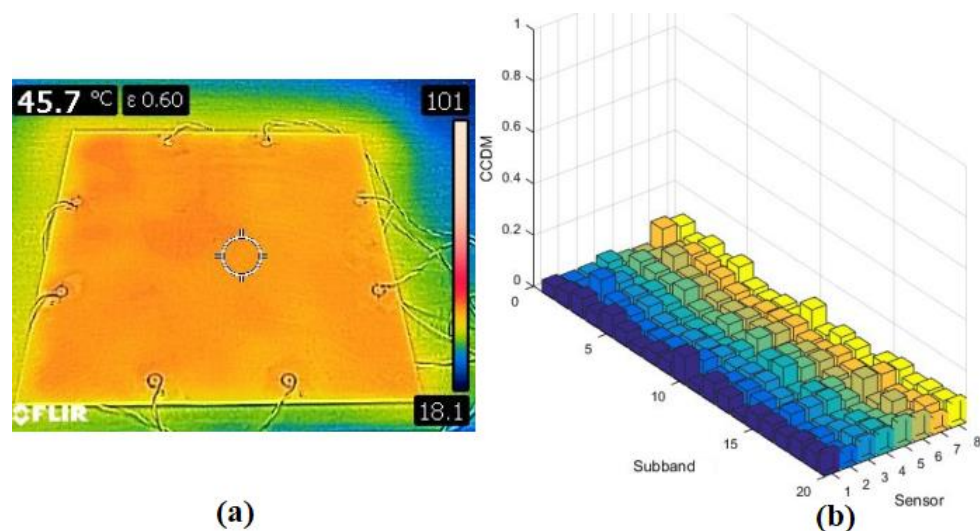
Figure 3a shows the thermal image of the plate uniformly heated to a temperature of 45 °C. The CCDM indices calculated for the 8 sensors in relation to the baseline signature in 10 kHz sub-bands are shown in Figure 3b.

**Figure 3.** (a) Thermal image of the uniformly heated structure; (b) CCDM indices calculated after compensation with the EFS method.

It is important to note that CCDM indices were calculated after compensating the impedance signatures using the EFS algorithm. According to the results, despite the temperature variation, the CCDM indices were low for all 8 transducers, remaining below 0.2. Although the temperature variation is significant, the heating is uniform throughout the structure. Consequently, the frequency and amplitude shifts in the impedance signatures are uniform, not causing changes in their shapes. Therefore, the EFS algorithm is effective in compensating the effects of temperature variation, making CCDM indices low and avoiding a false positive diagnosis of the monitored structure.

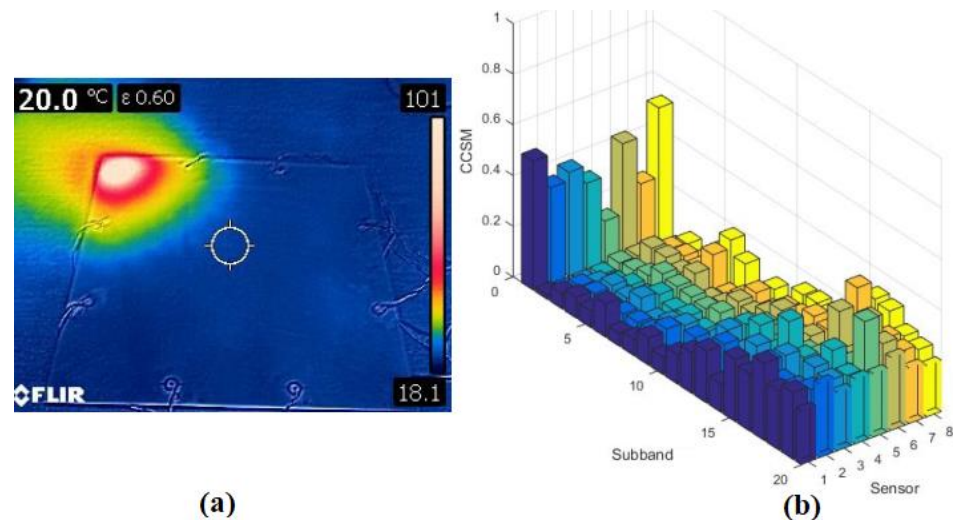
On the other hand, in practical applications, the heating of the structure may be irregular, that is, some parts may be hotter than others. In order to analyze the effects of the irregular temperature distribution, the plate was heated only in one of the corners between Sensors 6 and 7, according to the diagram shown in Figure 2b. The thermal image and CCDM indices obtained in this condition are shown in Figure 4a and b, respectively.

**Figure 4.** (a) Thermal image of the heated plate in one of the corners between Sensors 6 and 7; (b) CCDM indices calculated after compensation with the EFS method.

As can be seen in Figure 4b, unlike the previous result, the CCDM indices obtained in the condition of irregular temperature distribution were significantly higher. The high CCDM indices are explained by changes in the shape of the impedance signatures due to

irregular heating. As a consequence, variations in impedance signatures are similar to those caused by structural damage, making the EFS compensation method inefficient.

This situation can be critical in real applications, especially in the monitoring of large structures, where the structure can present parts with different temperatures. In this condition, the EFS compensation algorithm may not be feasible, leading to a false positive diagnosis.
