Methodological Routes for Failure Analysis in Continuous Rods for Artificial Lift Systems: A Data-Driven and Damage Characteristic Approach

Andrés Fernando Quintana Rondón, Jose Miguel Jiménez Martínez, Giovanni Juzga, Jorge Hernando Panqueva
Corporación para la Investigación de la Corrosión (CIC), Colombia

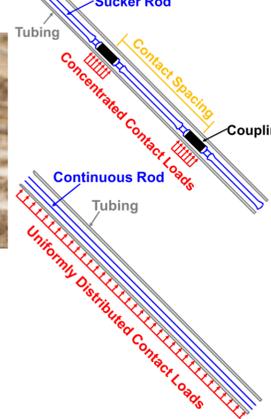
- Tubing and rod follow the well trajectory
- Flexion loads
- Contact loads which let wear by friction
- Buckling
- ALS service consists of cycles (fatigue loads)

Conventional Rod

Continuous Rod

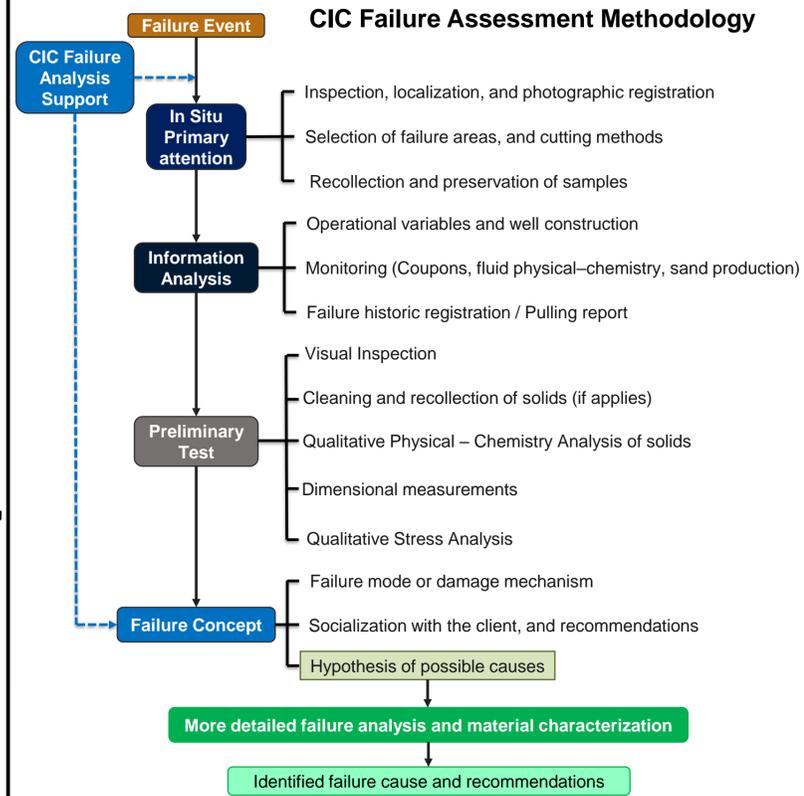
CIC Failure Assessment Methodology

Continuous rod is a relative new technology with no API standard
Need to understand and identify the main failure causes, in order to propose alternatives to avoid those failure mechanisms

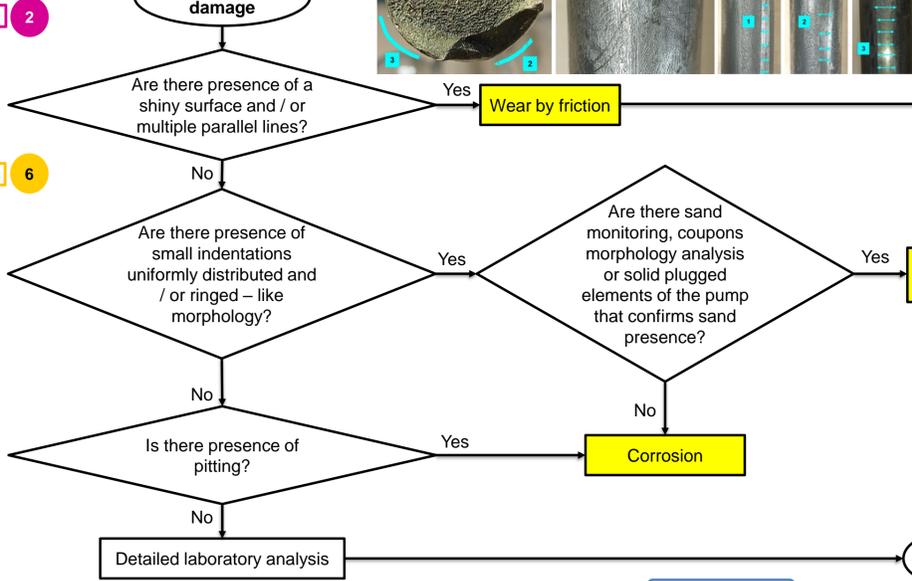
Mechanism damage

Friction generates a shiny surface or multiple parallel lines in axial or circumferential direction. Corrosion generates continuous bands or localized pitting, and abrasion is seen as small indentations uniformly distributed / or ringed – like morphology. These damage mechanisms are enough to initiate fatigue failures
