Defect Detection in Wind Turbine Blades Using Infrared Thermography, Image Processing, and U-Net [†]

Abstract: In this research, we developed and tested an automated defect detection system for wind turbine blades using infrared thermography (IRT) and a deep learning model U-Net.

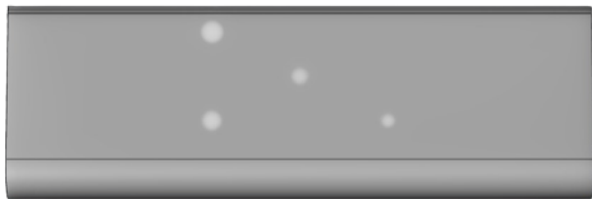
In order to study the best timing for capturing infrared images, we executed different simulations for the month of September. These simulations provided as results a sequence of infrared images that show clearly the appearance of (simulated) defects as shown in Figure 2. After this, we extracted the temperatures of the defected areas and the surface temperature from 10 consecutive points throughout the day, from 14:30 to 20:00, with measurements taken every 30 minutes. The choice of this time range was based on the solar radiation power being most ideal for defect detection during these hours. The results of these simulations are illustrated in Figures 3. The simulations were done in order to replicate a sunny day, and for the temperatures of the defected areas, we calculated the average temperature of the four defects simulated.

Figure 2. Infrared Image Showing the Appearance of Defects.

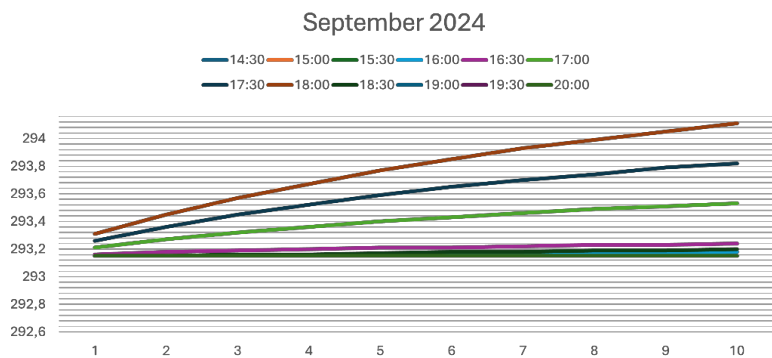
Figure 3. Temperature Curves for September Simulation Results.

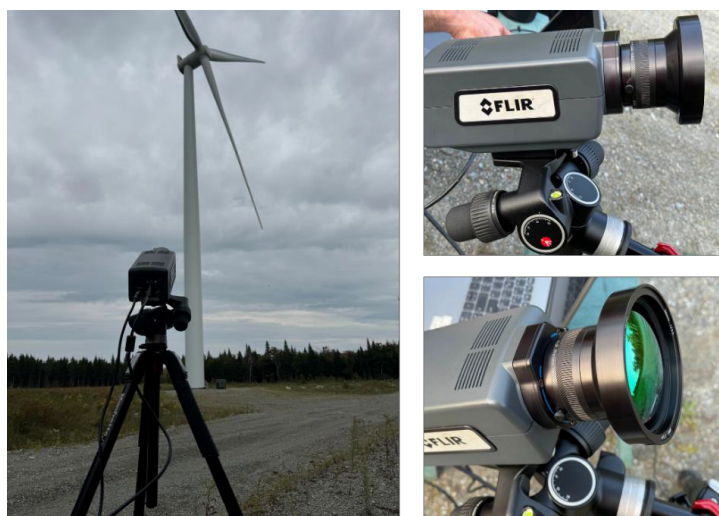
Following our preliminary study and the availability of equipment, we conducted fieldwork at a windfarm South of Quebec City on Thursday, September 12, 2024. The weather was cloudy in the morning and sunny in the afternoon with some clouds, enabling infrared image capture between 16:00 and 18:00, timed to align with the optimal conditions identified in our COMSOL study. Using a cooled FLIR model A6701 MWIR camera with a 100 mm lens as shown in Figure 4.

Figure 4. Infrared Camera Setup with 100 mm Lens for Blade Inspection

We achieved a clear view of several sections of wind turbine blades. During this test, infrared image sequences were recorded for two wind turbines.
