Non-Destructive Testing of Historic Buildings in Italy Using Infrared Thermography [†]

Keywords: Historical buildings; Sanctuary of Vicoforte; masonry; Airship hangar; Reinforced concrete; Diagnostic inspection

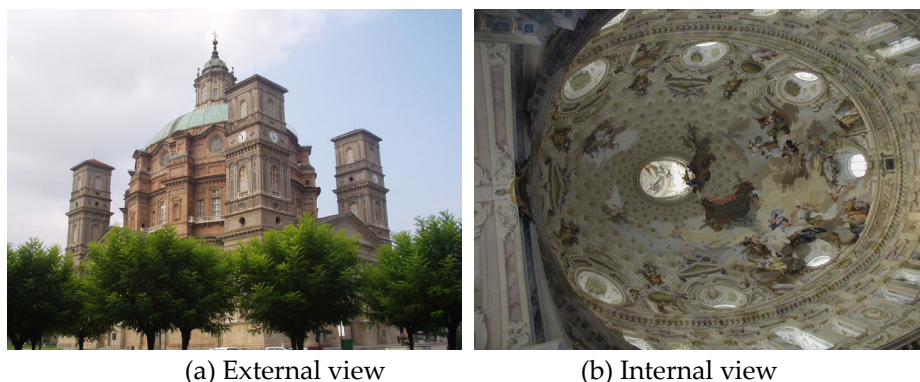
Figure 1. The Sanctuary of Vicoforte

The Sanctuary of Vicoforte, located in Mondovì, Piedmont, Italy (construction began in 1596, dome erected in 1731, lantern completed in 1733; Figure 1), features the world's largest elliptical masonry dome, with a major axis of approximately 37.15 m, a minor axis of about 24.80 m, and a height of approximately 16.60 m. The height from the ground to the top of the lantern is around 84 m. The church follows an elliptical centralized plan, with an altar room to the north and four bell towers added later. The church's drum exposes the masonry. The lower external walls are finished with stone cladding, while the bell towers have brick structures with mortar finishes.

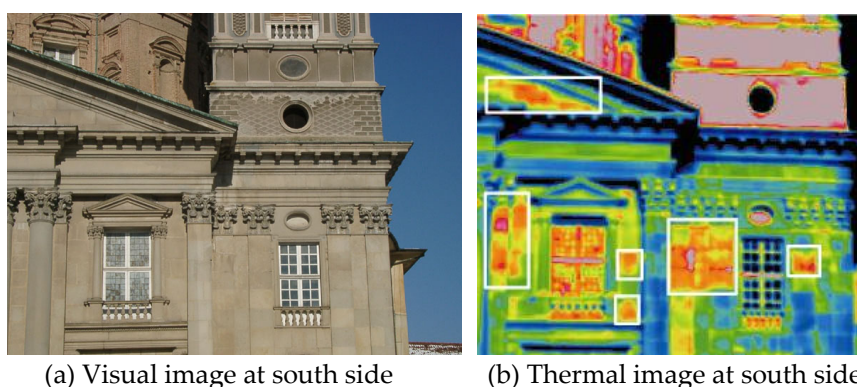
The results, as thermal images, are shown in Figures 2. According to the principle of defect detection using infrared thermography, when heated by solar radiation, spalling areas of the stone cladding are clearly detected as high temperature zones.

It was confirmed that defects in stone finishing could be detected using infrared thermography. Based on these results, reinforcement work was carried out.

Figure 2. Delamination of stone finishing

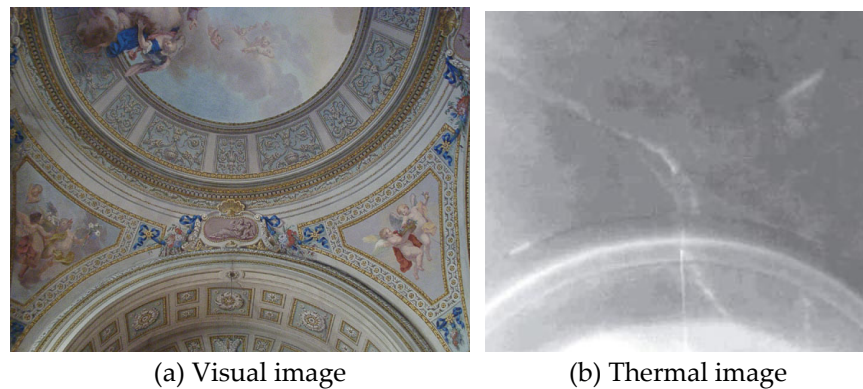
The measurement results for the first-floor chapel are shown in Figure 3. Areas showing delamination in the fresco, which pose a risk of falling, were clearly detected as high-temperature zones.

Figure 3. Delamination of fresco painting in the northwest chapel

At the Sanctuary, infrared thermography enabled non-contact, non-destructive measurement for the deterioration of stone cladding and interior frescoes, successfully detecting delamination and areas of damage. For interior fresco diagnosis using artificial heating, large-scale delamination was detected in high-temperature areas, but the detection of small-scale delamination was limited.

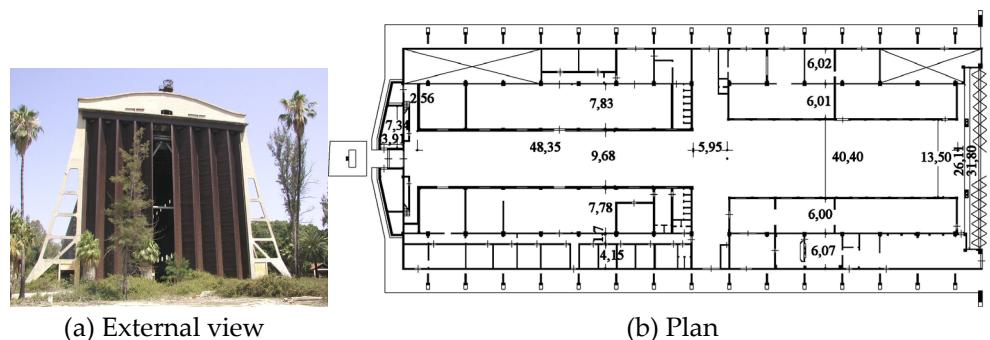
Figure 4. Airship Hangar in Augusta

The hangar, capable of housing an airship of 12,000 m³, is regarded as the only remaining example in the world built of reinforced concrete. The structure consists of 16 reinforced concrete buttresses, horizontal connecting beams, and walls. Its dimensions are approximately 105.5 m in length, 45.2 m in width, and 37.0 m in height, with internal dimensions of 100.0 m (length), 26.0 m (width), and 31.0 m (height) (Figure 4).

Though designated a national monument on December 24, 1987, the hangar had suffered extensive damage from frequent hooligan activity at the time of the survey. The weight of the iron doors caused differential settlement, resulting in large cracks in the roof and wall surfaces and raising serious concerns over structural stability.

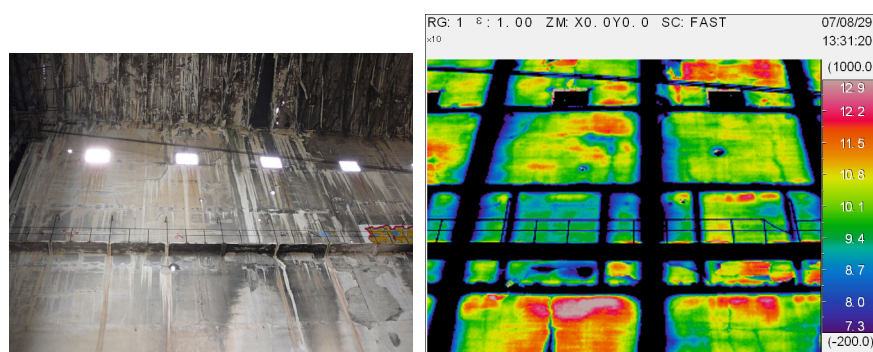
Figure 5 show the results of measuring the west exterior wall from the inside.

The influence of heat entering from outside through through-cracks in the exterior wall made the cracks detectable as high-temperature regions.

(a) Visual image (b) Thermal image
Figure 5. Cracks in the exterior wall

At the airship hangar, the survey demonstrated that, for thin exterior walls and roof slabs, a combination of solar heating and internal measurement could enable the detection of through-cracks, concrete spalling, and delaminated zones.
