True Smart and Green City?
8th Conference of the
International Forum on Urbanism

Conference Proceedings Paper

Categorization of Parcels without Road Frontage in Seoul and Development Possibilities for Sustainable Urban Transformation

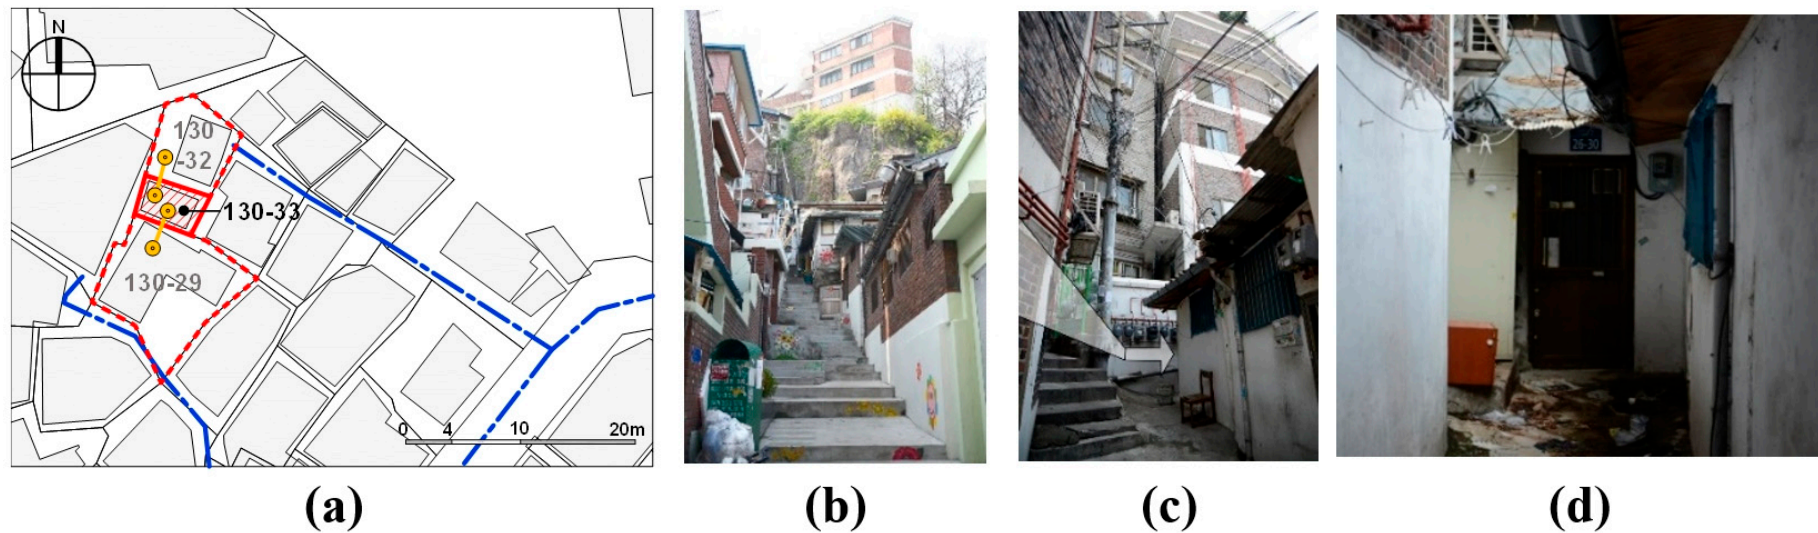
Figure 4. (a) Situation map around 130-33, Changsin 1 dong.

(b) (c) (d) Field pictures demonstrating access and situations of 130-33, Changsin 1 dong

130-33 Changsin 1 dong, the parcel without road frontage is located on the upper slope at the foot of a cliff above (Fig.4 (b)). The parcel has a small and old building, which has a main entrance looking out onto the narrow alley beside the 130-29 (Fig.4 (c), (d)). The parcel has a small and old building, which has a main entrance looking out onto the narrow alley beside the 130-29 (Fig.4 (c), (d)). Although the building has another entrance in the direction of the parcel, 130-32, it doesn't seem to be used. The parcel, 130-33 seems to be very hard to be developed together with 130-32 or 130-29 because the surrounding condition of site is inferior and complicated. The inferior condition means that it's very hard to access and the area of the parcel is very small at 23.1m². Even if three parcels of 130-29, 130-32 and 130-33 are bound and developed together, they would not have enough space for adequate sunlight and ventilation (Fig.4 (c)). The complicate condition means that 130-33 and the surrounding parcels are owned by different persons. In addition, 130-33 and 130-32 don't have building registers.

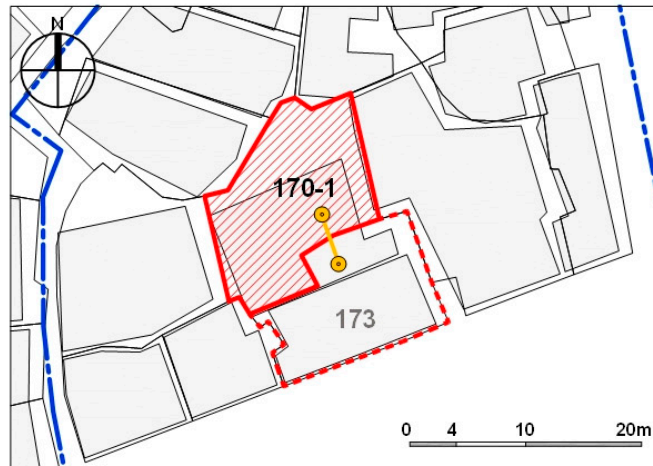
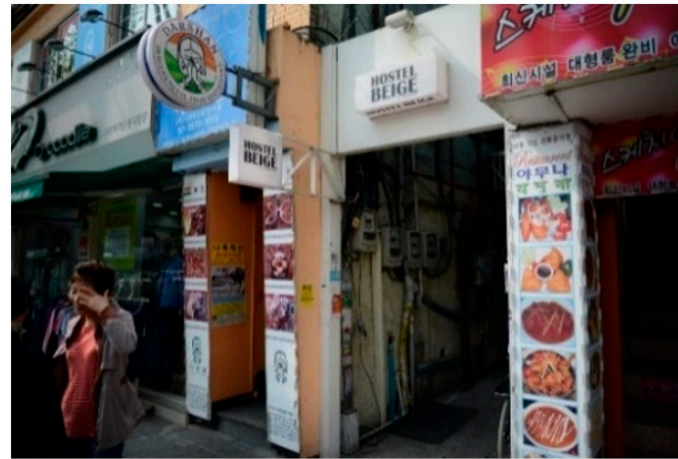
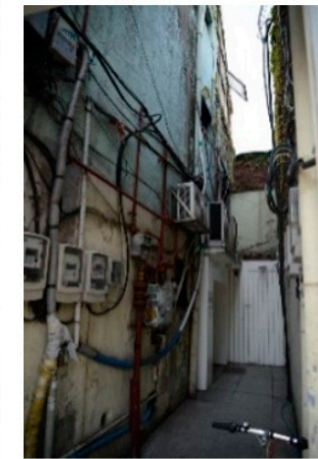
Figure 5. (a) Situation map around 170-1, Changsin 1 dong.

(b) (c) Field pictures demonstrating access and situations of 170-1, Changsin 1 dong

170-1 Changsin 1 dong, the parcel without road frontage is located behind the parcel 173 that faces Jongno, the main road of the area. 170-1 can be accessed from Jongno via a narrow alley located on the part of 173 (Fig.5 (b), (c)). Such an access are assumed to have a relation to ownership of two parcels by one person. The ownership provides accessibility and possibility of development for 170-1. The location and the ownership explains the recent alteration of the building on 170-1 to a hostel for foreigners (Fig. 5 (b)).

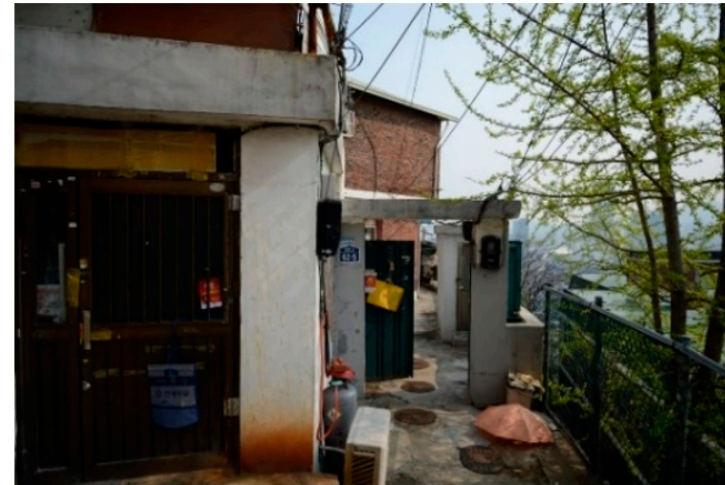
Figure 6. (a) Situation map around 23-638, Changsin 2 dong.

(b) Field pictures demonstrating access and situations of 23-638, Changsin 2 dong

23-638 Changsin 2 dong, the parcel without road frontage, can be accessed from the road through the part of 23-639 that is wide enough even to carry goods (Fig.6 (a), (b)). The building on 23-638 has a good view to its backside because it lies on the edge of a cliff in the middle of slope. In other words, it's not a poor condition to live in as it is. For the new development together with 23-639 in contact with a road, joint development would be possible upon the building agreement. Each owner lives in the building on each parcel, which was built around the same time.

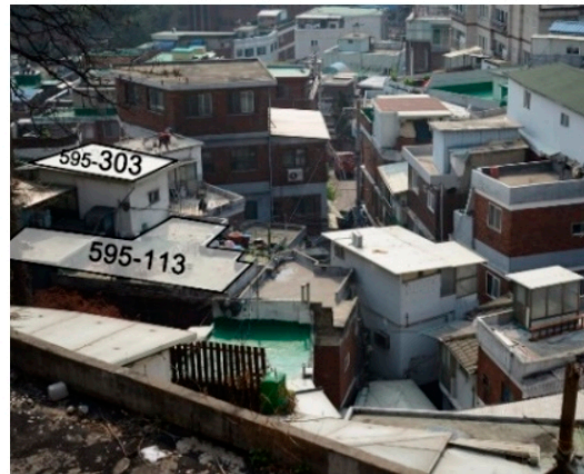
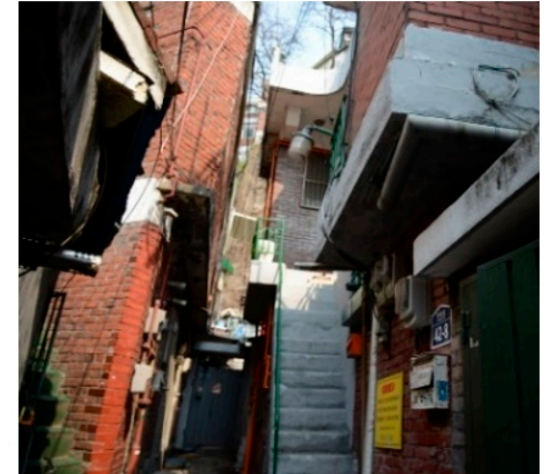
Figure 7. (a) Situation map around 595-303 and 595-86 Changsin 2 dong.

(b) (c) Field pictures demonstrating access and situations of 595-303, Changsin 2 dong

595-303 Changsin 2 dong, the parcel without road frontage, is one of the parcels surrounded by steep rock that was a quarry during the era of Japanese rule of Korea. In the area where rock was cut out, a lot of houses were built disorderly, that is to say, the urban squatter settlement was formed by the late 1960s (Fig.7 (a)). Although most buildings were registered by government policy, there remains many buildings without building register in this area. Furthermore, the overall forms of many buildings are indistinguishable from the adjacent buildings and most of those seem to have extended extemporaneously as time goes by (Fig.7 (c)). The building on 595-303 is included in those informal agglomerates. It doesn't have a building register. Its form is entirely integrated with the next building on 595-113 (Fig.7 (b)). Therefore, it needs more systematic approach than a parcel-level development like building agreement.

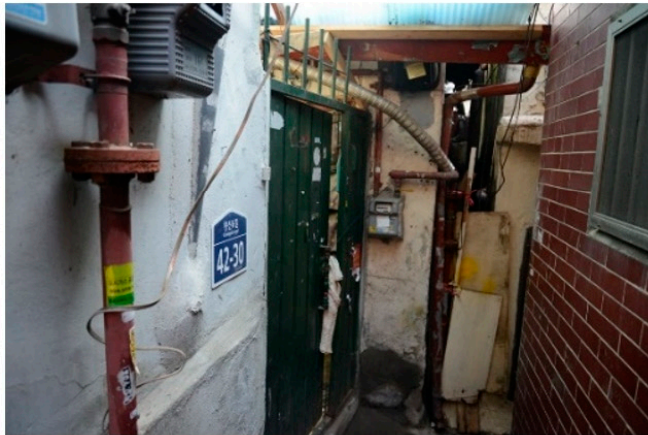
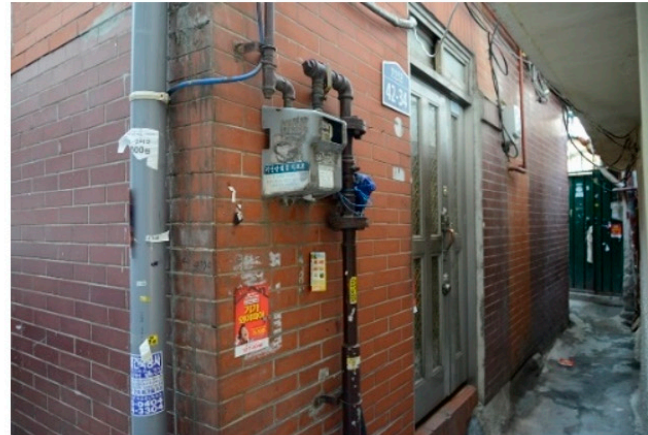
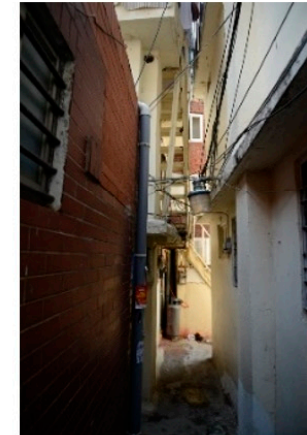
Figure 8. (a) (b) (c) Field pictures demonstrating access and situations of 595-86, Changsin 2 dong

595-86 Changsin 2 dong, the parcel without road frontage, near 595-303 is in the similar situation to 595-303. The access from road to the entrance is very narrow, damp and obscure (Fig.8 (a), (b), (c)). The building on the parcel is not registered. The area of the parcel is less than 50m². These features makes it difficult to remodel the building executively and physically. A senior woman dwelling in the area stated, “The more I spend the money for repair, the more the building require for repair. I need some different measures instead of a temporary repair.”

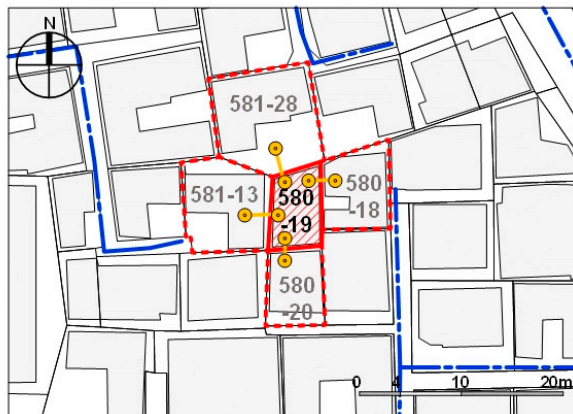
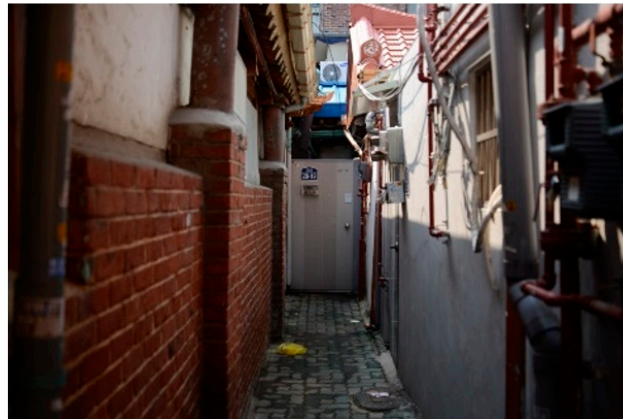
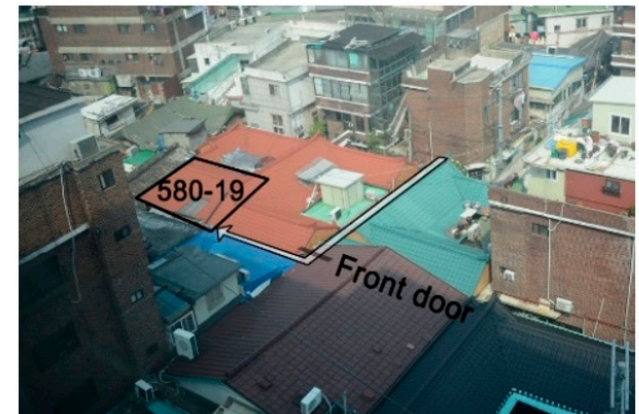
Figure 9. (a) Situation map around 580-19 Changsin 2 dong.

(b) (c) Field pictures demonstrating access and situations of 580-19, Changsin 2 dong

580-19 Changsin 2 dong, the parcel without road frontage, is in the relatively normal condition. It is located near a street market and the main road, Jongno. Although the building has an entrance in the south-east corner of 580-20 (Fig.9 (a), (b)), its new red roof explains that it has been recently remodeled (Fig.9 (c)). The parcel has four building agreement alternatives with an adjacent parcel to north, south, east or west. Most of buildings in this area are constructed in 1930s as sorts of Hanok.

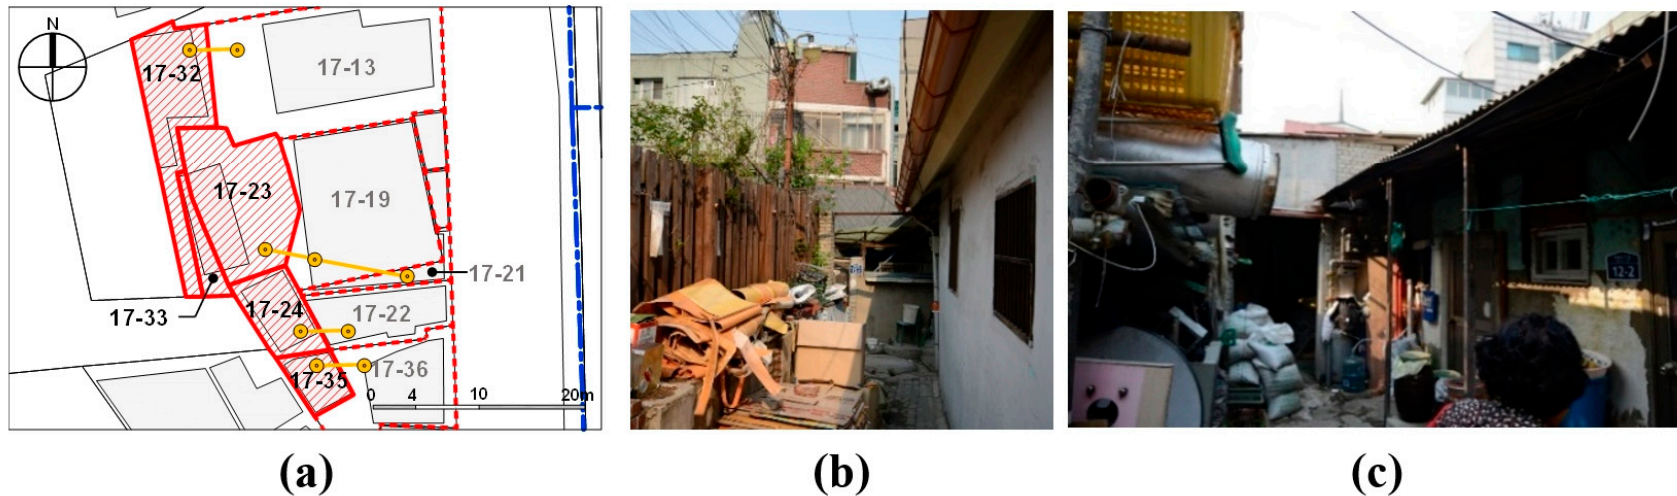
Figure 10. (a) Situation map around 17-32, 17-23, 17-33, 17-24 and 17-35 Changsin 3 dong.
(b) (c) Field pictures of 17-32, 17-23, 17-33, 17-24 and 17-35 Changsin 3 dong

Although the parcels, 17-32, 17-23, 17-33, 17-24 and 17-35 Changsin 3 dong have no legal road frontage, they have an on-site access alley from the west park site to four buildings on these parcels (Fig.10 (a), (b)). To the east, there are larger parcels with taller buildings fronting a wide road(Fig.10 (a)). However, there is no access route between a group of 17-32, 17-23, 17-33, 17-24 and 17-35, and a group of 17-13, 17-19, 17-21, 17-22, and 17-36 (Fig.10 (a)). The buildings on parcels of two groups have so different conditions - building use, building age, and etc. - that building agreement between two groups would be hard to accomplish.

The parcels without road frontage are owned by different persons. In front of the parcel, 17-24, there is a small courtyard shared by four worn-out buildings (Fig.10 (a), (c)). Although buildings are on lease, they have no building register.

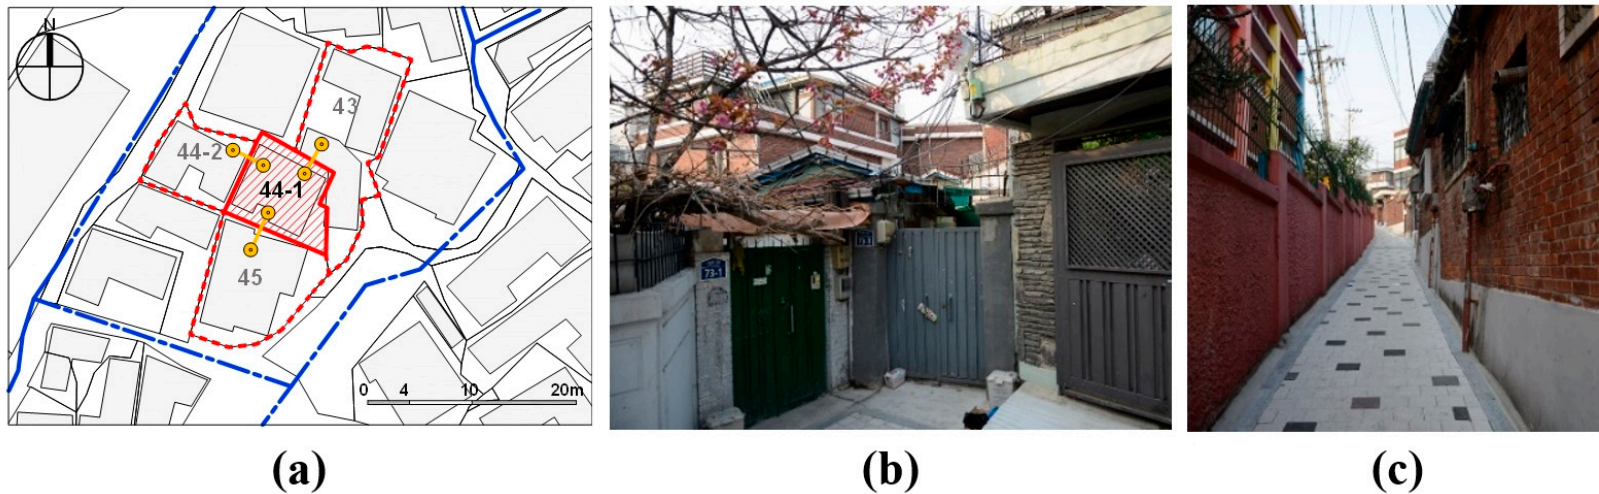
Figure 11. (a) Situation map around 44-1 Sungin 1 dong.

(b) (c) Field pictures demonstrating access and situations of 44-1 Sungin 1 dong

44-1 Sungin 1 dong, the parcel without road frontage, is located in the quiet residential area. The main entrance of the parcel is at its south-east corner, which is a part of the adjacent parcel 45 or 43 (Fig.11 (a), (b)). Although the parcels in the area are owned by different people, some aspects make it possible enough to redevelop them with building agreement. They have similarity in conditions of building age and building materials as well as good environmental quality of surroundings including pavements (Fig.11 (c)).

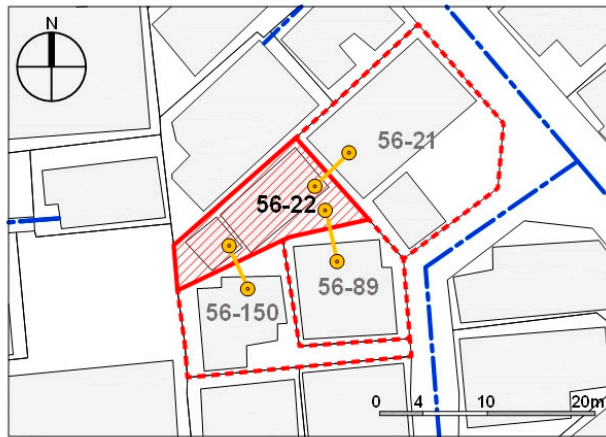
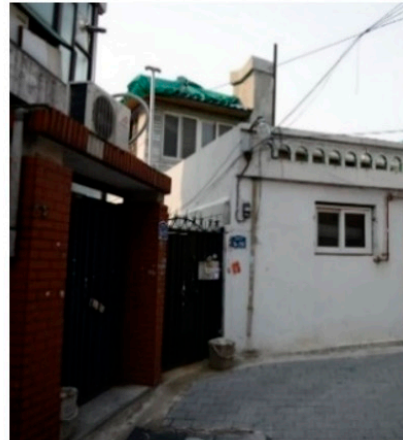
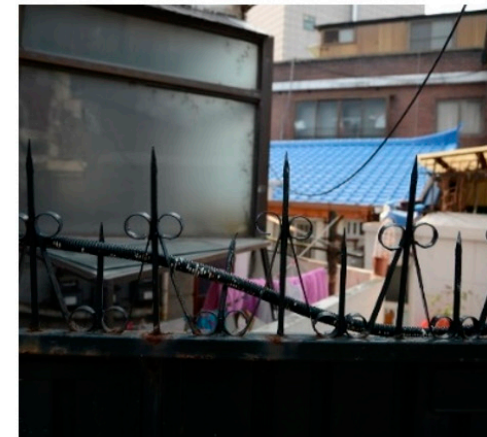
Figure 12. (a) Situation map around 56-22 Sungin 1 dong.

(b) (c) Field pictures demonstrating access and situations of 56-22 Sungin 1 dong

56-22 Sungin 1 dong, the parcel without road frontage is located in the similar condition to 44-1 as mentioned above. The parcel uses the part of 56-89 and 56-21 for access to the building located deep from the road (Fig.12 (a), (b)). Owners of all adjacent buildings live on each parcel, which forms a good condition for building agreement. Even if not redeveloped through building agreement, the current situation is not bad for living. The building on the parcel was recently remodeled (Fig.12 (c)).

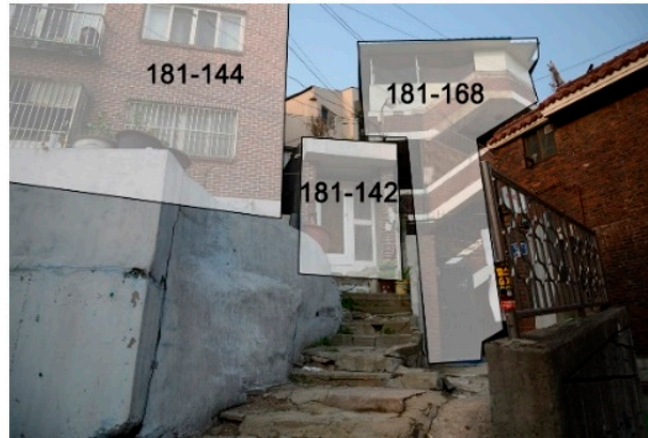
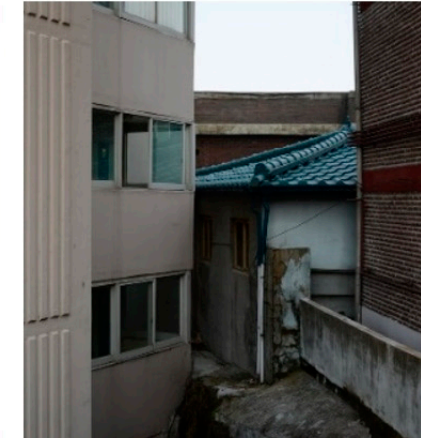
Figure 13. (a) Situation map around 181-142 Sungin 1 dong.

(b) (c) Field pictures demonstrating access and situations of 181-142 Sungin 1 dong

The parcel 181-142 Sungin 1 dong touches the parcel 58-555, owned by the borough Jongno-gu and used as a road currently, with its long and narrow part (Fig.13 (a)). Because the part isn't wide enough for even a person to pass through, 181-142 is considered as a parcel without road frontage in this study.

Considering the adjacent parcels 181-143 and 181-144, it's hard to expect building agreement between 181-142 and adjacent parcels because their conditions, especially such as the built year, are different: adjacent buildings on 181-143 and 181-144 are built in 1995 and 1997 respectively; the building on 181-142 seems to be much more deteriorated than the adjacent buildings (Fig.13 (c)) – it has no choice but to be judged from its appearance because it has no building register.

With another adjacent parcel 181-168, it's also hard to expect building agreement between 181-142 and 181-168 because the condition of building on 181-168 is so complicated as follows. First, although its building register was terminated several years ago, there still is a 4-story building on the ground and there are people living inside. Second, it is owned by eight people. Finally, the building is over the boundary with 58-555 owned by the borough as mentioned above. Therefore if a building is legally built again, it would have less floor area than the current building has.

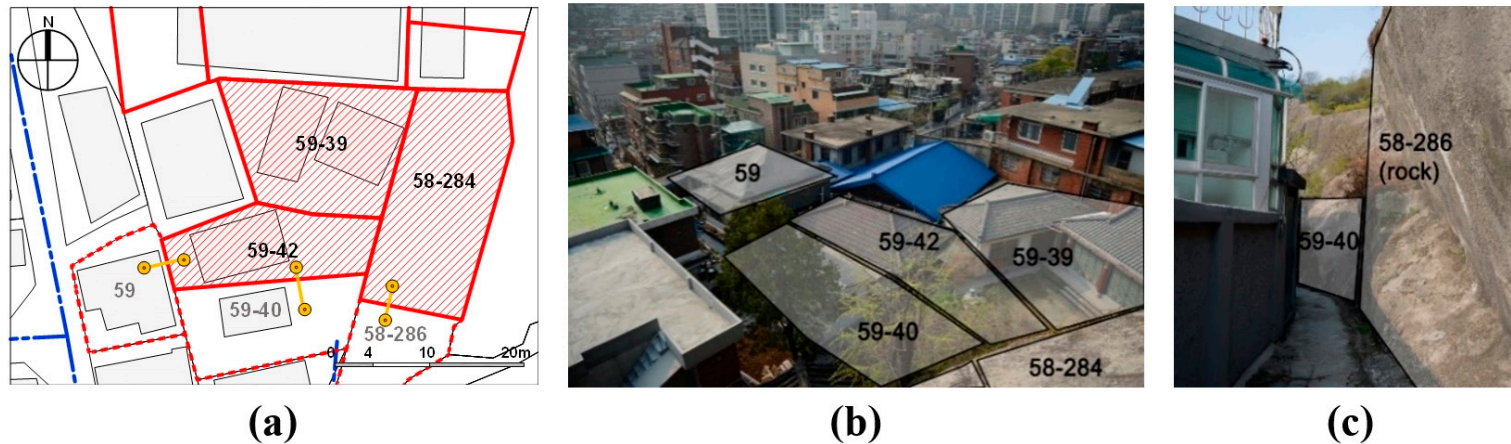
Figure 15. (a) Situation map around 59-39, 59-42 and 58-284 Sungin 1 dong.

(b) (c) Field pictures demonstrating access and situations of 59-39, 59-42 and 58-284 Sungin 1 dong

The parcels 59-39, 59-42 and 58-284 without road frontage are used as a temple. 59-39 and 58-284 are owned by the temple and owner's address of 59-42 is registered to 59-39. Three parcels without road frontage are considered to be effectively belonged to the temple. As examined on the field, three parcels and 59-40 share a courtyard at the center of four parcels and the entrance to the courtyard at the south border of 59-40(Fig.15 (b), (c)). However, the relationship between the owner of 59-40 and the temple is not verified.

According to the land registration map and land register, the temple had owned the parcel 58-286 that only had road frontage of all the temple's parcels. But in 2010, the temple sold it resulting to isolated parcels from the road. However, the temple seems to have no difficulty in accessing from the road because it shares the courtyard and the entrance as explained in the previous paragraph. Moreover in fact, 58-286 and 58-284 are not flat ground but steep rock, so they cannot be used as accesses to the buildings inside.

The parcels with road frontage in the north of 59-39 and 59-42 have several buildings and are owned by one person. Therefore it's hard to expect building agreement with them. The easiest way for 59-42 to have road frontage is to negotiate with the adjacent parcel 59 to the west. But it is assumed to be difficult because of different building uses. Despite such situations, nothing would be a problem to the temple because the parcels have the stable condition to access and live in.
