# Post-War Building Damage Detection

**Abstract:** Natural disaster and wars wreak havoc not only on individuals and critical infrastructure, but also leave behind ruined residential buildings and housings. The size, type and location of damaged houses are essential data sources for the post-disaster reconstruction process. Building damage detection due to war activities has not been thoroughly discussed in the literature. In this work, an automated building damage detection technique that relies on both pre- and post-war aerial images is proposed. Building damage estimation is done using shadow information and Gray Level Co-occurrence Matrix features. Accuracy assessment applied over a Syrian war-affected zone near Damascus, reveals the excellent performance of the proposed technique.

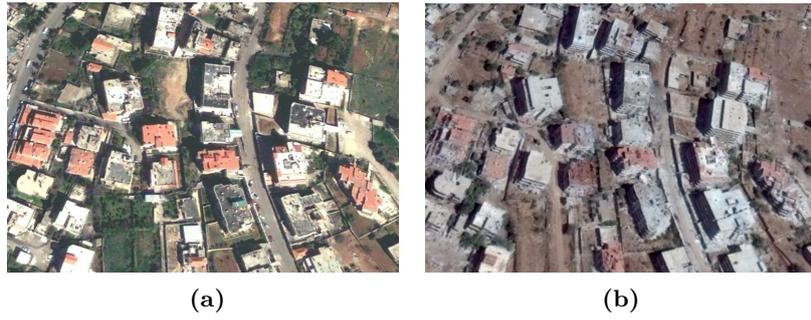
**Figure 1.** Figures 1a and 1b show the pre- and post-war original images, respectively, for Zabadani Study Area.

The literature does not provide for the best of our knowledge a relevant dataset for war affected areas to benchmark against. And thus, we focused in this work on images taken in 2015 during the Syrian civil war for Zabadani region near Damascus. Figures 1a and 1b depict the pre- and post-war original images captured on May 18, 2015, and August 5, 2105, respectively using GeoEye-1.

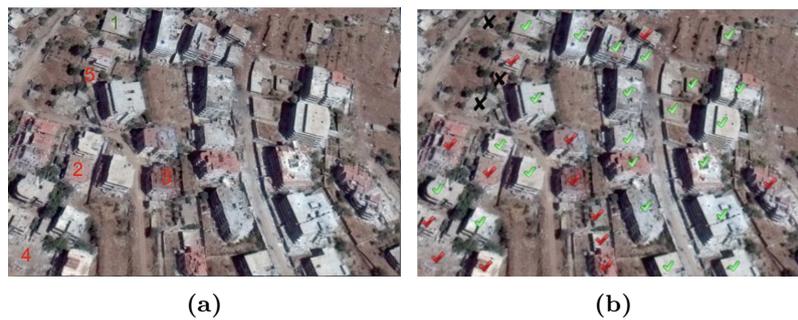
**Figure 2.** Figure 2a shows 5 labeled buildings investigated in details in Table 1 and Figure 2b shows building damage assessment results of the proposed algorithm.

Table 1 shows the values for *SAD*, *VD* and *CD*, respectively, for 5 buildings labeled in Figure 2a (post-war Zabadani Study Area). Damaged buildings are labeled using red color, while normal ones are labeled using green. Results for remaining buildings are omitted due to space limitation.

For Building Number 4, no shadow is detected in the post-war image and thus the relative building is considered as totally damaged. Generally speaking, normal buildings have high spatial relation between its gray levels in addition to higher homogeneity, and vice versa. Therefore, normal buildings Variance and Correlation values are higher than those of damaged buildings. Building Number 5 is misclassified as a normal building due the absence of noticeable major structure deformation in the post war image, thus having low **VD** and low **CD** values.

Figure 2b shows the resultant image of applying proposed building damage detection algorithm on Zabadani study area, where truly detected normal buildings are labeled with a green tic-mark, truly detected damaged buildings are labeled with a red tic-mark, and finally, undetected damaged buildings are marked by a black cross. Table 2 shows the accuracy assessment results for the proposed building damage detection algorithm using three metrics defined as follows:

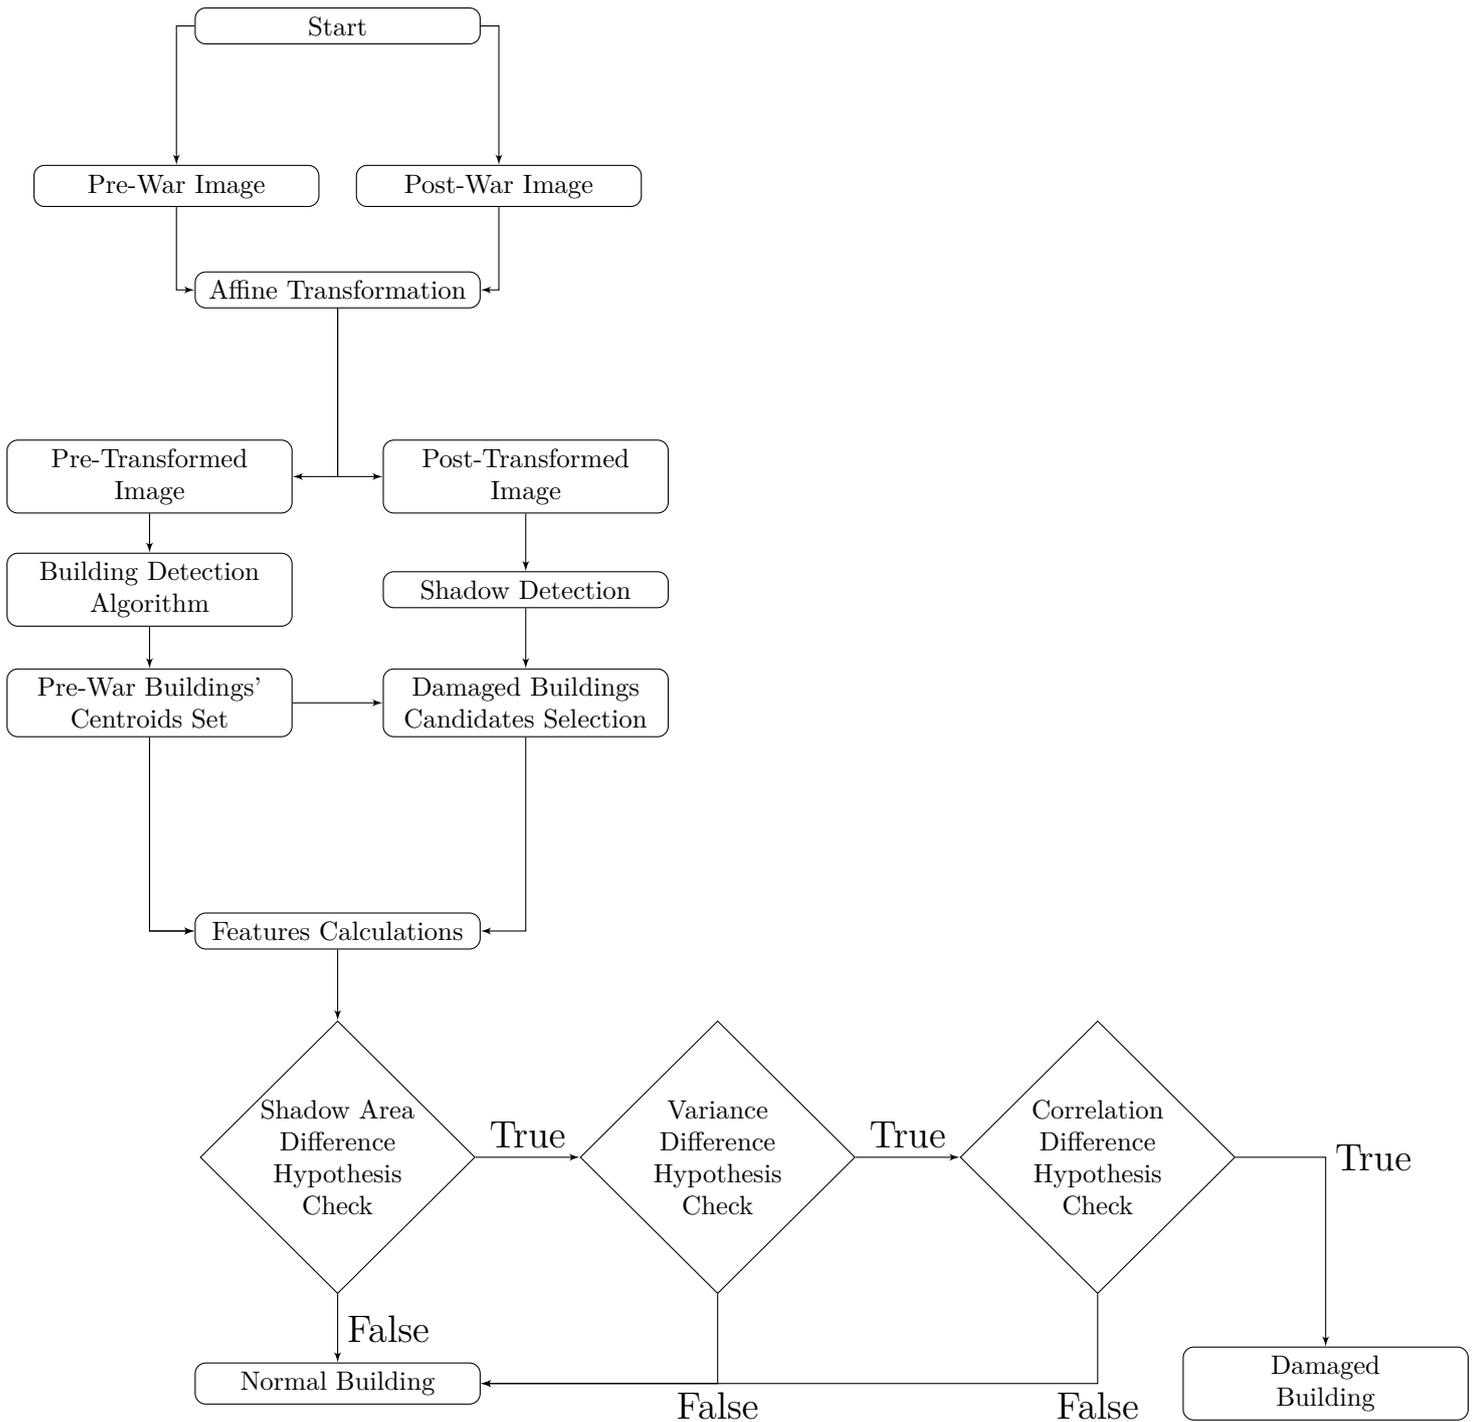
**Figure 3.** Proposed Building Damage Detection Block Diagram.

As a decision making process, three hypothesis are checked: (i) First, Shadow Area Difference, *SAD*, between pre- and post-war images should exceed a predefined threshold. (ii) Second, Variance Difference, *VD*, should also exceed a predefined threshold and the same applies for (iii) Correlation Difference, *CD*.

If no building shadow exists in the post-war image, then the building will be classified directly as a damaged building. Threshold selection is done experimentally for the scope of this work. In future work, machine learning techniques will be used in order to design an optimal classifier.

Figure 3 shows the block diagram of the proposed building damage detection algorithm.
