# Cause Estimation of Damages in Pathein Suspension Bridge Based on Vibration Measurements <sup>†</sup>

**Abstract:** Pathein suspension bridge situated in Pathein city in the south of Myanmar has shown various symptoms of damage and the safety of the bridge is questionable. The authority concerned reported that the bridge is undergoing severe deteriorations since its construction, namely towers' inclination, excessive deflections, bearing failure, heavy corrosion of main cables and hangers, hangers' inclination, and slippage of clamps. The deformed shape of the stiffening girder was found to be unusual with maximum deflection nearer to the towers, however, in a single span bridge, such as Pathein bridge, the maximum deflection is expected to be at mid-span. This paper could estimate the possible reasons for the unusual excessive deformations in the stiffening girder and bearing failure. Tension force of hangers was estimated based on vibration measurements, the distribution of hangers' force was found to be non-uniform with low-tension force in hangers closer to the towers. The non-uniform distribution of the hangers' tension force is possibly due to shortcomings of the design of

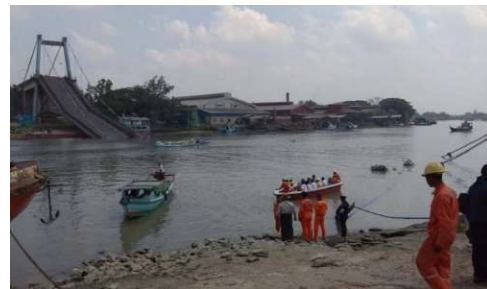
Figure 1. Myaungmya bridge after the collapse

A survey conducted in 2012 by Japan Infrastructure Partners pointed out that many bridges constructed in Myanmar recently have already shown severe deteriorations and they require remediate actions [1]. On April 1, 2018, Myaungmya suspension bridge located in Ayeyawady region in south of Myanmar collapsed and two persons were reported missing [2], the bridge has shown significant deteriorations and the traffic was restricted to one lane [1], however, the safety of the bridge was not accurately assessed, Figure 1 shows Myaungmya bridge after the collapse.

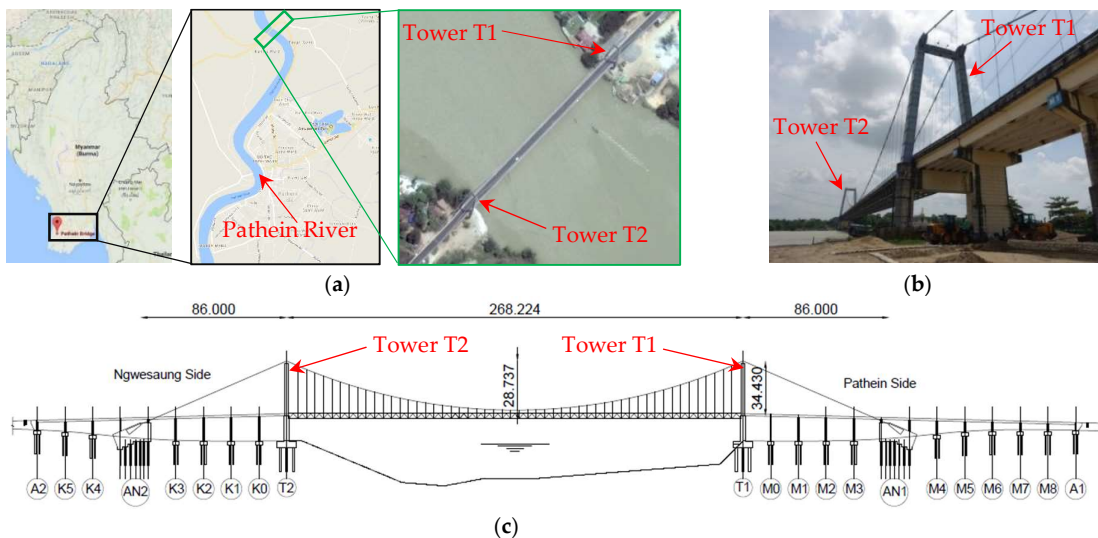
**Figure 2.** Pathein bridge. (a) Location of the bridge on Myanmar's map; (b) Picture of the bridge; (c) Elevation of the bridge as per design drawings.

Pathein suspension bridge, situated in Pathein city in the south of Myanmar, was constructed in 2004. The bridge is crossing Pathein river and is believed to have a significant importance for the traffic crossing the river. The bridge consists of one main span of 268.224 m and two side spans of 86 m. The bridge's main span consists of stiffening truss suspended by 52 hangers on each side of the bridge, while the side spans consist of precast concrete girders, Figure 2 shows an overview of the bridge. It is noticeable that in the real bridge, hangers exist on side spans as well, however, they do not exist in the design drawings, they were constructed for an aesthetic purpose and they carry no force.

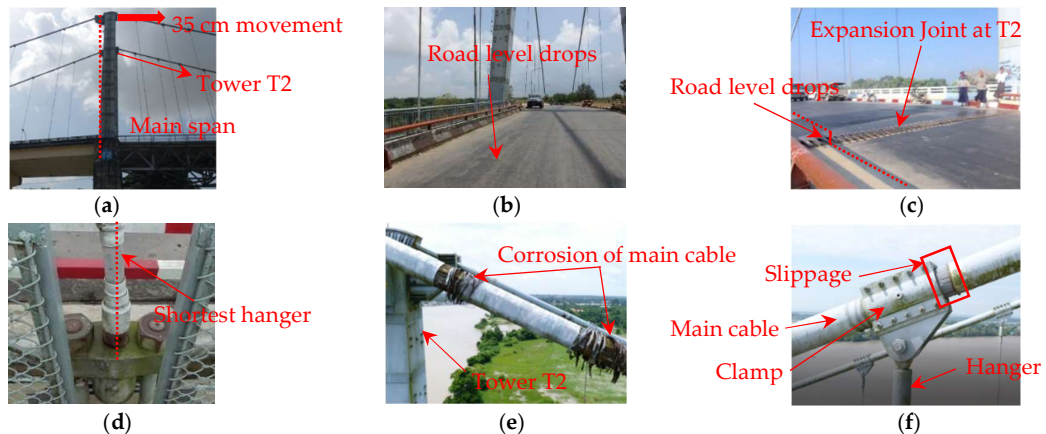
Pathein bridge has shown various deteriorations, the safety of the bridge is questionable and an immediate assessment and monitoring is crucial. Visual investigations and investigations using drone were carried out in July 2017, the damages of the bridge could be summarized in six damages. Top of towers T2 and T1 moved 35 and 21 cm respectively towards the main span, excessive deflections in stiffening girder, failure of the bearing at downstream of T2, heavy corrosion of main cables and hangers, hangers' inclination, and slippage of clamps, Figure 3 shows all the damages in the bridge. It is notable to mention that the deflection of the stiffening girder is unusual with maximum deflection of 40.43 cm near tower T2, however, maximum deflection is normally found at the mid-span in single span bridges, Figure 4 shows the deformed shape of the bridge measured in October 2016.

**Figure 3.** The damages in Pathein bridge. (a) Inclination of tower T2; (b) Road level sinking down; (c) Road level drops down after the bearing failed; (d) Inclination of hangers; (e) Corrosion of the main cable; (f) Slippage of clamps.

The low-tension force near the towers caused an excessive downward force to be transferred to bearings, which is not designed to carry such downward force. The failure of the bearing of the downstream of Tower T2 is possibly due to the excessive force that had to be carried by hangers near the tower T2. Once the bearing failed and the road level dropped at tower T2, the first hangers (hanger 1 in Figure 8) carried larger force. The bridge was lifted up at tower T2 and the bearing was rehabilitated and supported by adding new rollers to support the excessive force. The bearing at the other side (at tower T1) is also suspected to fail since it is undergoing similar conditions, as a precaution, new steel rollers were added to support the bridge in case of any future failure of the bearing. The maintenance crew welded the bearings at tower T1 and no rotation is allowed anymore, further study on how fixation of the bearings can affect the behavior of the bridge is needed.

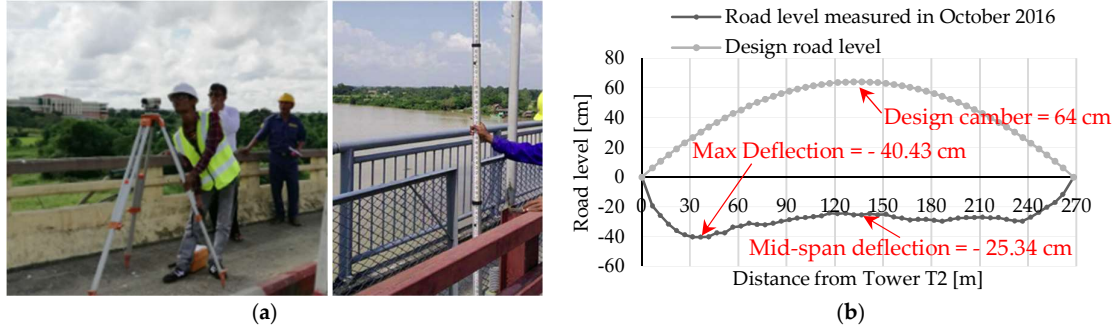
Figure 4. (a) During the measurement of road level; (b) Design road level and measured road level.

Towers' inclination caused the road level of Pathein bridge to drop down, however, the maximum deflection is expected to be in mid-span. Preparation of hangers in longer lengths caused additional deflections in the stiffening girder. The error in hangers' length preparation was maximum in hangers near the towers while it was negligible in hangers near mid-span, therefore, it is reasonable that deflections are larger near towers. The final deflection is a combination of the deflection caused

by towers' inclination and the deflection caused by the shortcoming of hangers' length design, the maximum deflection happened to be near tower T2.

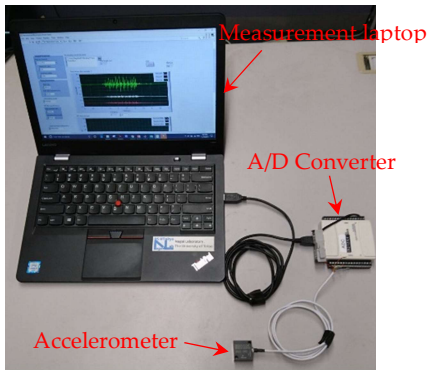
Figure 5. Measurements' system

Vibration measurements were conducted in November 2017 to estimate the hangers' tension force distribution along the bridge. The measurements were conducted using 3-axis piezoelectric accelerometers, Figure 5 shows the measurements' system. The accelerometer was attached to the hangers using double-sided tape, then, the hangers were excited by hitting them several times using a rubber hammer. The data were collected with a sampling rate of 400 Hz and the acceleration of the hangers in the direction of bridge axis was considered for the analysis. The data were recorded for 60 seconds for each hanger, and Fast Fourier Transformation (FFT) was calculated to estimate the frequency property of the recorded acceleration, Figure 6 shows the measurements' procedures. The 1st mode frequency of 32 hangers out of 52 hangers of each side was successfully estimated, however, the shortest 20 hangers were difficult to estimate and further measurements are required, Figure 7 shows the frequency domain plots of the first 16 hangers in DS (1st hanger is closest to T2).

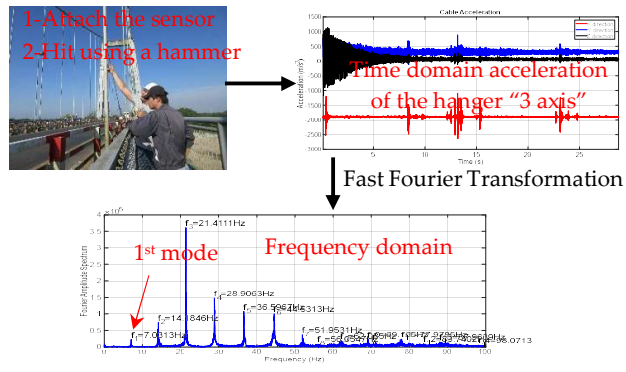
Figure 6. Measurements' procedure

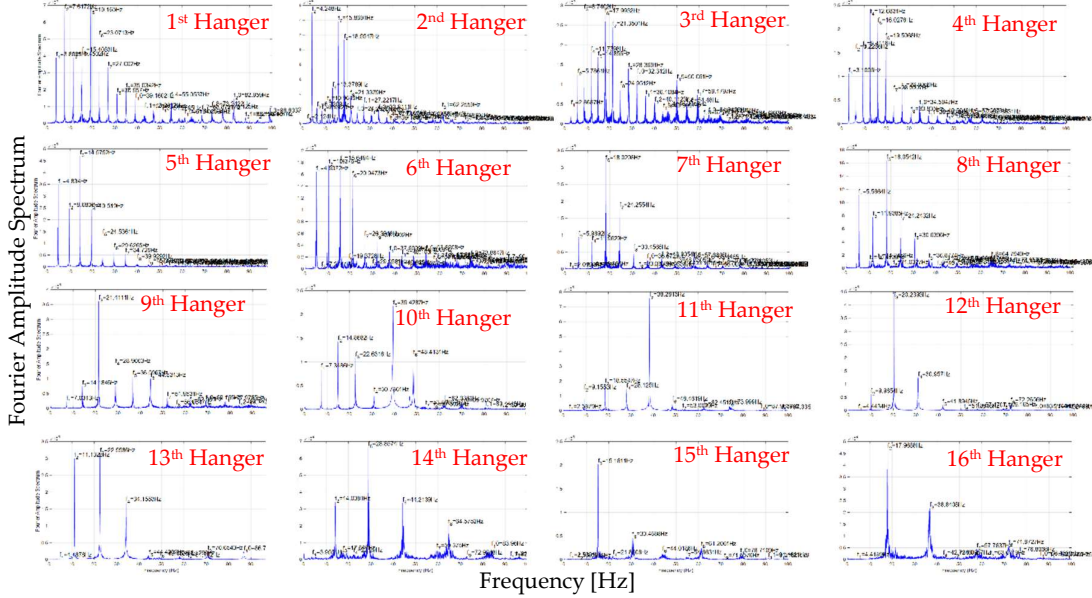
Figure 7. The frequency domain plots of the first 16 hangers in DS (1st hanger is closest to T2).

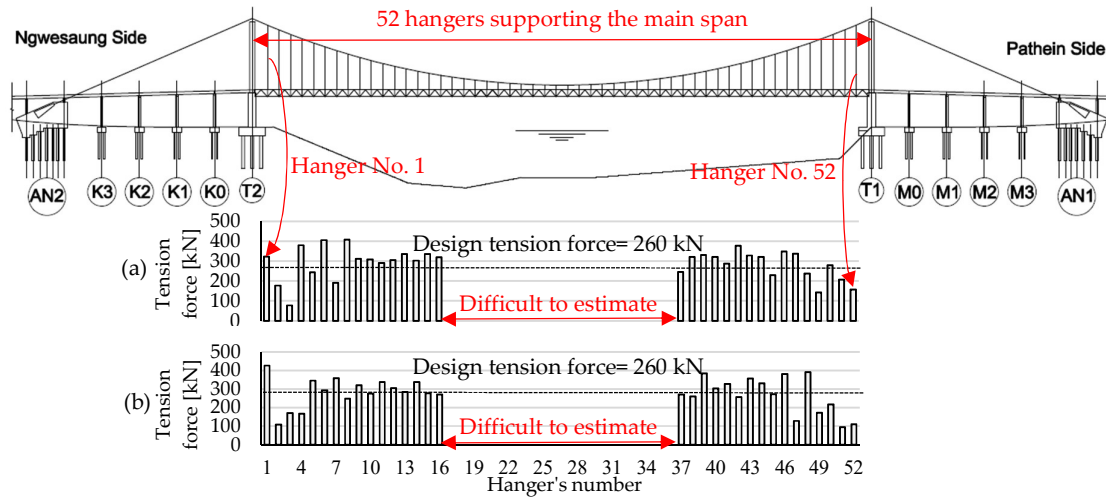
**Figure 8.** Hangers' tension force distribution of Pathein Bridge. (a) Tension force of hangers of upstream; (b) Tension force of hangers of downstream.

n, this indicates that the flexural rigidity has a small influence on the natural frequencies, however, the shorter (less than 12 m) hangers' frequencies show nonlinearity and the flexural rigidity should be considered. The tension force of the hangers was estimated using the practical formula of Zui et al. (1996) since it considers both sag and flexural rigidity of the cable. Figure 8 shows the distribution of the tension force for both upstream and downstream (32 hangers on each side).

The geometry of the main cable is usually chosen so that it coincides with the funicular curve of the total dead load, this is to make sure that both towers and girder are moment-free at the mean temperature. The design profile of the main cable of Pathein bridge was found not to fit the funicular shape, consequently, the manufacturer prepared hangers in longer lengths than the required length to maintain the road level as per design profile (vertical curve radius  $R=14,000$  m). The error of the hangers' length preparation was maximum (75 cm) in the longest hangers (27.2 m) while it was negligible in shortest hangers. Considering the distribution of the tension force along the bridge (Figure 8), it is noticeable that hangers near the towers (except hanger 1 in US and DS) carry lower tension force compared to the design tension force (260 kN), this is likely due to the shortcomings of the design of the main cables and hangers.
