Conference Paper

Experimental analysis of monotonic and cyclic pull-out of steel fibres by means of acoustic emission and X-ray microfocus computed tomography [†]

[†] Presented at 18th International Conference on Experimental Mechanics, Brussels, Belgium, July 2018

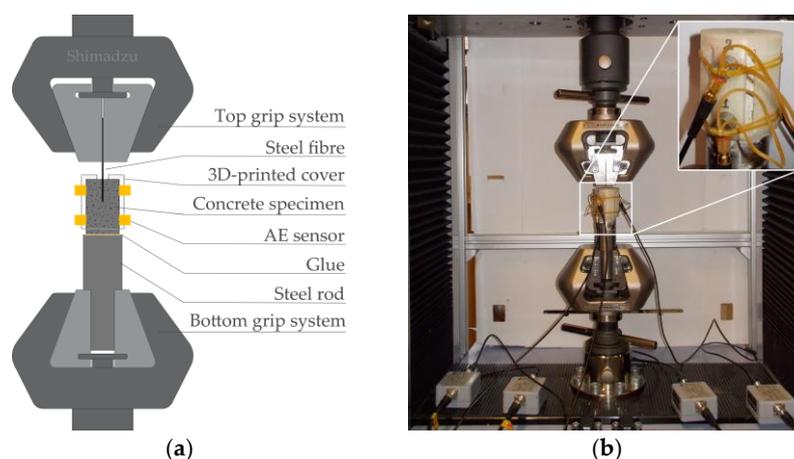
Figure 1. Experimental setup: (a) Schematic overview; (b) Photograph with detail of concrete specimen with 3D-printed cover and AE sensors.

Monotonic and cyclic pull-out tests of the steel fibres are performed with a universal testing machine (Shimadzu AG-XMST-X/X-Type, 100 kN maximum capacity), Figure 1(a). The specimen's bottom side is glued on a steel rod that is clamped in the machine's grip system. The end-hook of the fibre's protruding end is removed and the straight fibre is securely clamped in the top grip system. The testing machine records the pull-out load and displacement. Different loading patterns are applied, namely (1) monotonic pull-out at 0.6 mm/min; (2) loading cycles before reaching the maximum pull-out force; and (3) loading cycles after the maximum force. Both cyclic patterns are continued by a monotonic pull-out. The tests are performed up to complete fibre pull-out or specimen failure. The loading ratio, frequency and number of cycles are varying parameters among the cyclic tests. The developed experimental procedure makes use of micro-CT scans and AE monitoring for damage progress analysis.

Secondly, four piezoelectric broadband sensors, with frequency range 50-2000 kHz (DigitalWave B1025), continuously measure AE waves reaching the specimen's surface. A self-designed 3D-printed cover (Figure 1(b)) fixes their position and the connection with the surface is made by vacuum gel. The four sensors form a vertical plane with a height of 27 mm and a width of 30 mm through the specimen's center. A preamplifier of 34 dB gain makes the connection between a sensor and the Vallen AMSY-5 acquisition system. In this system, a frequency filter of 230-850 kHz and an amplitude threshold of 36.2 dB are applied to avoid low-amplitude background noise. The sampling rate equals 10 MHz. The Vallen VisualAE software is used to process and display the test data in real time.

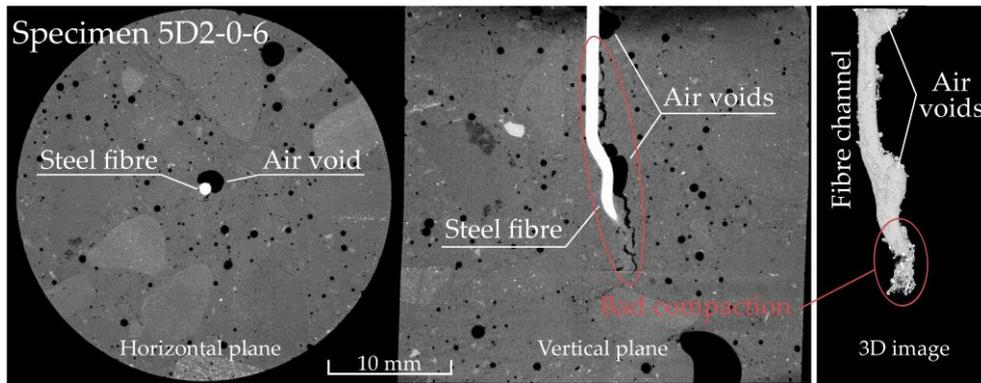
Figure 2. Micro-CT scans of specimen 5D2-0-6: horizontal and vertical plane through the specimen’s centre and a 3D outer surface image of the fibre channel and connected air void after fibre pull-out.

Micro-CT scans visualize the specimen's microstructure in 3D, leading to valuable information on the specimen and the bond between steel fibre and concrete matrix. After scanning the six specimens of group 5D2-0, specimen 5D2-0-6 appeared to have three defects: (1) a bad compaction along the fibre; (2) an air void at the fibre's end-hook; and (3) an air void at the fibre's top, as indicated in Figure 2. As a result, 5D2-0-6 has a deviating pull-out behavior compared to the group with similar properties, refer to Figure 3(a). The partial disconnection between fibre and matrix (defect 1, 2 and 3) leads to a decreased anchorage surface, resulting in a lower maximal pull-out force (590 N compared to the average of 926 N). Due to the absence of confining concrete in defect 2, the end-hook of the fibre is not straightened completely. Continuing the fibre pull-out, the frictional resistance is increased due to the hook's residual deformations (a second peak value of 362 N compared to the average of 214 N). Lastly, the lost anchorage surface at the fibre's top in defect 3 leads to the early drop of the pull-out force to 0 N at 16 mm, which is about 4 mm before the average curve.

All 40 specimens are scanned before testing and some of them appear to have one or more defects. These specimens can be selected and omitted from testing or their deviating behavior can be correctly interpreted. As such, micro-CT scanning provides a deeper insight additional to the traditional pull-out setup. A following research step is to quantify the relation between the magnitude of the debonded area due to defects and the decrease of pull-out force.

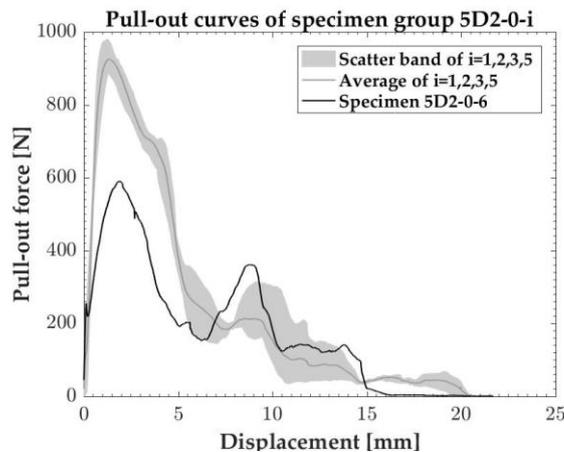
Figure 3. Pull-out curve of specimen 5D2-0-6 compared to the average and scatter band of the group.

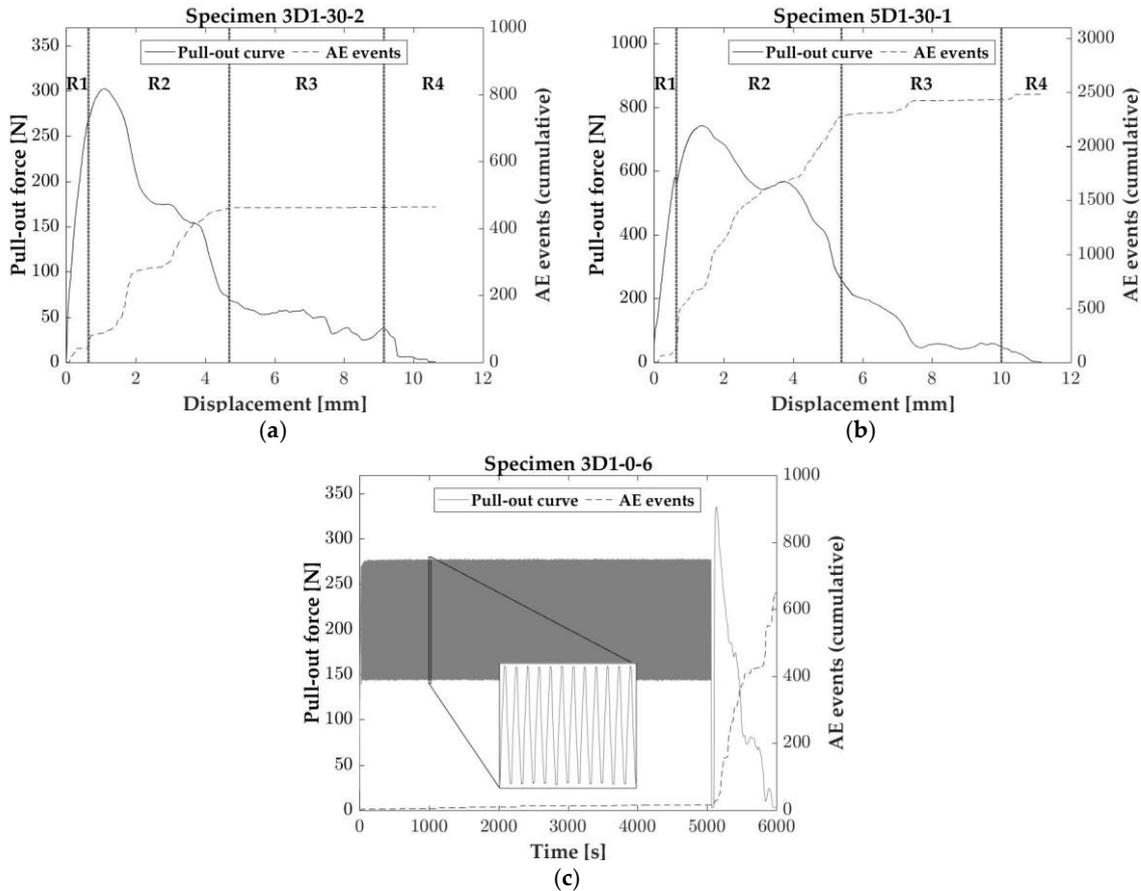
Figure 4. Pull-out curves with cumulative AE measurements for specimen (a) 3D1-30-2; (b) 5D1-30-1; (c) 3D1-0-6 with loading cycles before the maximal pull-out force.

The AE measurements detect and locate damage initiation and propagation within the concrete specimen. During a pull-out test, four regions (R1 to R4) with corresponding energy dissipation mechanisms are distinguished [9]. The obtained AE response supports the distinction of these regions, as shown in Figure 4(a-b). During R1, elastic behavior and debonding along the interface, no or only a few acoustic events are detected. Thereafter, in R2, the plastic deformation and straightening of the end-hook causes local concrete crushing with an increase of AE events. Subsequently, the frictional sliding movement of the straightened fibre through the matrix channel in R3 induces insignificant AE activity, although residual fibre deformations can still produce a few events. Lastly, in R4, the frictional resistance reduces due to the fibre’s exit, whereby concrete spalling at the specimen’s surface could occur, leading to an additional amount of AE events. Furthermore, the AE activity is higher for a 5D hooked-end fibre compared to a 3D fibre, due to four bends to straighten in R2 instead of two.

Besides monotonic pull-out, also loading cycles are applied in several tests. Figure 4(c) presents 2000 cycles between 43 and 83 % of the maximal pull-out force at a frequency of 0.4 Hz. During the cyclic loading, almost no detectable damage, e.g. micro-cracking, has yet occurred. A very low amount of AE activity is measured, namely 19 events on the total amount of 650 events. Only at continuing the fibre pull-out process, AE events and the related damage are detected. Therefore, the applied loading pattern does not lead to a distinct fatigue behavior. It is expected that much more cycles or higher load limits are required to obtain significant fatigue damage.

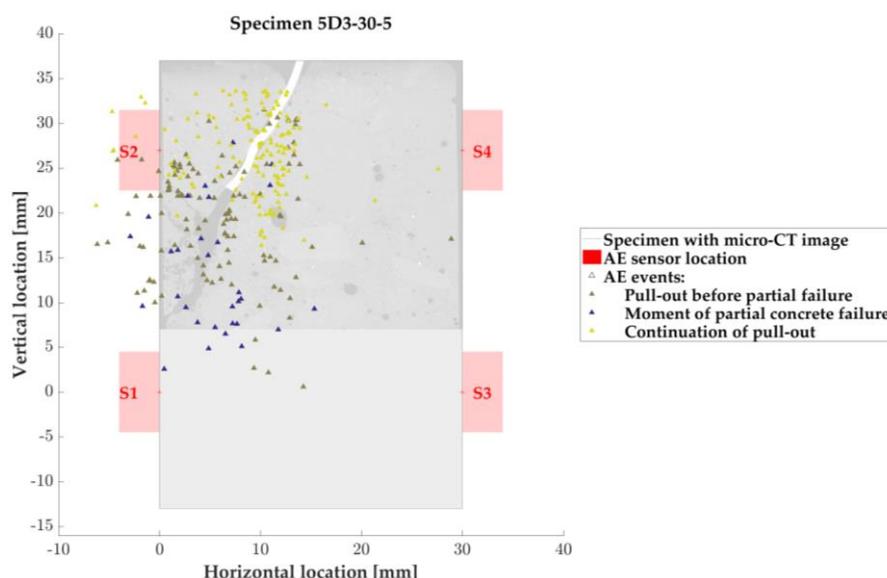
Figure 5. Micro-CT scan of 5D3-30-5 with AE localization of damage during the pull-out process.

The combination of micro-CT scans and AE measurements leads to the localization of damage together with the visualization of the fibre, aggregates and pores position. During the pull-out test of specimen 5D3-30-5, a part of the concrete was pushed off during straightening of the fibre. The large inclination, the large anchorage length and the stronger 5D fibre cause this concrete failure. After the partial failure and corresponding decrease of pull-out force from 1020 N to 503 N, the pull-out process continued until half of the embedded length is pulled-out. Figure 5 presents a micro-CT scan at the end of the test, together with the localization of AE events, indicated by colored triangles. These triangles are grouped according to the phases: pull-out before partial failure, moment of partial concrete failure, and continuation of pull-out. AE sources located outside the specimen are due to reflections around the sensors and the fracture plane. The AE localized events support the failure mode and correspond to the occurring damage pattern. The first pull-out phase and the partial failure are located at the fibre’s end-hook; the AE sources after partial failure follow the pull-out process.
