Development of Delamination Detection System for Concrete Decks by Using Convolutional Neural Network [†]

[†] Presented at the 18th International Conference on Experimental Mechanics, ICEM18, Brussels, 2018

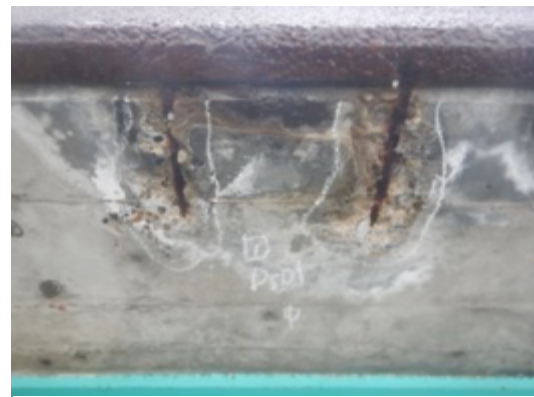
Delamination is a state where a thin cover of the concrete deck of a bridge is partially laminated from the surface of the deck (Figure 1). This is one type of damage which is defined in the Niigata inspection code. If delamination increases, the rebar inside the deck is exposed (rebar exposure), which is considered to be serious condition as stated in the inspection code. In order to judge delamination accurately, non-destructive evaluation such as ground penetrating radar (GPR) or infrared thermography (IR) has been proposed [4]. These technologies enable managers of expressways to specify the delamination on the top surface along their roads. However, GPR or IR cannot be simply applied for the inspection in municipalities’ bridges, because these bridges are scattered all around the municipality, and the location of delamination at the bottom of the bridge should be specified in the inspection.

Figure 1. A typical picture of delamination (with rebar exposure)

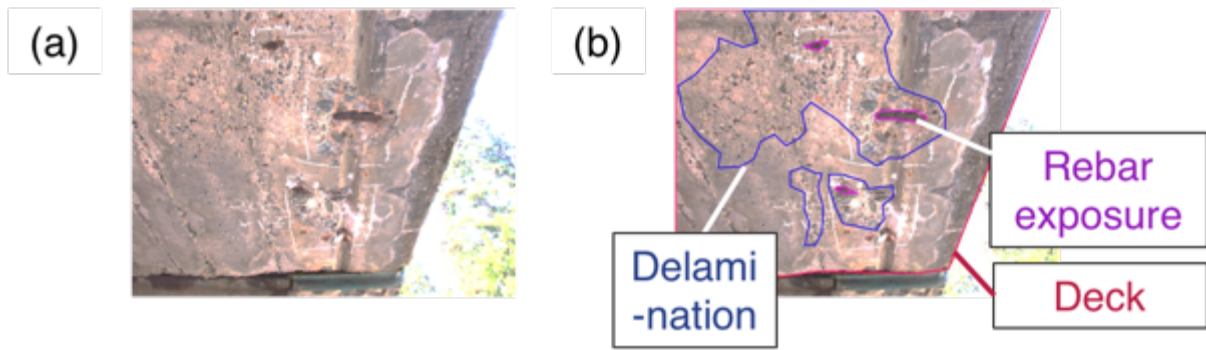
For each of these photographs, annotation of the area of “concrete deck,” “delamination” and “rebar exposure” is created by the students in the department of civil engineering (Figure 2.). The annotation is marked as a polygon shape. Here, delamination is defined as a state where aggregate inside the concrete deck is visible, and rebar exposure as a state where an exposed rebar can be identified in the image.

Figure 2. One of the trained images before annotation (a); after annotation of “deck,” “delamination” and “rebar exposure” (b)
