# Preliminary High-temperature Tests of Textile Reinforced Concrete (TRC) †

† Presented at the 18<sup>th</sup> International Conference on Experimental Mechanics, ICEM18, Brussels, 2018

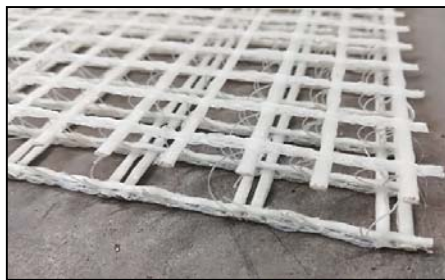
**Figure 2.1** Three-dimensional AR-glass fiber reinforcement

The reinforcement was a three-dimensional, alkali-resistant glass (3D AR-glass) fiber textile (see Figure 2.1). The mesh size differed among the two perpendicular directions and among the two faces, varying between 9 and 18 mm. However, the cross-sectional area of the reinforcement was equal in both faces; 70.5 mm<sup>2</sup> lengthways and 71.6 mm<sup>2</sup> crossways. The weight of the textile before finishing is 917 gr/m<sup>2</sup> and the tensile strength is equal to 1200 MPa, according to the manufacturer. The distance between the two faces is 12 mm.

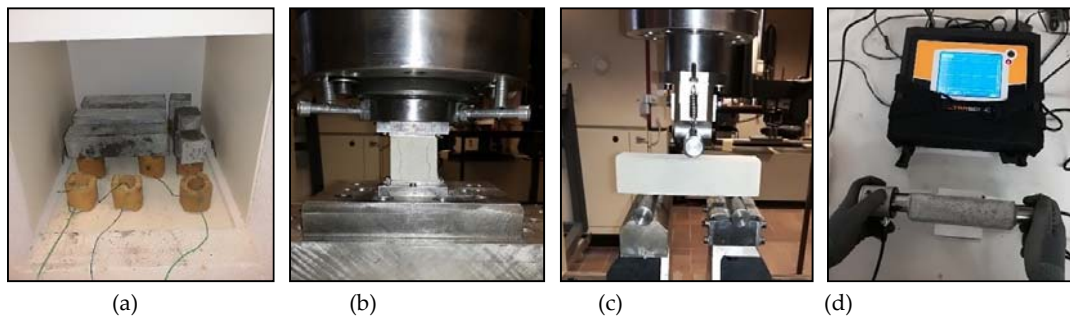
**Figure 2.2** Test series 1; (a) Specimens and thermocouples inside the furnace; (b) compression tests on cubic specimens; (c) three-point bending tests on prismatic specimens; (d) UPV measurement

The first test series consists of compression, flexure and Ultrasonic Pulse Velocity (UPV) tests on mortars, before and after heating to 850 °C. The temperature was chosen to be equal to 850 °C, as this is the temperature that corresponds to 30 minutes of exposure to a typical cellulosic fire, according to [4]. The heating was achieved with a small furnace which has the potential to reach temperatures above 1000 °C. The temperature was measured and monitored by the furnace's controller but additional thermocouples to verify the measurements were used as shown in Figure 2.2(a).

The tests were conducted on cubic (40 mm) and prismatic specimens (160x40x40 mm). Six cubic and six prismatic specimens were made from each mortar, M1 and M2. Three cubes were tested in compression without being exposed to high temperature and three after exposure. Moreover, three prismatic specimens were tested in 3-point bending before and three after exposure to high temperature. UPV measurements were conducted to all specimens (cubes and prisms from M1 and M2) before and after the heat treatment. All these tests are shown in Figure 2.2(b-d).

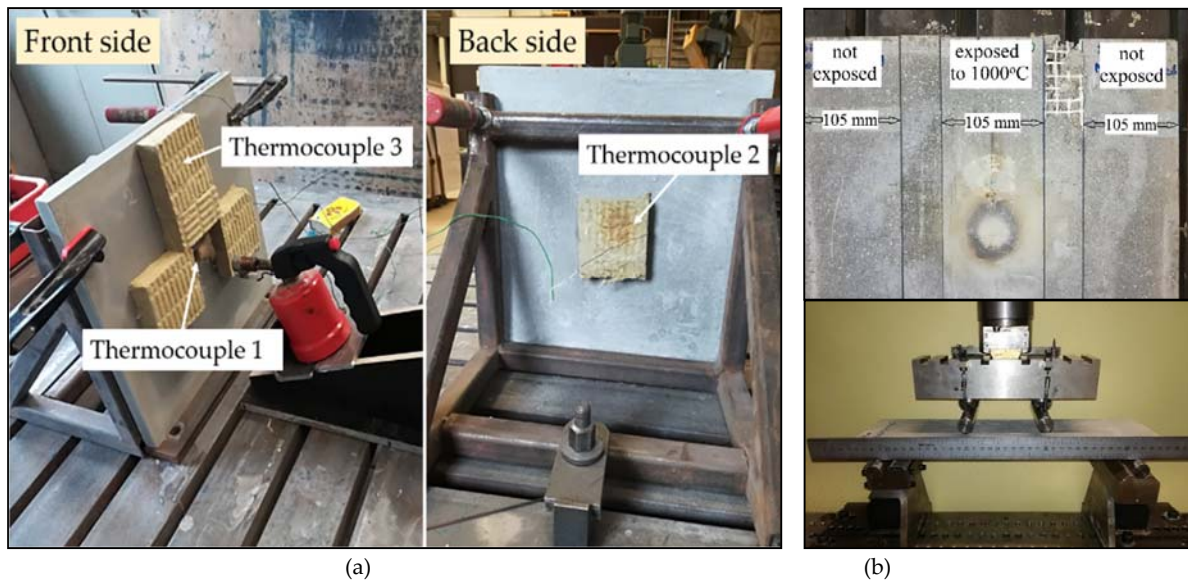
**Figure 2.3** (a) Set-up of gas-burning tests on TRC tiles; (b-top) Three specimens cut from each tile, after the fire-exposure; (b-bottom) Four-point bending tests on specimens cut from the tiles

In the second test series burning tests on tile specimens of TRC were conducted using a simple gas burner. Two tiles 400x400 mm and 22 mm thick were made, one from mortar M1 and one layer of the available 3D textile, and one from mortar M2 and one layer of the same textile. The textile was placed in the middle of the tiles so that the cover was equal to 5 mm in all cases. As seen Figure 2.3(a), the tiles were fixed with a simple set-up on a vertical position and a flame was applied at the center with a gas burner. The temperature was measured using K-type thermocouples, at three different points: (1) at the center of the front face (where the flame was directly applied), (2) at the center of the

After the test was finished, the specimens were left to cool down naturally and one day later three specimens (strips of 105 mm width) were cut from each tile using a diamond saw [see Figure 2.3(b-top)]. One specimen was cut from the center (area exposed to the high temperature) and two specimens were cut from the edges of the tiles (not exposed to high temperature - the temperature did not raise above ambient, according to the measurements obtained from thermocouple 2, which was placed 160 mm away from the center). Those specimens were then subjected to four-point bending tests as shown in Figure 2.3(b-bottom).

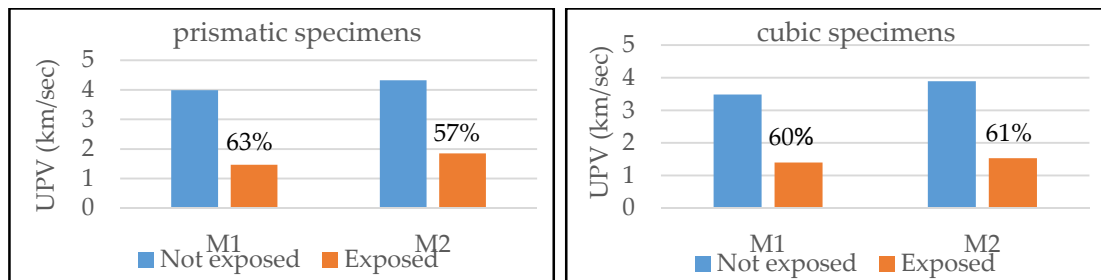
**Figure 3.1** Ultrasonic Pulse Velocity measured on specimens of mortars M1 and M2, before and after exposure to 850°C. Comparisons and percentages of decrease.

Hereby, the results from the first series of tests are presented. Figure 3.1 gives the results of the UPV measured from all cubic and prismatic specimens. Each bar represents the average value of three identical specimens. It is clear that the decrease of the UPV is approximately equal to 60% in both mortars, but the point of interest is the residual strength of the material. However, the authors did not manage to find a predictive model in current literature that would relate the UPV value to the expected compressive strength of mortars with the same characteristics. As shown in [6], characteristics such as cement type, aggregates type, maximum grain size, water to cement ratio and additives play a significant role in the correlation between the UPV value and the elastic properties and strength of concrete. Thus, a different calibration curve needs to be defined for each case. There is, nonetheless, a clear indication about the degradation of the mortars.

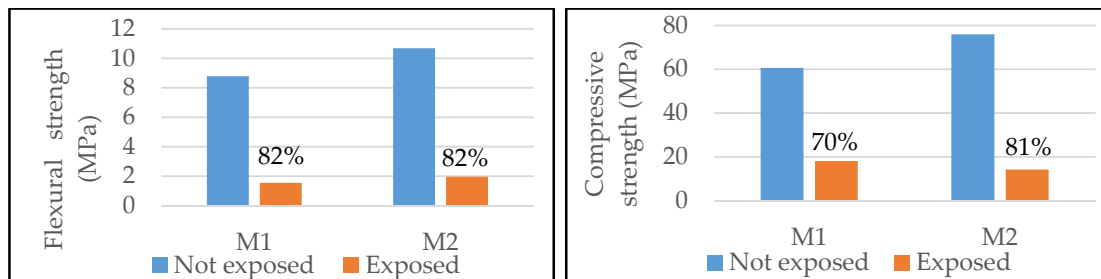
**Figure 3.2** Compression and three-point bending test results of mortars M1 and M2, before and after exposure to 850°C. Comparisons and percentages of decrease.

In Figure 3.2 it is observed that the loss of strength (compressive and flexural) varies between 70% and 82%, which is considered rather severe. It is, therefore, expected that in a case of a real fire, where the heating rate is much faster in the first minutes (20 °C to 530 °C in 3 minutes, which could not be reproduced by the furnace that was used for these tests) and for an exposure longer than 30 minutes (which means temperature higher than 850 °C) the degradation of the mortar will probably be too severe. Of course, further tests, need to be done, with more representative conditions.

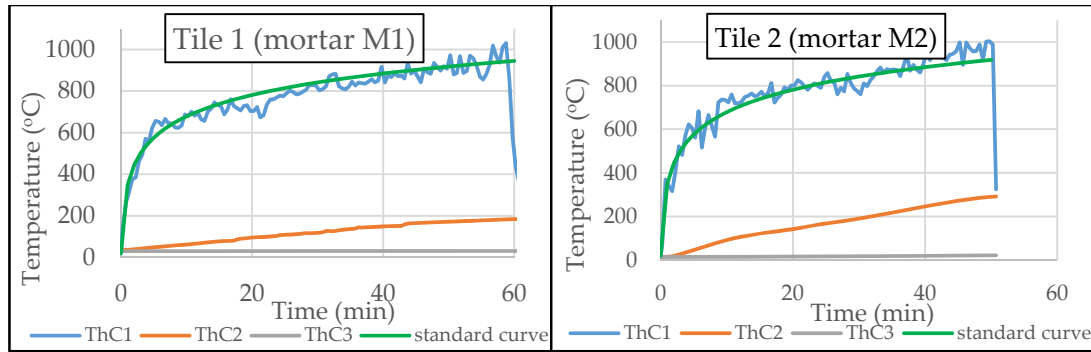
**Figure 3.3** Recordings of thermocouples 1,2 and 3 (ThC1, ThC2, ThC3 respectively) during the flame-exposure testing of the tiles; comparison with standard fire curve [4]

In the following Figure 3.3, the recordings measured from the thermocouples during the flame-exposure tests on Tile 1 and Tile 2 are given. What can be observed is that even with this simple set-up the standard fire curve [4] could be simulated quite accurately (although only at a narrow area at the center of the tiles). It is also observed that the temperature measured by thermocouple 2 (ThC2, center of back face) is almost parallel to the temperature applied at the center of the front face, and it is quite important to note that the difference between ThC1 and ThC2 varies between the two mortars; it is close to 750 °C for mortar M1 and close to 600 °C for M2. Therefore, mortar M1 is less thermally

conductive, even though they both present a relatively low thermal conductivity (temperature difference in the order of 600-800°C by a thickness of only 22 mm).

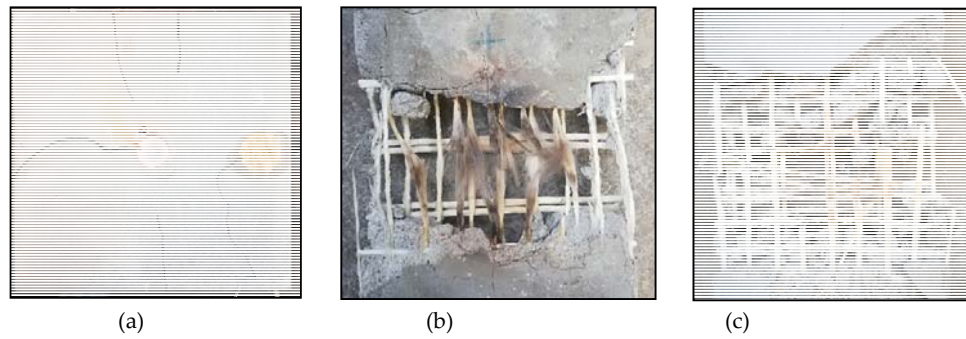
**Figure 3.4** (a) Cracking of the tiles exposed to a flame at their center; (b-c) Damage of the glass textiles due to fire exposure for tiles 1 and 2, respectively

What was also observed on the two tiles is that cracks were formed, as marked on Figure 3.4(a). All cracks were propagating to the center. The damage of the fibers near the central area where the flame was applied is visible in Figure 3.4(b-c). It should be noted that the textiles were revealed by removing the mortar after testing the specimens in four-point bending. The results of the bending tests on exposed and not-exposed specimens are shown in Figure 3.5.

As seen at the graphs presented in Figure 3.5, the maximum load and displacement of the fire exposed specimens, has decreased more significantly for the tile specimen of mortar M1. It is also observed from Figure 3.4 that the fibers of the specimen from tile 1 seem more damaged than those of the specimen from tile 2. This, however, comes in contradiction with the observation that the thermal conductivity of mortar M1 is less than the one of M2. In that case, since the cover thickness is the same, less damage on tile 1 should be expected. However, no firm conclusions can be reached

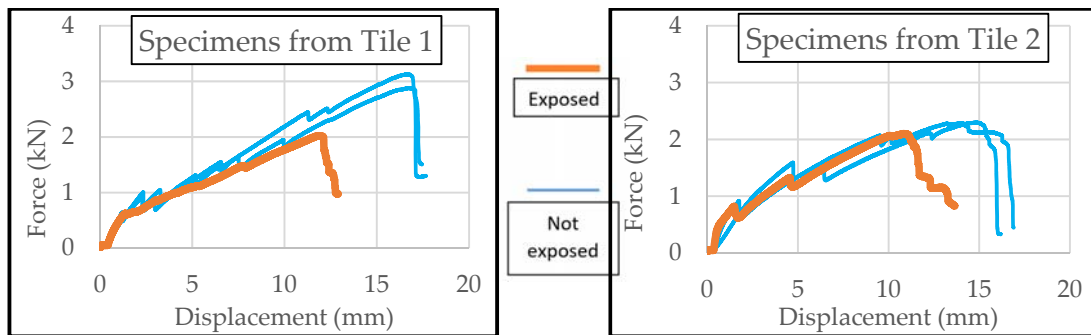
**Figure 3.5** Force displacement curves obtained from four-point testing of specimens cut from Tiles 1 & 2.
