Damage progress assessment on textile reinforced cement retrofit patches attached to traditional masonry using acoustic emission

Eleni Tsangouri, David Martin Linn III, Dimitrios G. Aggelis

Textile reinforced cement (TRC) repair solution

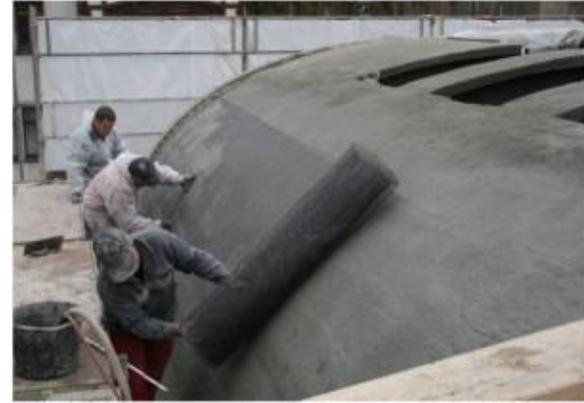
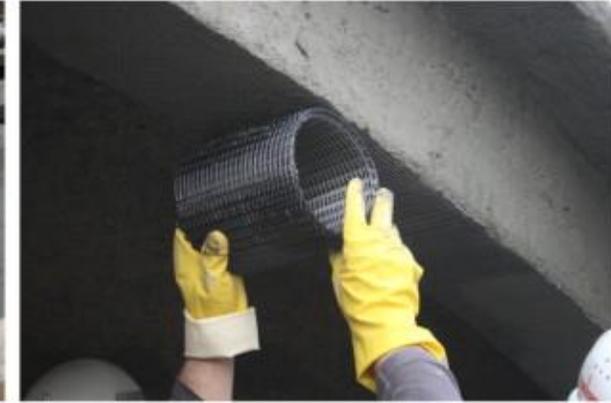
TRC repair patch for the restoration of masonry heritage structures

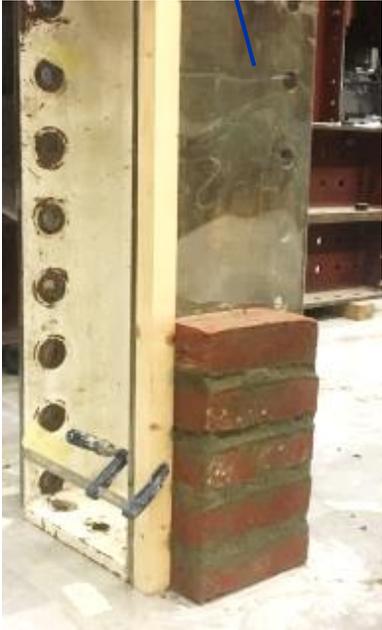
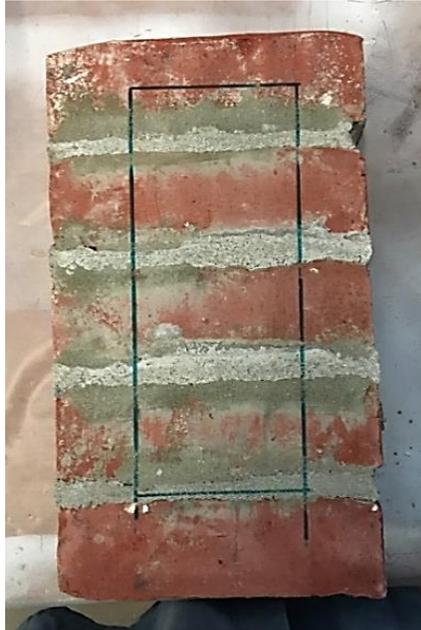
TRC-substrate samples preparation and casting

Wall construction supported & leveled
28 days curing

! Bricks irregularity

Surface roughness:
Rough (no preparation)
Smooth (grinder used)

Red brick CEM I 42.5 R

Bonded area=100x250mm

TRC thickness=10mm

Wood formwork
Textile clamped between formwork blocks

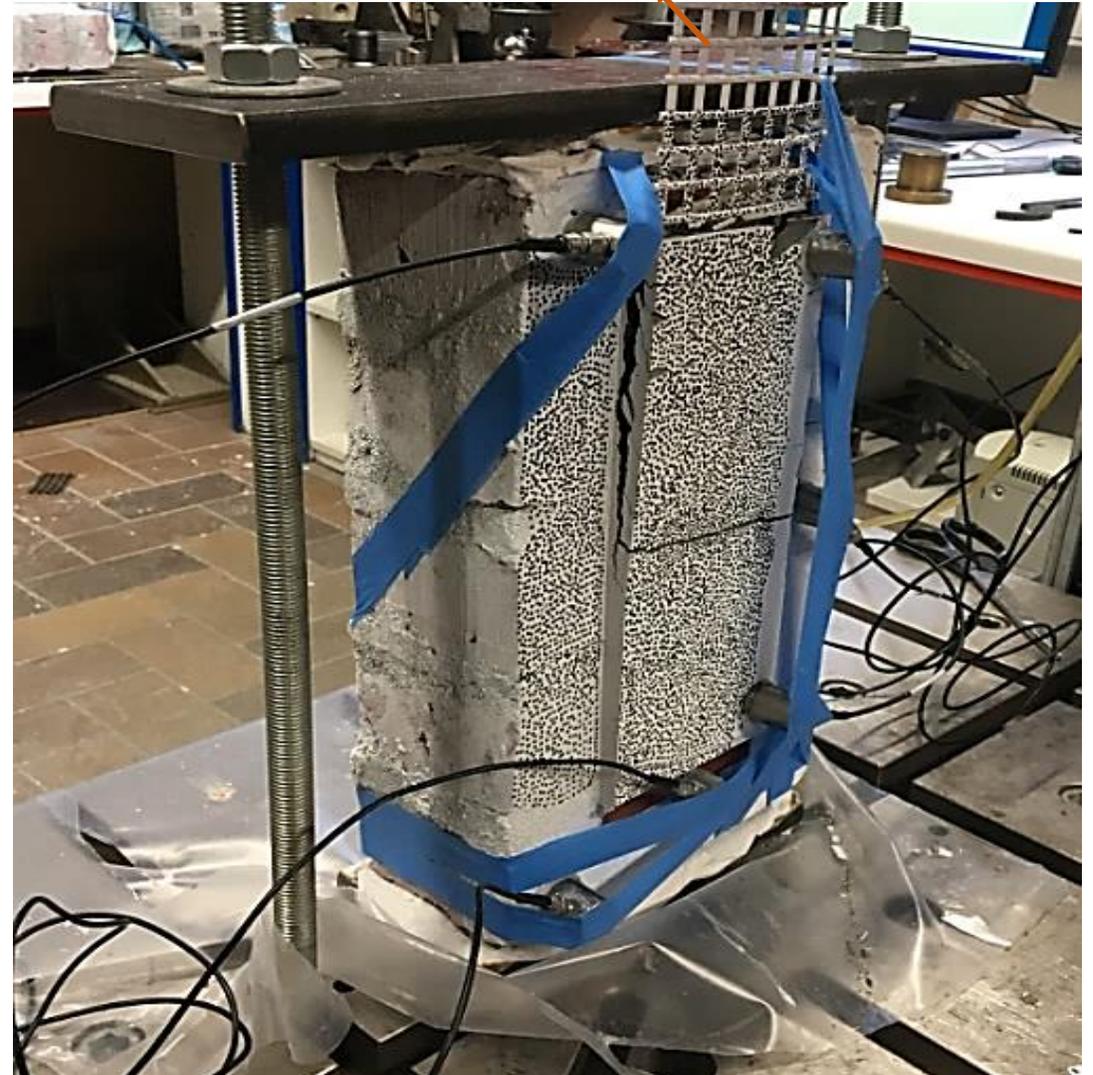
TRC-substrate samples test set-up, support setting and testing

RILEM TC 250-CSM

Grips to Instron: pair of aluminum plates + epoxy glue (100x60x2mm)

Instron5885 100kN load cell

Test rate: 0.2 mm/min

“Reacting Steel Frame”

Plaster at top/bottom + fastened steel plates

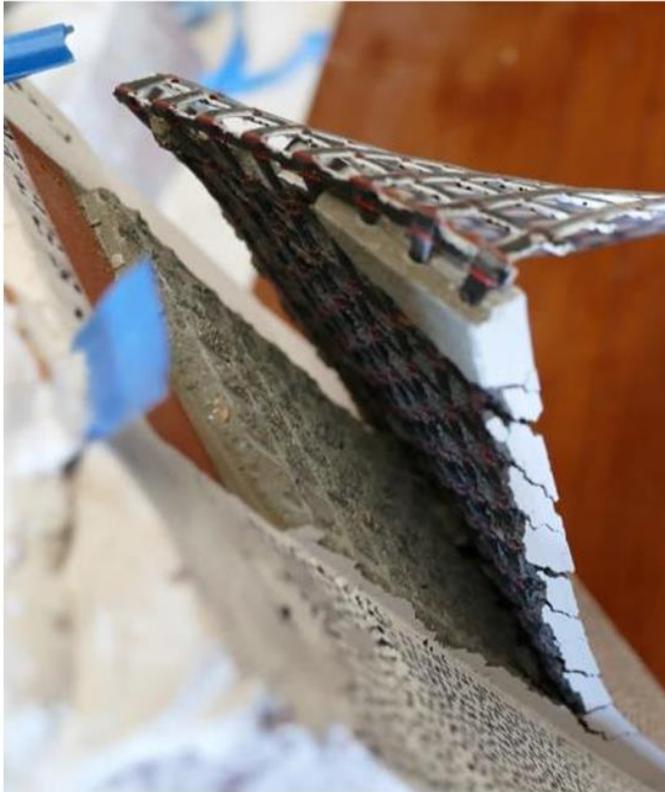
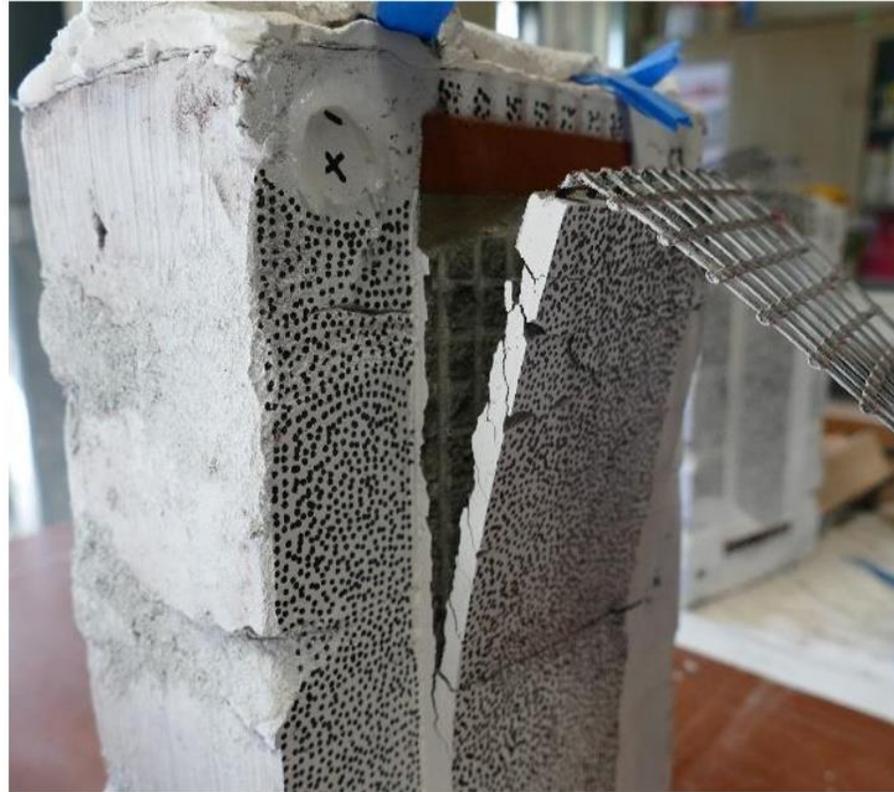
TRC-substrate bond tests results

Pictures taken after the test
