Nano topography evaluation of NiTi alloy exposed to artificial saliva and different mouthwashes

Zoran Bobić^{1*}, Bojan Petrović², Sanja Kojić¹, Vladimir Terek¹, Branko Škorić¹, Lazar Kovačević¹ and Pal Terek¹

¹ University of Novi Sad, Faculty of Technical Sciences, Trg Dositeja Obradovića 6, Novi Sad, 21000, Serbia

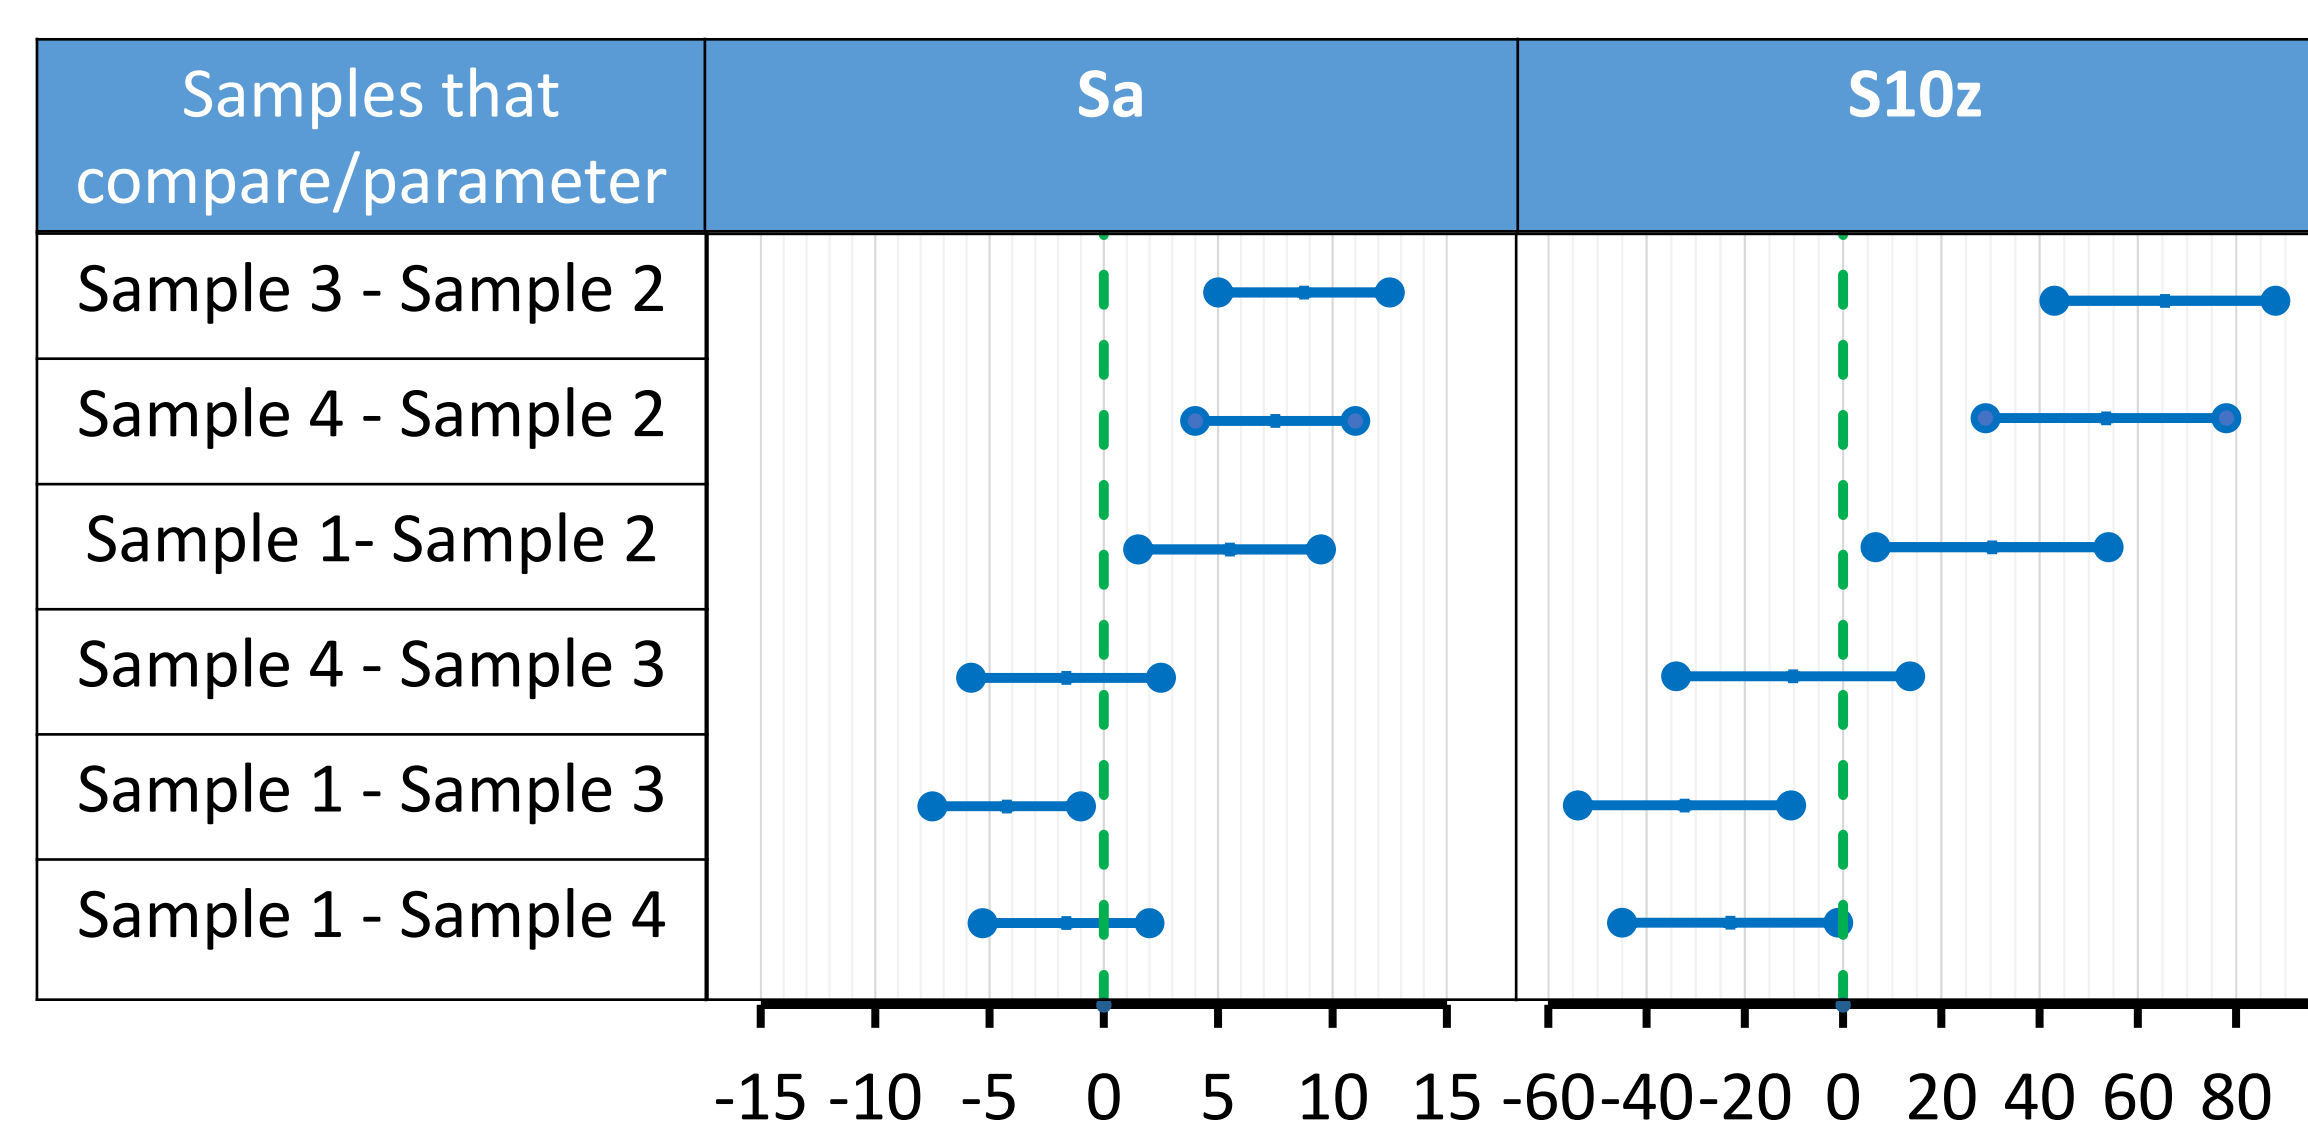
Fig 4. Results of one-way Anova: comparisons of differences in roughness parameters Sa and S10z caused by corrosive mediums

The comparison of the effects of corrosive media on surface roughness parameters are given in Fig. 4. Regarding the Sa parameter, the difference is significant for comparisons of sample 1 and sample 3 and the comparisons of sample 2 and other samples. On the other side, regarding the S10z parameters, the difference is insignificant only for comparison between sample 3 and sample 4.
