The Decoupling of Corrosion and Fatigue for Aircraft Service Life Management

[CMDWC 2021]: STREAM "MATERIALS DEGRADATION IN DEFENCE AND CIVILIAN AIRCRAFT"

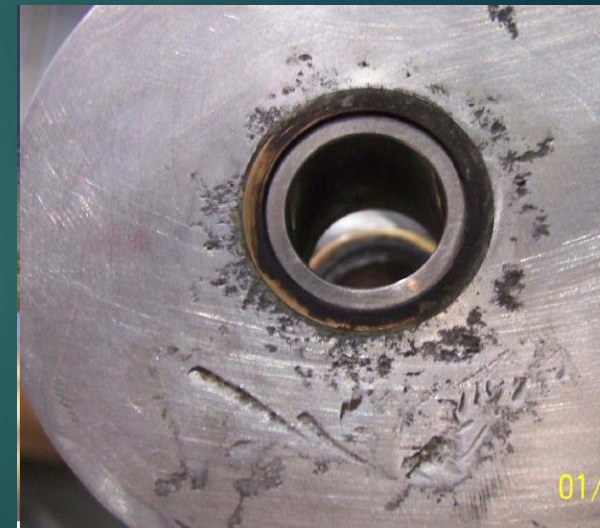
A view of corrosion pitting around a AA7050-T7451 lug.

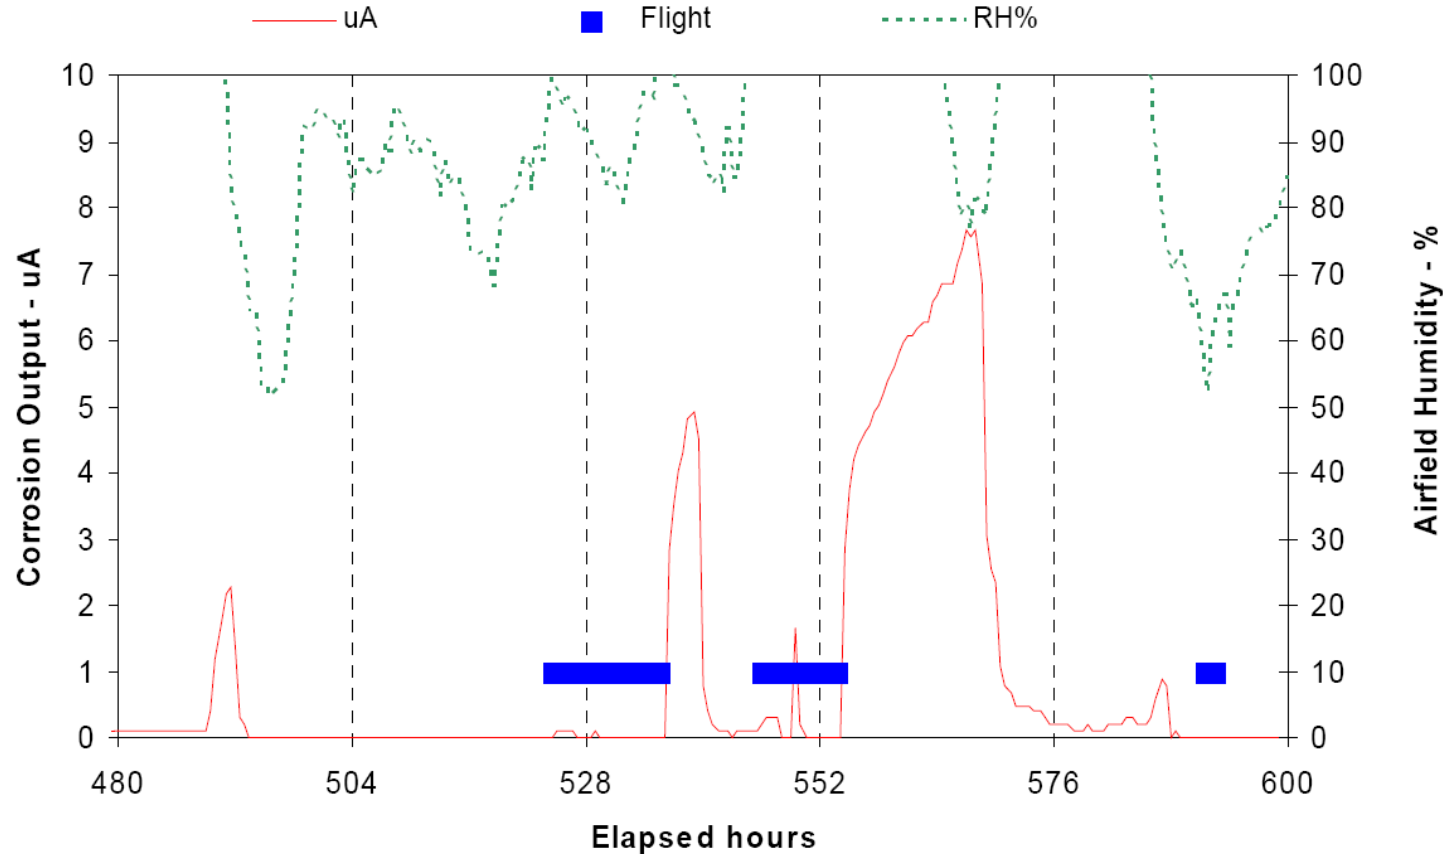
Typical output from the P-3C corrosion monitor, showing corrosion current (μA), periods of flight and airfield relative humidity (RH).

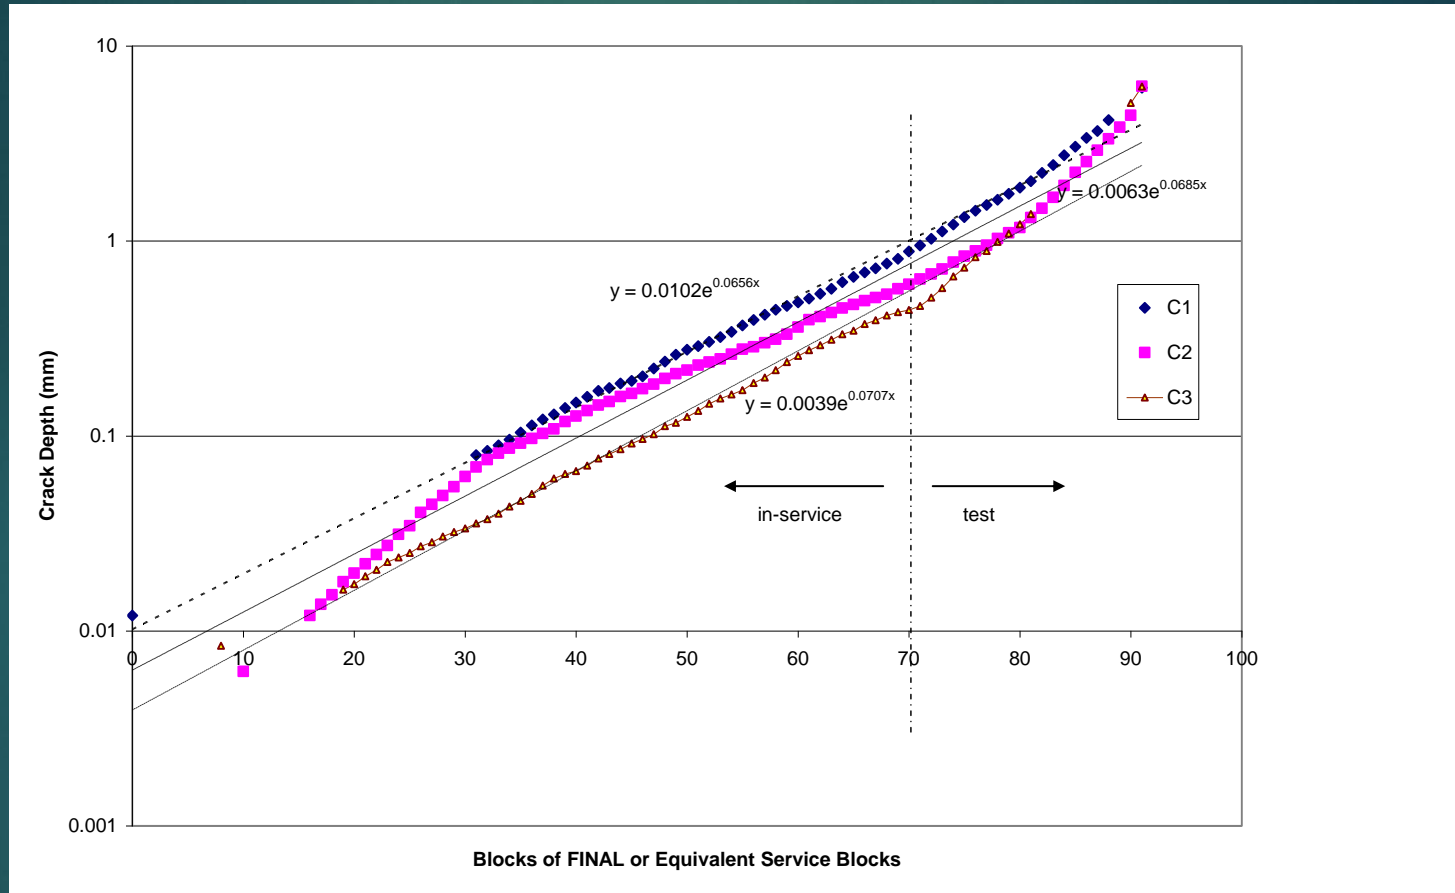
Crack growth for three major cracks on the Y470 bulkhead flange (“70 blocks” denotes start of FINAL testing)

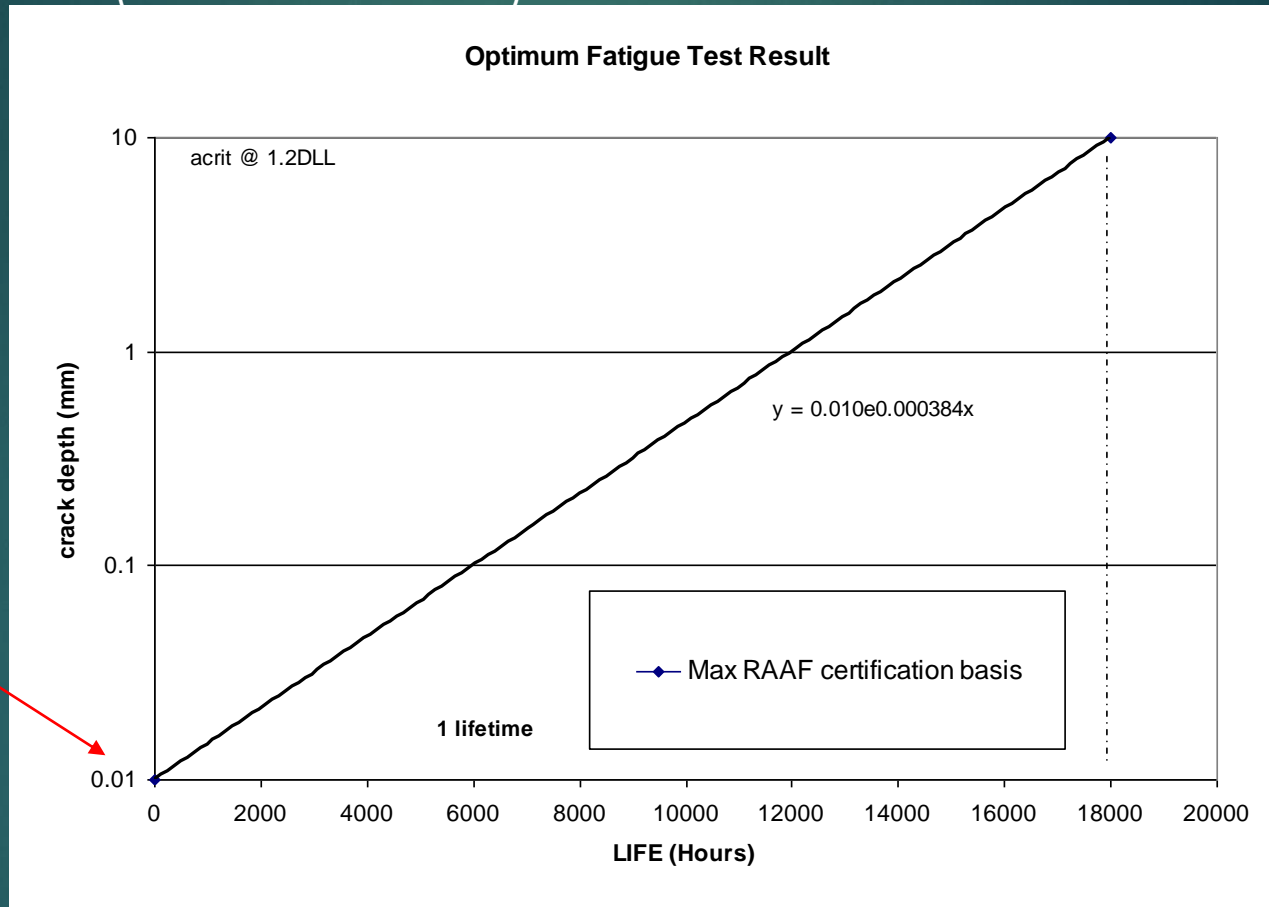
- ▶ For an optimum design: a_{crit} just meets Residual Strength Criteria at end of FSFT (UK DEF STAN 970).

Scatter Factor = 3

Mean nucleation depth

This represents the fastest possible crack (Lead Crack Concept)

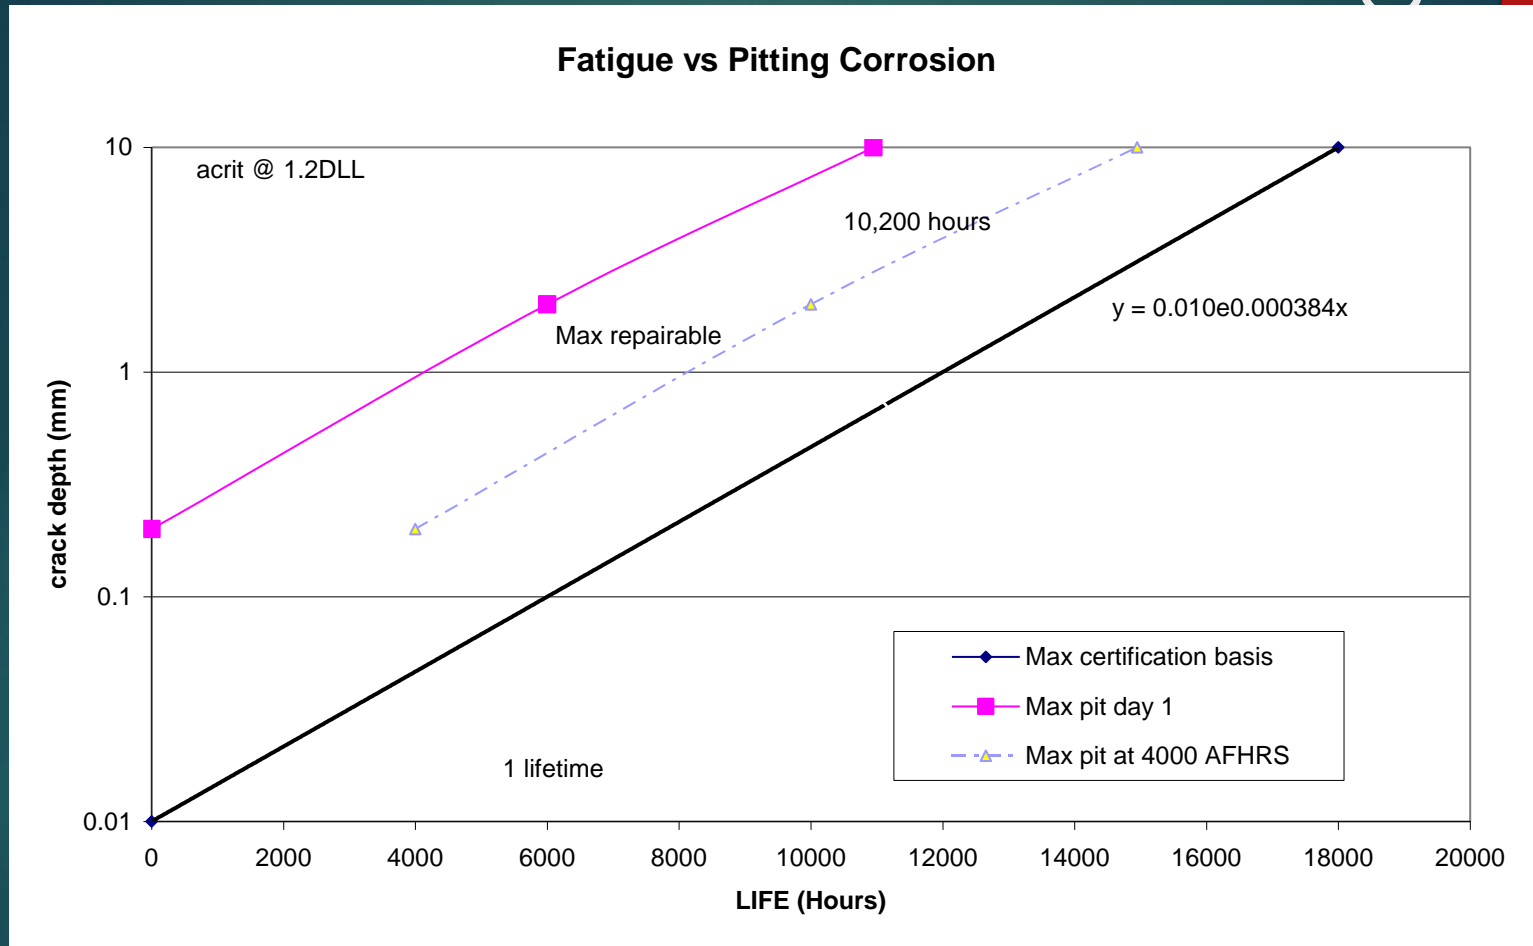
10,200 hours from nucleation to failure! Divide by scatter factor.... Significant safe period!

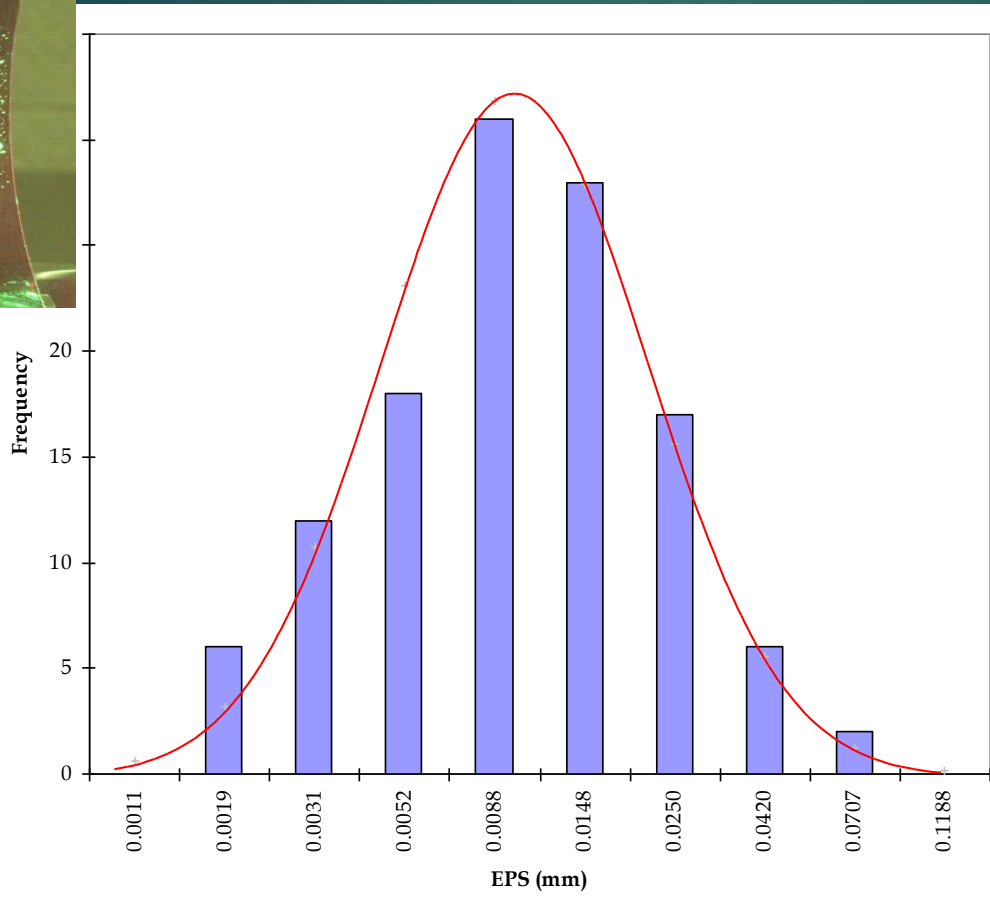
Log-normal distribution of the Equivalent Crack Pre-Size (EPS) of the etched coupon specimens – 120+ points
