Influence of Surface Treatment on Hydrogen Embrittlement of Commercial Vehicle Seat Slider Bracket

Advanced Technology Group, Centre for Research Engineering and Advanced Technologies (CREAT), UNO Minda Ltd. Pune, Maharashtra, India

Problem statement: Tooth lock was found broken in the failed seat slider assembly.

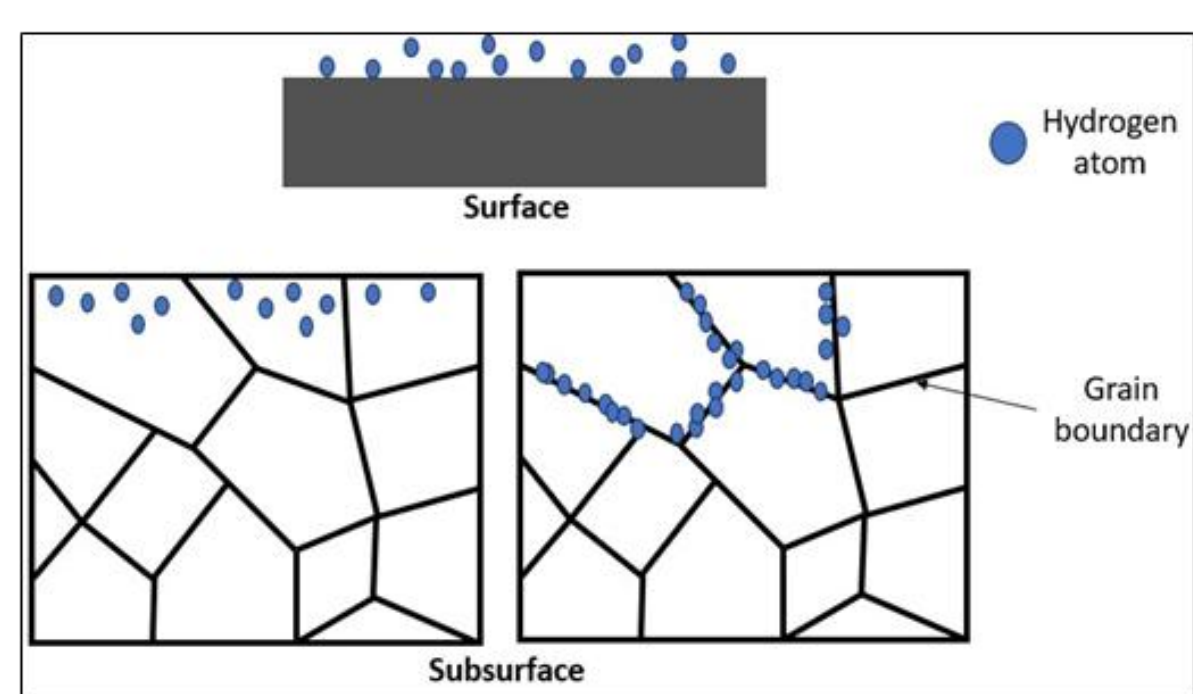
H₂ Embrittlement Mechanism

Root Cause: The intergranular fracture tend towards the hydrogen embrittlement susceptibility of tooth lock part of seat slider. This hydrogen embrittlement could be due to hydrogen pickup during heat treatment like carbonitriding or even tempering.

- ❖ H₂ can be diffused as H⁺ ions during processes like electroplating, carburizing, and welding.
- ❖ Leads to reduced ductility and lower load bearing capacity resulting brittle fracture.
- ❖ **High hardness and dislocation density** create trapping sites for H₂.

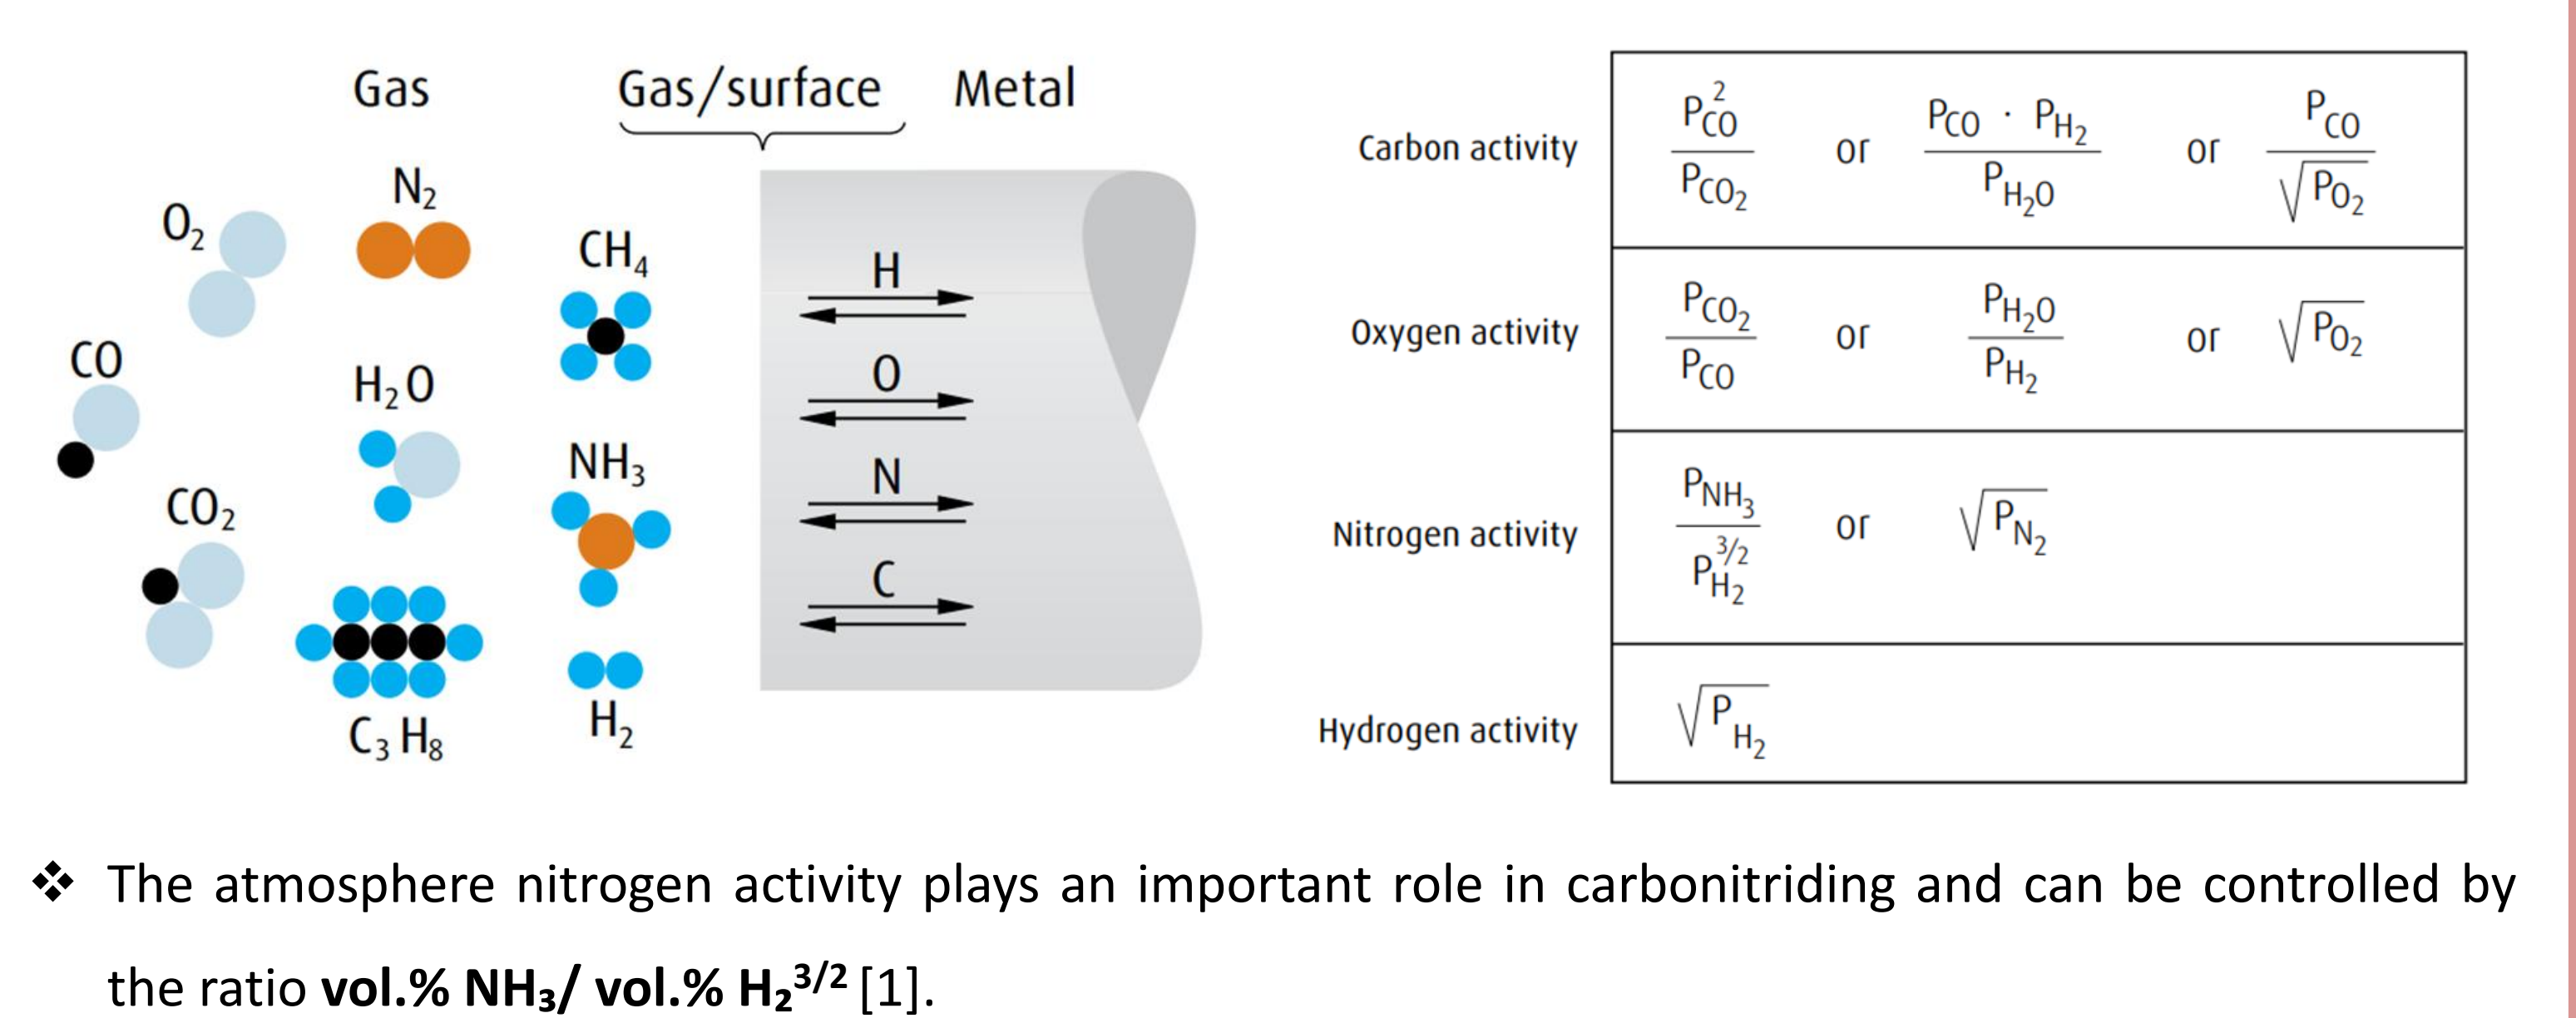
Possible H₂ pick up during Carbonitriding

- ✅ Identified root cause: H₂ pick up on the tip of the tooth during hardening treatment
- ✅ Increase in hardness induced during heat treatment, amplified the materials susceptibility to H₂ penetration and subsequent cracking.
- ✅ Corrective actions on heat treatment process, and furnace environment are necessary.
