# Correlation between acoustic emission parameters and fracture behavior of repaired marble specimens

Anastasios Mpalaskas<sup>1</sup>, Dimitrios G. Aggelis<sup>2</sup>, Theodore E. Matikas<sup>1</sup>

<sup>1</sup>Department of Materials Science and Engineering, University of Ioannina, Greece <sup>2</sup>Department Mechanics of Materials and Constructions, Vrije Universiteit Brussel (VUB), Pleinlaan 2, 1050 Brussels, Belgium

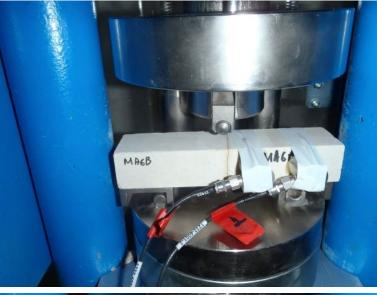
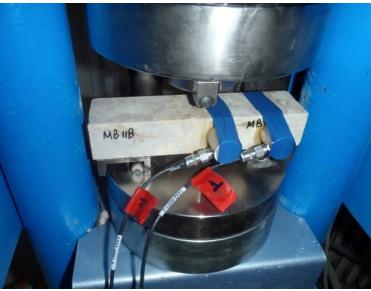
# **Experimental part (3-P bending)**

#### BS EN EN 13892-2:2002

Displacement rate 50N/s automatically terminated at the moment of the instant load drop

Two piezoelectric sensors named (R15, Mistras)/ 150 kHz

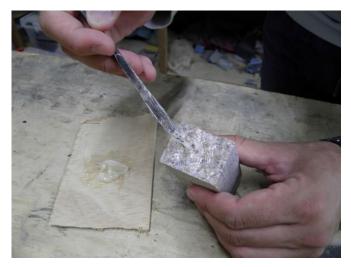
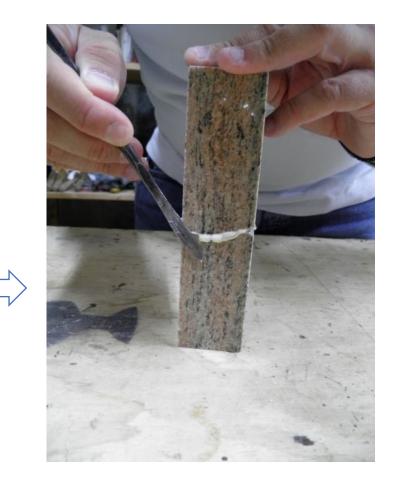
# **Experimental part (Repair)**

### **Repair method:**

- Two-component solvent-free bonding system based on epoxy resin and hardener named "Epoxol" in its commercial product name
- The bonding was established with precautions so that the original geometry of the specimen was not altered

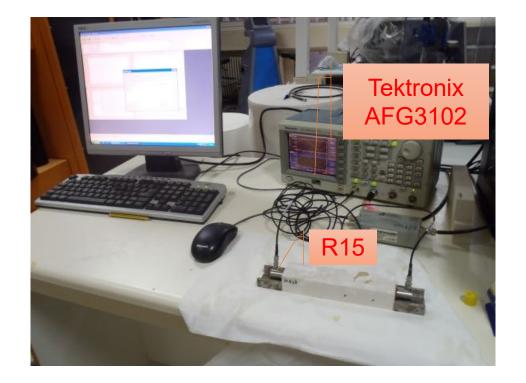
# **Experimental part (Ultrasonic Inspection)**

#### **Ultrasonic set up:**

- The distance between the pulser and the receiver was of 160 mm and also a layer of grease between the sensors and the specimen placed improved the acoustic coupling
- A waveform generator named Tektronix AFG3102, concurrently with a two-channel PCI-2 Mistras board data acquisition system, was applied
- The resonance of the transducers was of 150 kHz and (R15, Mistras Group).

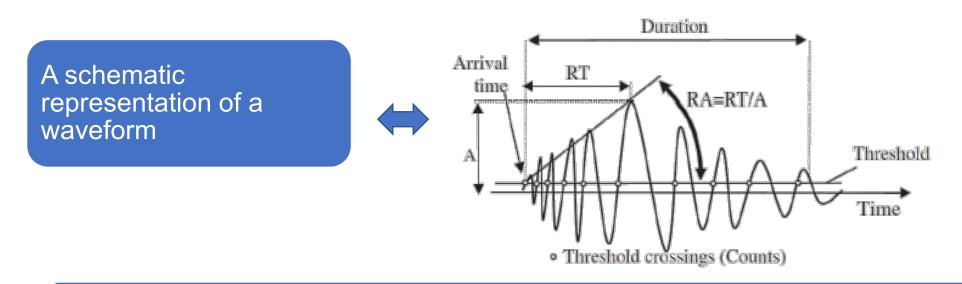
# **Experimental part (Acoustic Emission)**

#### Main features

- the duration DUR (the period between the first and the last threshold crossing),
- the maximum amplitude AMP (dB).
- the "rise time" (RT) (which is the time between the first threshold crossing and the point of peak amplitude in μs). Rise Time is related to the fracture mode of the crack, and so is the inverse of the slope of the initial part of the signal (RA value, RT/A in μs/V).
- AF (average frequency) can be measured by the total number of threshold crossings divided by the duration and can characterize the Frequency content

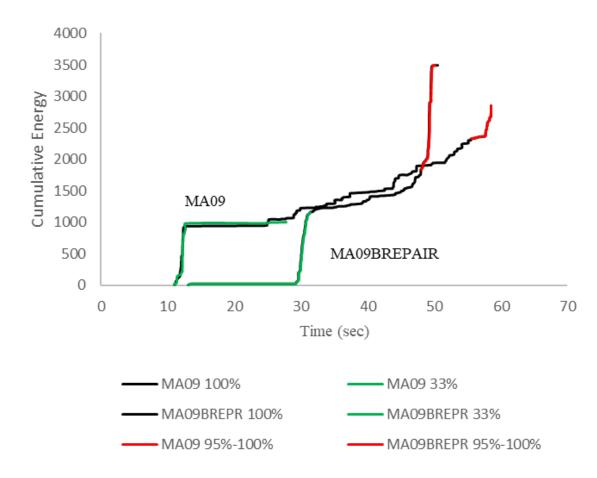
Cumulative Energy at the three Different stages of loading for same **sound** and **repaired** specimen

- The sound specimens exhibit a large AE rate from very early loading in contrast to the repaired that start emitting after the load reached approximately 25% of the maximum
- This is attributed to the initial elastic deformation of the epoxy which has a lower elasticity than marble

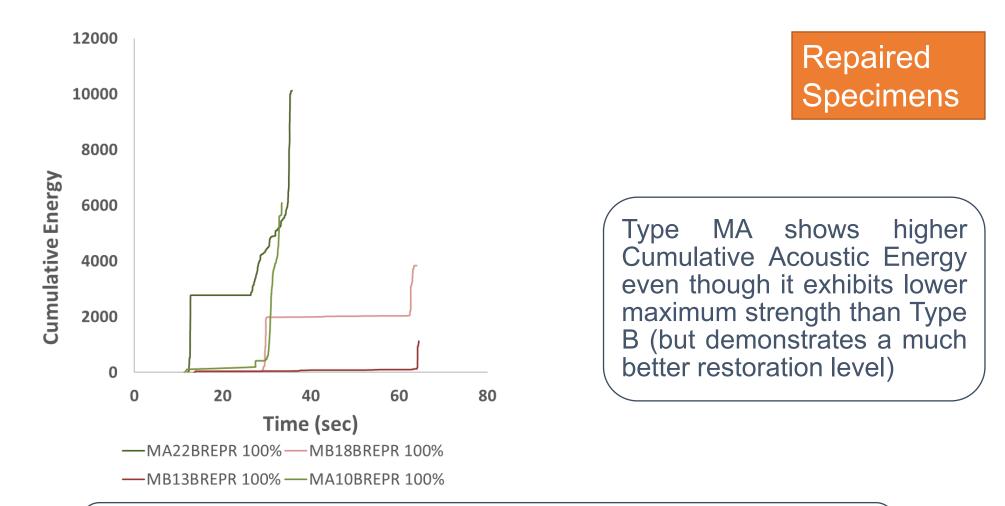
For the acoustic emission energy emitted, the most significant role is on the interface bonding between the epoxy and the marble at the fracture surface because the level of restoration seems to correlate with the cumulative Energy

While the level of restoration of Marble Type A is prominently 0.72 compared with the 0.48 of marble Type B the average cumulative Energy per specimen for the cluster of all the hits, follows the trend of restoration for the repaired sample

- The Cumulative energy of repaired Marble Type A not only increased after repair but also overpassed the cumulative Energy of repaired Marble Type B.
- For the acoustic emission energy emitted, the most significant role is on the interface bonding between the epoxy and the marble at the fracture surface consequently the level of restoration seems to correlate with the cumulative Energy.

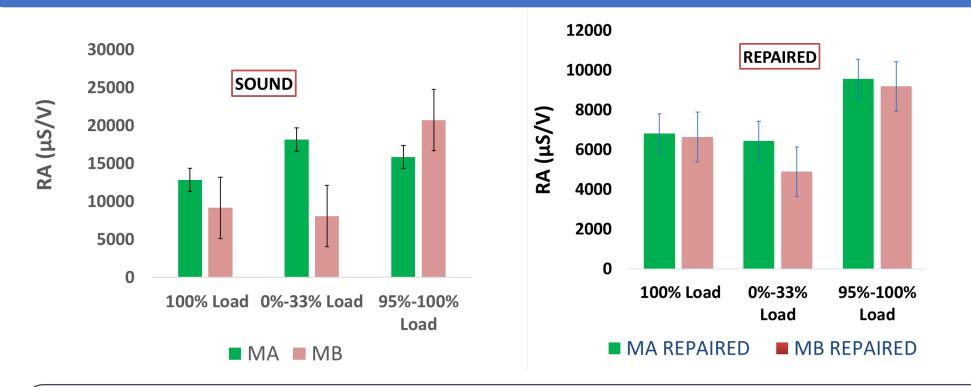
Mean values of RA of MA and MB sound and repaired specimens for three loading stages

At the last stage close to macroscopic fracture, the values are much closer with MB showing even higher values. The trend is that parameters affected by the mode of fracture get closer to equal values at the last stage of loading close to the macroscopic failure. It is proved more clearly by the repaired specimens

While the RA values of sound specimens of Type A are higher about 40% compared with the Type B accordingly, the restored ones have shown different trend reaching equal values amongst the two types for the 100% population of hits examined. The explanation can be found of the dominant role of the epoxy bonding interface with the marble that affects the mode of fracture in both Types of Marble with the same mechanism even with not the same effectiveness.

At the final (95%-100%) loading stage, the RA gets almost equal values for both repaired Marble Types. Justification is that RA affected by the mode of fracture and getting closer to equal values at the last stage of loading before the macroscopic failure. At that point, the stress field is dynamic with a high dosage of randomness after each crack propagation event compared to the initial static field.

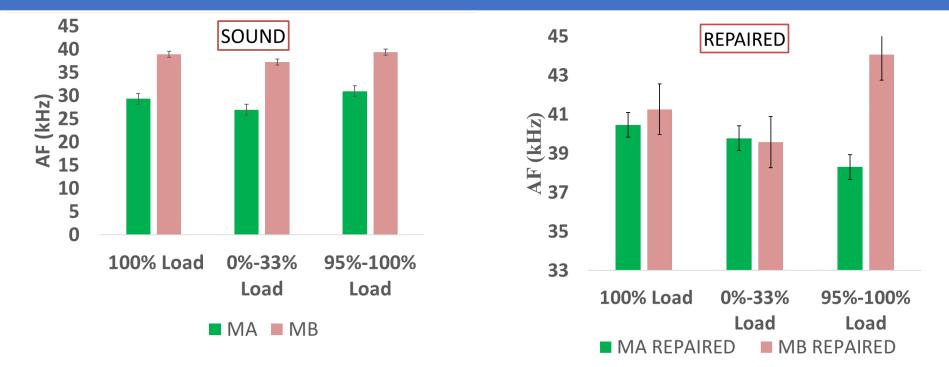
Mean values of AF of MA and MB sound and repaired specimens for three loading stages

Average Frequency AF, do not show very clear results regarding the characterization of the fracture mechanism for the repaired samples

• The main reason is the resonance of the R15 sensors, which prevent the AF from successfully describes the failure process even with the more detailed examination through the different loading steps analysis
