Abstract

Prestressed concrete has been used all over the world for bridge construction, but severe corrosion of steel strand in post-tensioned tendons has been documented. Recently, the corrosion was associated with physically and chemically deficient segregated grout with elevated moisture and concentrations of aggressive chemical species that allowed for early aggressive corrosion to develop. The transport of moisture and ionic species was thought to be related to capillary transport through the braided steel wires, but other transport mechanisms within the tendon duct may be possible as well. The grout mass pressure within grout column increases the hydrostatic pressure in the system. Vertical elevation of the grout with hydrostatic pressure of grout mass may elevate the moisture content at higher elevations. The paper reviews the results of lab and field testing characterizing deficient grouts and the various transport mechanisms that can be form in post-tensioned tendons, including modeling efforts of unsaturated flow and solute transport using HYDRUS-1D.

The Ringling Bridge

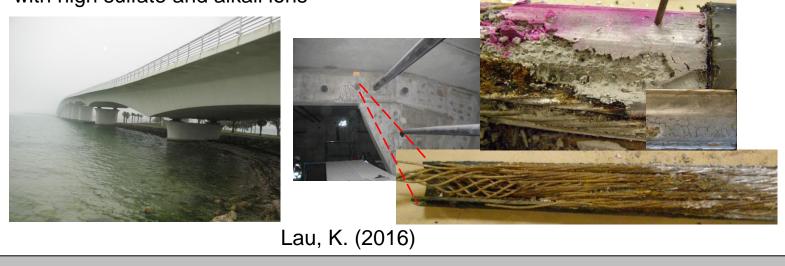
- Tendon failure after only 8 years of service due to corrosion and more than 10% external tendons were replaced.
- Investigation of the cause of unexpected failure of post-tensioned tendons utilizing updated thixotropic grout products.
- Corrosion mechanism not fully explained by chloride and carbonation induced corrosion, bleed water, and voids

>Corrosion was related with segregated grout characterized as a moisture-rich with high sulfate and alkali ions

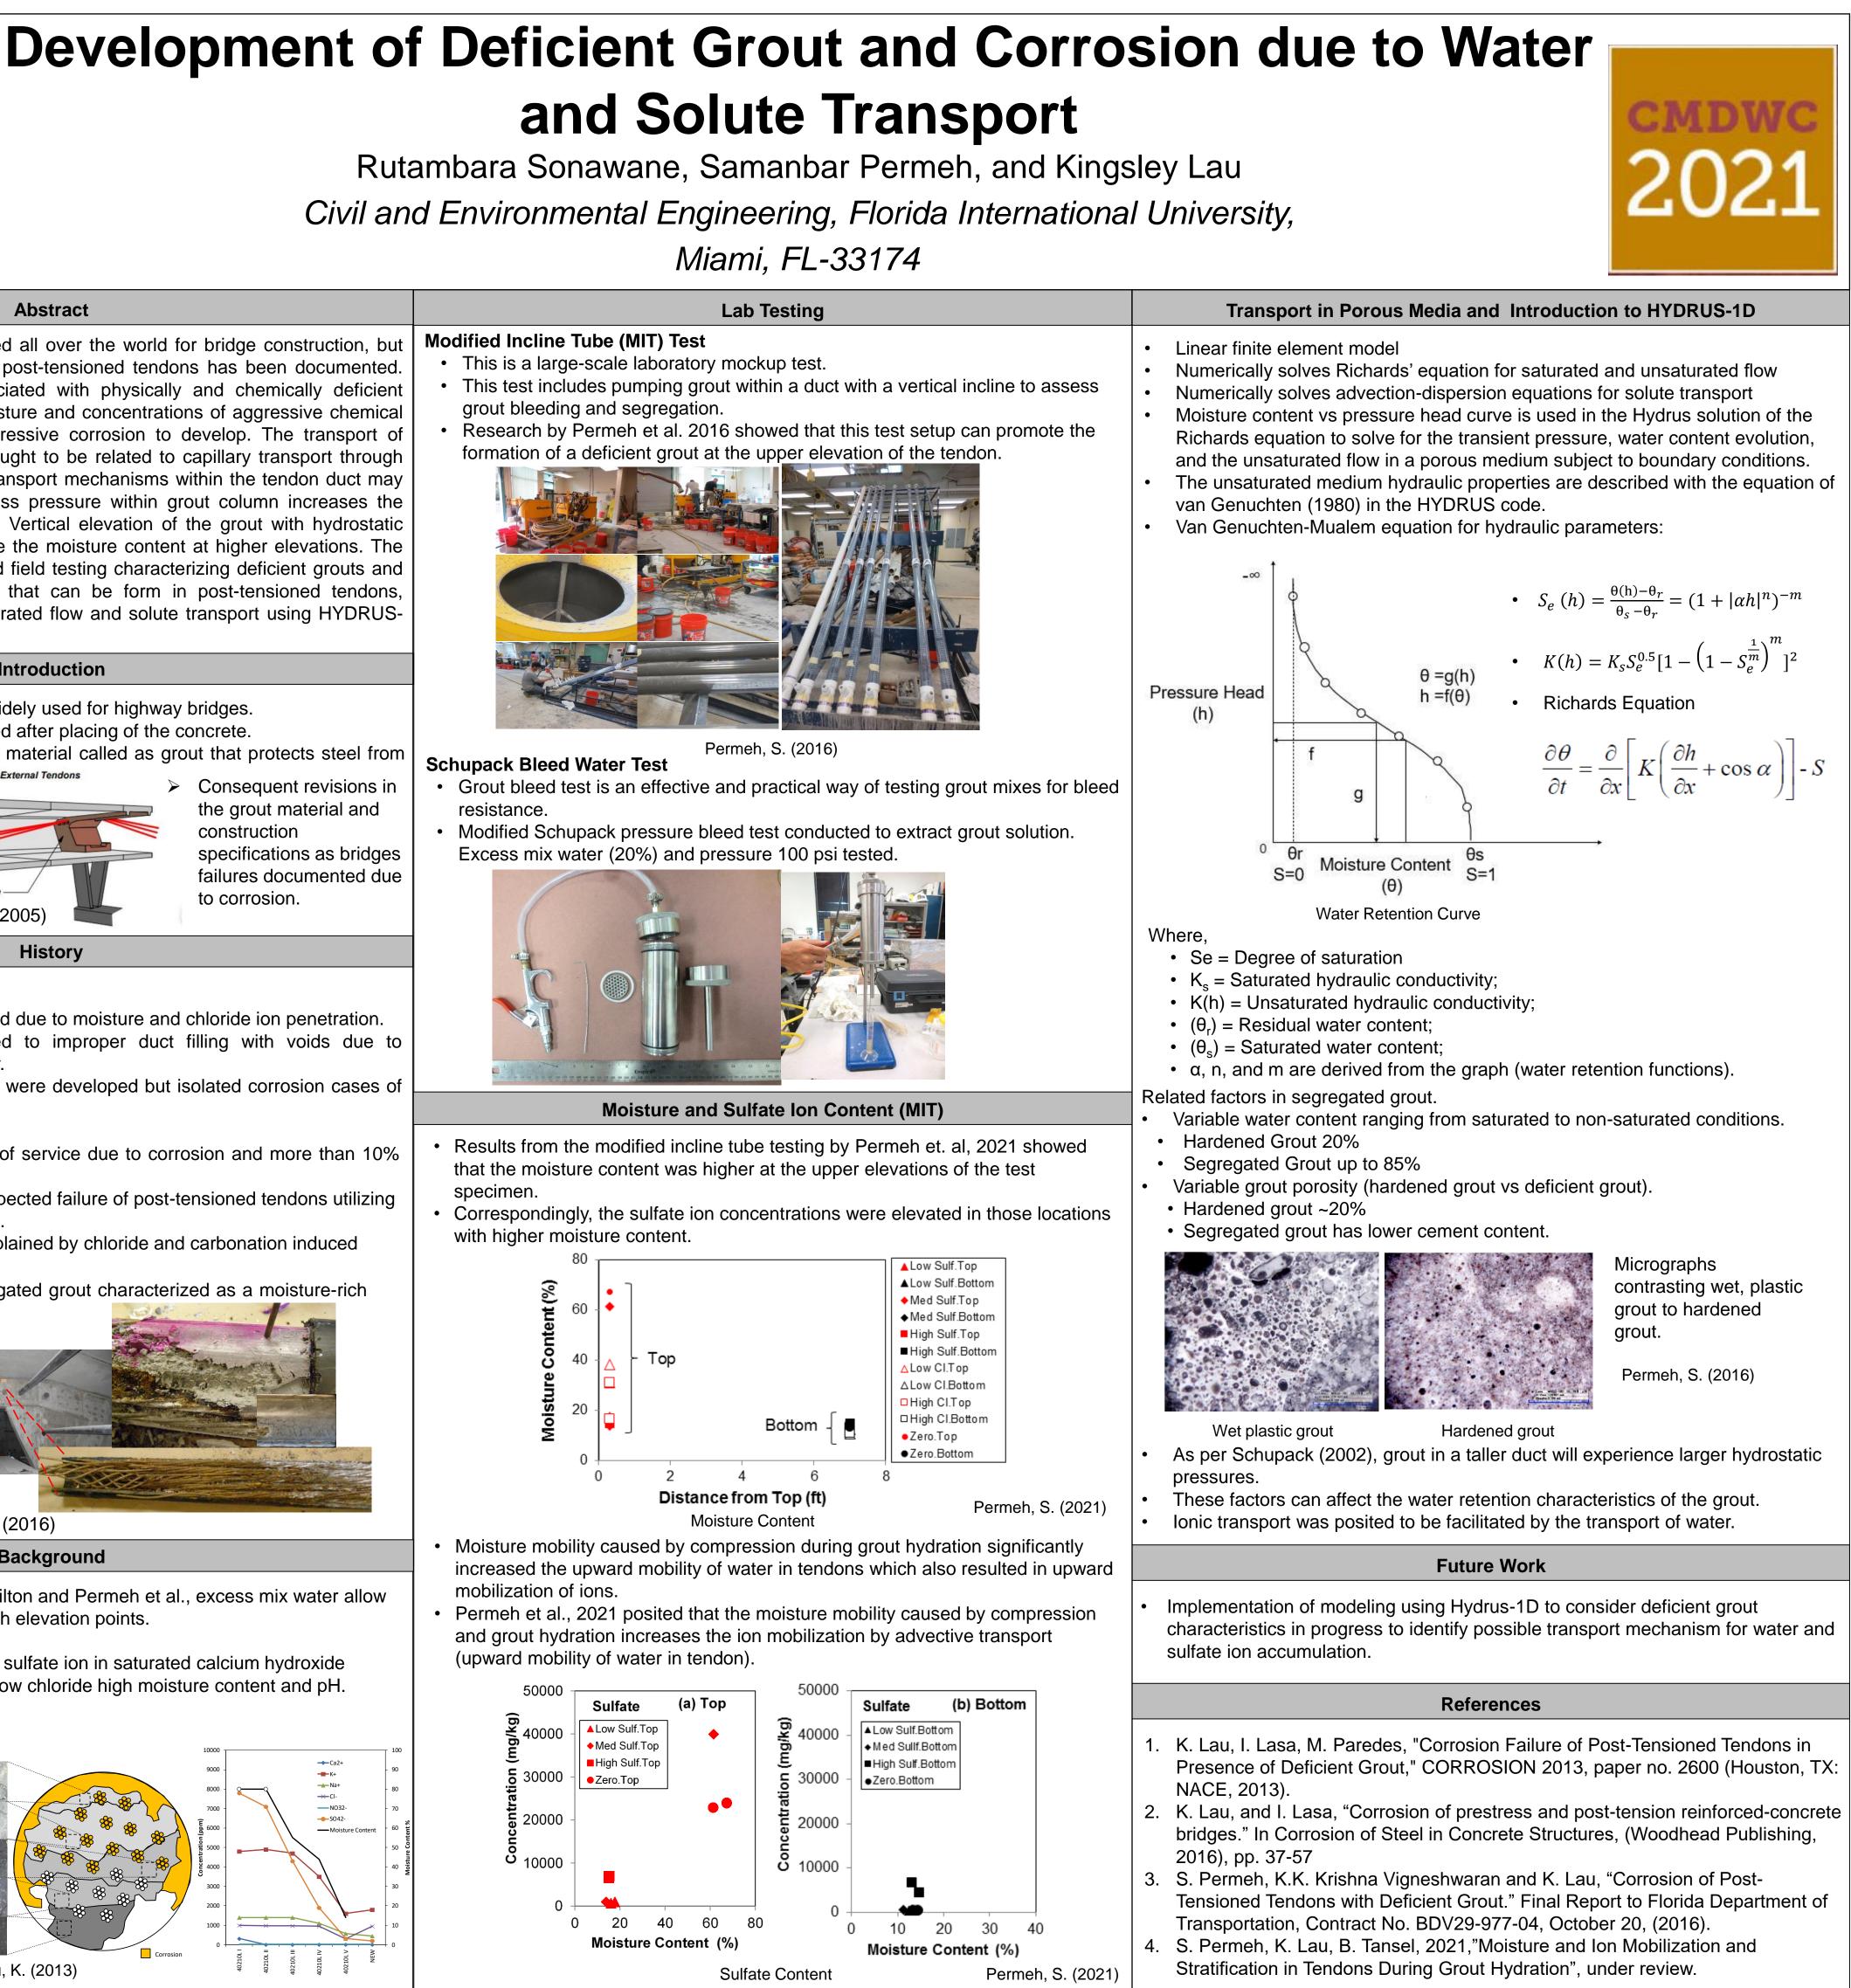
- Moisture mobility caused by compression during grout hydration significantly increased the upward mobility of water in tendons which also resulted in upward mobilization of ions.
- Permeh et al., 2021 posited that the moisture mobility caused by compression and grout hydration increases the ion mobilization by advective transport (upward mobility of water in tendon).

- Distance from Top (ft)
 - **Moisture Content**
