Low-Power Vibrothermography for Detecting and Quantifying Defects on CFRP Composites

Abstract: Detecting barely visible impact damage (BVID) in carbon fibre-reinforced polymer (CFRP) materials is a key challenge in maintaining the safety and reliability of composite structures. This study presents the application of low-power vibrothermography to identify such defects. Using a Long-wave infrared (LWIR) camera, thermal data were captured from the CFRP specimens that inhibit BVID. How image-processing, specifically principal component analysis (PCA) and sparse principal component (SPCA) analysis can enhance thermal contrast and improve the accuracy of defect size is also explored. By combining low-energy excitation with advanced data analysis, this research aims to develop a more accessible and reliable approach to non-destructive testing (NDT) for composite materials.

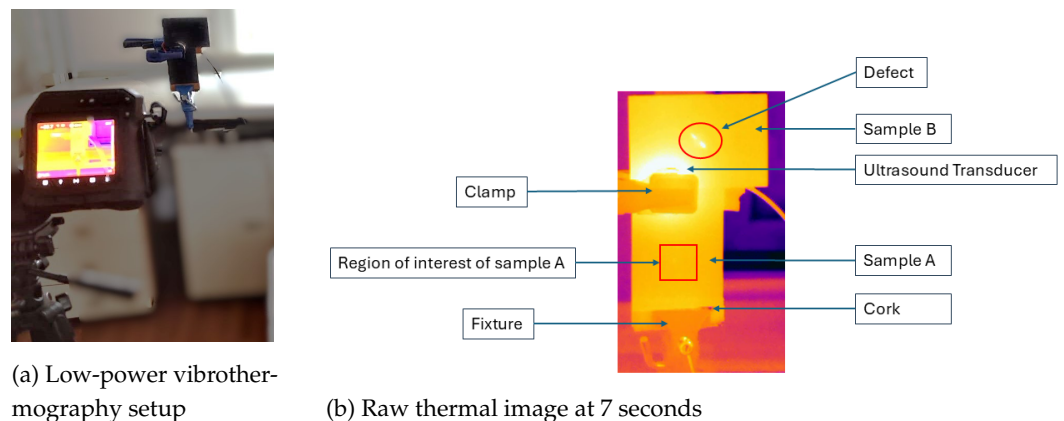
Figure 1. (a) Experimental setup of the low-power vibrothermography; (b) raw thermal image.

The experimental setup was designed to investigate BVID in CFRP specimens using a low-power vibrothermography technique. Mechanical excitation was delivered using a narrowband piezoelectric transducer with a centre frequency of 30 kHz. A function generator produced a sinusoidal signal at 30.13 kHz and 20 V peak-to-peak (Vpp), which was then amplified using a voltage amplifier set to its maximum gain of 20 times. To ensure good transmission of ultrasonic energy into the specimen, a thin layer of couplant (Cytolax ultrasound gel) was applied between the transducer and the CFRP surface. The transducer was held firmly in place using a clamp. The amplifier is rated for a maximum peak output power of 40 watts. Thermal responses were captured using a FLIR T560 LWIR camera, featuring a resolution of 640 × 480 pixels and a frame rate of 30 frames per second. The camera records thermal image sequences before, during, and after excitation. All experiments were performed under stable ambient conditions to minimise environmental thermal noise. Figure 1(a) shows the setup of the vibrothermography experiment.

Thermal responses from two CFRP specimens, each with a thickness of 1.65 mm and subjected to 8 J (sample B) and 4 J impact energy (sample A), respectively, were recorded using a low-power vibrothermography setup. Figure 1(b) is the raw image extracted from the video data at 7 seconds. In this experiment, both CFRP specimens were excited simultaneously using a single piezoelectric transducer. The transducer was positioned so that half of its surface was in contact with sample A (impacted at 4 joules) and the other half with sample B (impacted at 8 joules). This shared setup ensured that both samples received the same excitation conditions, enabling a fair comparison of their thermal responses. Under low-power excitation, sample B, which had experienced the higher impact energy, exhibited a clearly visible thermal signature at the damage site. The defect was detectable directly from the raw thermal frames, suggesting sufficient signal frequency to trigger localised heating through the low-power ultrasonic excitation. For Sample A, the thermal response at the impact site was much less pronounced. While there was a slight temperature variation near the expected defect location, the thermal contrast was low, and the defect was not clearly visible in the raw thermal frames. To address this limitation, further image processing was applied to the thermal sequence from Sample A using PCA and SPCA.
