# Tool Wear Assessment in Composite Helical Milling via Acoustic Emission Monitoring <sup>†</sup>

This study investigates the machining challenges of fiber-reinforced composite materials (FRCMs), focusing on carbon fiber-reinforced polymer (CFRP) plates, which exhibit high abrasiveness, delamination tendency, and accelerated tool wear. Two solid carbide helical end mills, designed for composite machining, were evaluated through helical interpolation drilling. Acoustic emission signals were continuously acquired via a piezoelectric sensor during standardized cycles, and tool wear was assessed using confocal microscopy and a digital altimeter. Signal processing played a central role, combining energy-based metrics and damage indices to identify the onset of wear and early delamination, enhancing the understanding of tool degradation and improving machining reliability.

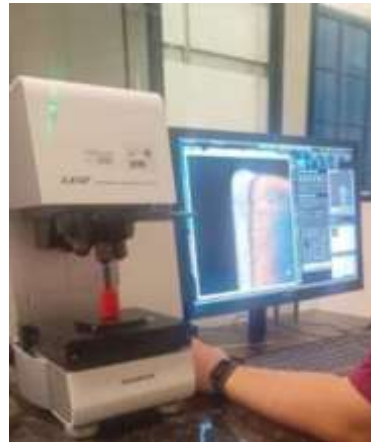
Before machining, the cutting tools were measured using a TESA micro-hite M600 digital height gauge and scanned with an Olympus OLS 4100 confocal laser microscope

to obtain the initial geometry of the cutting edges (Figure 2. Tool measurements to check for wear).

**Figure 2.** Tool measurements to check for wear.

The analysis of tool deterioration was carried out using high-precision equipment. With the TESA micro-hite M600 digital altimeter, a reduction in tool height was observed, indicating wear on the frontal face. Additionally, the Olympus OLS 4100 confocal microscope enabled detailed mapping of wear on the lateral flank and cutting edge, revealing rounding and gradual deterioration of the edges.

It was noted that wear is more pronounced along with the tool periphery, gradually decreasing toward the center. This pattern aligns with the theoretical relationship between cutting speed and wear: since tangential velocity is higher at the tool's edge, wear tends to be more severe in this region. As the contact point approaches the tool center, cutting speed decreases, resulting in lower wear rates.

Measurements revealed cutting-edge wear ranging from 0.02 mm to 0.06 mm in the carbide end mills. Localized chipping was also observed on some tool blades, although the trend of decreasing wear from the outer to the inner region remained consistent.
