Proceeding

# Delaying Effect of Fatigue Crack Propagation by Single-pulse Laser Irradiation <sup>†</sup>

<sup>†</sup> Presented at 18<sup>th</sup> International Conference on Experimental Mechanics, Belgium, July 1-5, 2018.

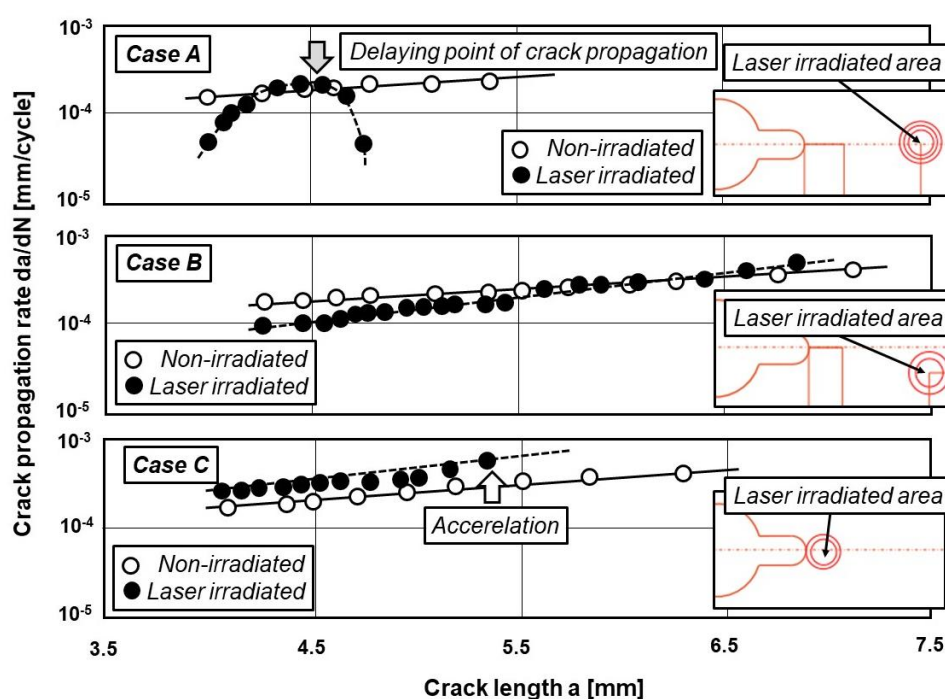
Figure 7 indicates the plot of the fatigue crack propagation rate ( $da/dN$ ) vs. the crack length ( $a$ ). The open circles represent the propagation rate of the non-irradiated specimen, and the solid circles represent the single-pulse laser irradiated specimen. The single-pulse laser irradiated positions were ahead of the crack tip (case A), slightly below and ahead of the crack tip (case B), and on the crack tip itself (case C). In case B, the fatigue crack propagation rate is almost the same as that of the non-irradiated specimen, meaning that single-pulse laser irradiation has no effect when applied at this position. When the crack tip itself is irradiated by the single-pulse laser (case C), the crack propagation rate is slightly increased, from which we may conclude that the irradiation caused a brittle fracture. On the other hand, it is clear that case A is very effective in reducing the crack propagation rate. It is presumed that the formation of residual stresses around the laser-irradiated area strongly affected the crack propagation behavior. Consequently, the most suitable position for laser irradiation was area close to the tip of fatigue crack on the crack plane.

**Figure 7.** Effect of pulse laser irradiation location on fatigue crack propagation rate
