Comparison of non-destructive techniques for impact damage area assessment in aramid/epoxy composites[†]

Abstract: This research focused on the assessment of the damaged area on aramid/epoxy composites subjected to high velocity impact. Digital X-ray radiography and active pulsed thermography techniques were used for performing post-mortem analysis of the impacted specimens (8 to 28 aramid layers). Two types of projectiles were used: 9 mm Luger FMJ and .357 Magnum FMJ. Two types of dedicated algorithms were developed to post-process the thermograms obtained and the results are compared with the damaged diameter measured directly on the X-ray radiographs. The output of the three methods are therefore compared and discussed.

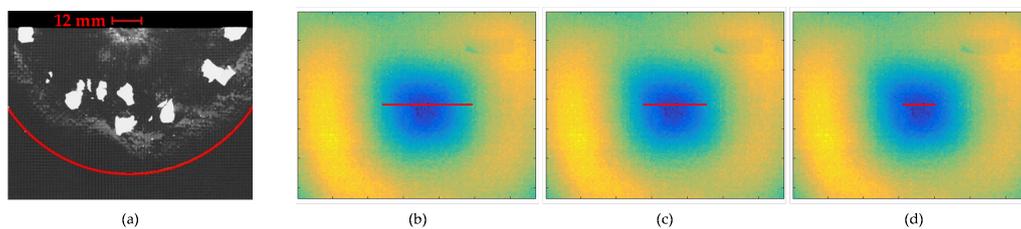
Figure 1. Equivalent damaged diameter for (a) X-ray technique (b) heating rate below 0.16 percentile ($m=1$), (c) heating rate below 0.023 percentile ($m=2$) and (d) 0.0013 percentile ($m=3$). Image (a) corresponds with the specimen 23L_1 while images (b), (c) and (d) correspond with specimen 18L_4.

being p the number of pixels of the selected line. This procedure is illustrated in Figure 1b, 1c and 1d. Three values of damaged diameter were obtained for looking for heating-rate lower with respect the 0.16, 0.023 and 0.0013 percentiles of heating rate, corresponding to $m = 1$, $m = 2$ and $m = 3$, respectively. The graphical representation of the damaged diameter for each m value is depicted in Figures 1b, 1c and 1d.

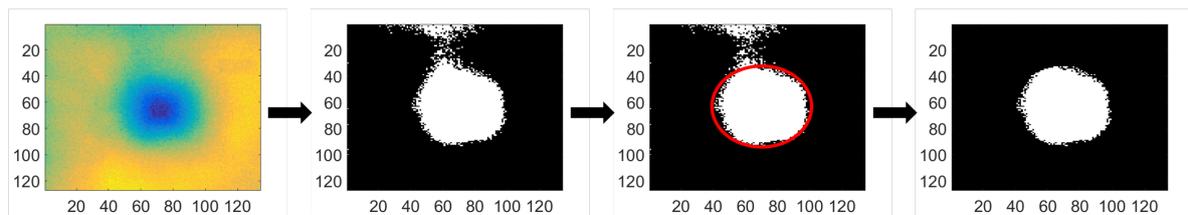
Figure 2. Damaged area identification procedure with the Temperature Difference Method.

being ΔT_{dam} and ΔT_{undam} the normalized temperature increment matrices for the damaged and undamaged specimen's thermography, respectively, taken at the i -th time, and ΔT_{subt} the temperature increment matrix with the normal heating effect subtracted. If a certain pixel from the damaged thermogram is heated in the same way that the counterpart pixel on the undamaged thermogram, ΔT_{subt} for this particular pixel is zero. Consequently, all pixels with ΔT_{subt} lower than zero were considered to refer to damaged areas. A new image was then built from each thermogram: if $\Delta T_{\text{subt}} \leq 0$ the pixel is depicted as white, or else the pixel was depicted as black. A circular-like damaged area was expected, however, due to the inherent variability of the thermography process, some pixels were mistakenly marked as damaged (top part of second and third images in Figure 2). In order to solve this issue, a circular area was selected (red circle on the third image of Figure 2) and all the white pixels out of the red circle were eliminated. The final step was counting the white pixels on the treated image (last image of Figure 2). Assuming a circular damaged area, the equivalent diameter was obtained for comparison with the other methods.

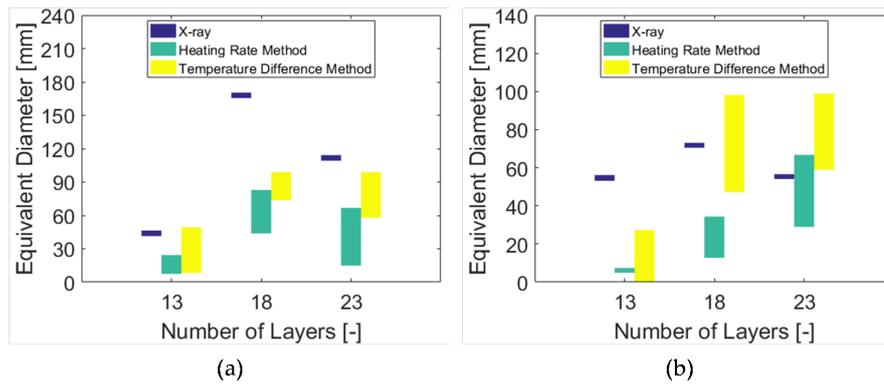
Figure 3. Comparison of the quantitative values of equivalent damaged diameter for the three techniques presented. (a) specimens impacted with the 9 mm projectile and (b) with the .357 projectile.

This method was carried out for all thicknesses, both types of projectiles and all time values. The results of equivalent damaged diameter evolution with time are shown in Figure 4. In Figure 3, they were plotted as a yellow range the maximum and minimum damaged diameter values obtained through this technique (i.e. maximum and minimum values of the curves shown in Figure 4).

Figure 3 shows the main findings of this work. Regarding the X-ray results, a large increase in damaged area was noticed for the specimens which stopped the bullet (18 and 23 layers) in the case of 9 mm bullet (figure 3a). This is explained by the greater amount of absorbed energy, which caused a larger delamination area, since this is the main mechanism of energy absorption in aramid fiber composites, rather than other failure mechanisms (i.e. fibre breakage). For both types of projectiles, it was detected that the largest damage area was reached with 18 layers.

Regarding the Heating Rate Method, the values of equivalent damaged diameters, for $m=1$ (maximum) to $m=3$ (minimum) are represented as a green range in Figure 3. With respect to the 9 mm projectile, it can be seen that the Heating Rate method is able to mimic the trend shown in the X-ray results (i.e. largest damaged area corresponding to 18 layers), even though the values were higher. The largest difference observed for the 18-layer specimen might be justified considering that the damaged area reached the edges of the composite, and the boundary conditions specially affected this sample. Also, in some cases, the residues left by the projectile were minimum and therefore it was difficult to accurately delineate the damaged diameter. This occurred mainly for the 13 layers and the 23 layers impacted with the .357 Magnum. This method was unable to detect any damaged diameter for the 13 layer impacted with the .357 projectile for $m=2$ and $m=3$. Consequently, only one value and not a range is reported in this case. Speaking about the Temperature Difference Method, in Figure 4, continuous lines correspond to the 9 mm Luger (labeled “_2” in Figure 4) whereas the dashed lines correspond to the specimens impacted with the .357 Magnum projectile (labeled “_4” in Figure 4). For the 18 and 23 layer specimens, the entire image was depicted as damage up to a particular value of time. Conversely, for the 13 layers, no damage was initially found. These misleading points were eliminated from the analysis and disregarded in Figure 3. This technique worked as expected for the 13 layers specimens (blue curves in Figure 4) since the plateau-like area could be a good approximation of the diameter of the damaged area. Regarding the curves for the other numbers of layers, it can be said that the trend shown in Figure 4 for the X-ray method is well represented, since the largest damage (i.e. highest curve) is produced for the 18 layers impacted with the 9 mm projectile. However, the Temperature Difference technique tells that the damage for the 23 layers specimens (red curves in Figure 4) is approximately the same. This is in good agreement with the Heating Rate Method but not with the X-ray results since, for the latter, the 23 layers impacted with 9 mm projectile showed the largest damage. This may be justified by the problem in delimitating the damaged area as explained above. The same issue, but at a lower scale, was found for the 13 layers specimen impacted with the .357 projectile since, for both thermography techniques, greater damage was caused by the 9 mm projectile and not by the .357 as found in the X-ray analysis. For all the techniques used, the 13 layers specimens were the ones with lower damage and, in fact, this is well represented in Figure 4. Overall, the round nose projectile (9 mm) was observed to yield more damage than the conical tip one (.357). This is in accordance with Miles [9] where it was stated that due to the larger contact surface area of round nose projectiles, the projectile is subjected to more resistance upon impact, being the main composite’s energy dissipation method delamination rather than shearing of the fibres.

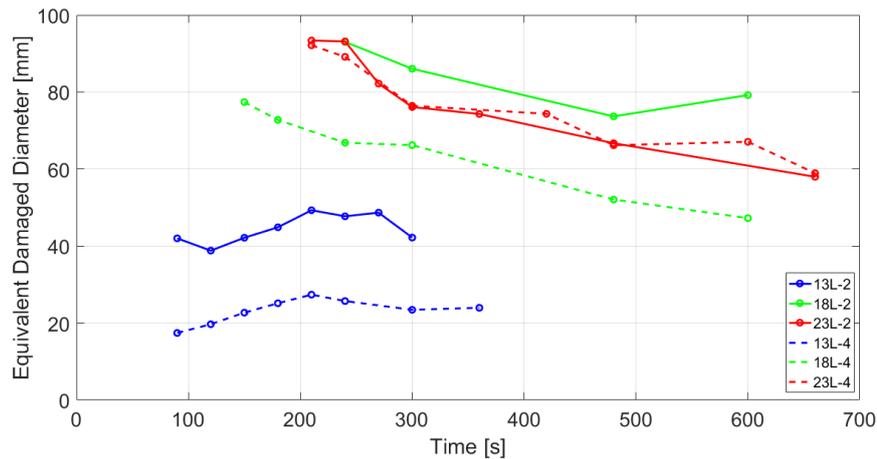
Figure 4. Equivalent damaged diameter area time evolution for the Temperature Difference Method.
