Proceeding

Evaluation of fracture process in concrete by means of acoustic approaches[†]

[†] Presented at the 18th International Conference on Experimental Mechanics, ICEM18, Brussels, 2018

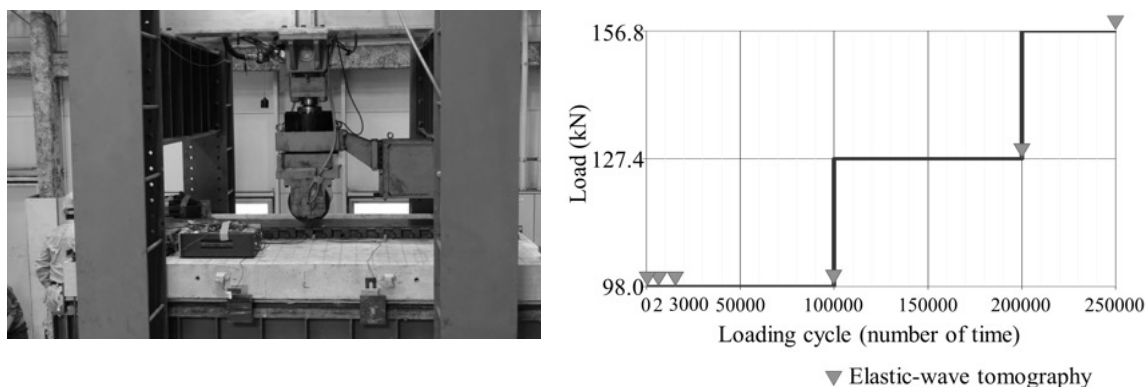
Figure 1. Wheel loading apparatus (left) and load application program (right).

In order to simulate cracks actually observed in the slabs due to fatigue, repeated loading with a steel wheel was conducted. As shown in Fig. 1, a foundation put on the slab is cyclically moved in a lateral direction, which is different from the wheel-loading apparatus installed movable loading-wheel [3]. In the apparatus, a steel wheel of 300 mm in diameter and 400 mm in width can be loaded up to 250 kN in the case of repeated lateral loading and 534 kN in the case of static vertical loading. The foundation can move horizontally from ±500 mm to ±1000 mm. In the experiment, the motion of ±500 mm and the repeated rate 8.97 rpm were applied. Here, step-wise cyclic loadings are employed as shown in Fig. 1. In the first steps, the load of 98 kN was repeatedly applied up to 100k times. In the second steps, the load of 127.4 kN were applied up to 200k times. Then, the third step loadings were conducted until 250k times with 156.8 kN load where the fatigue limit of the specimen was estimated as 235×k times.

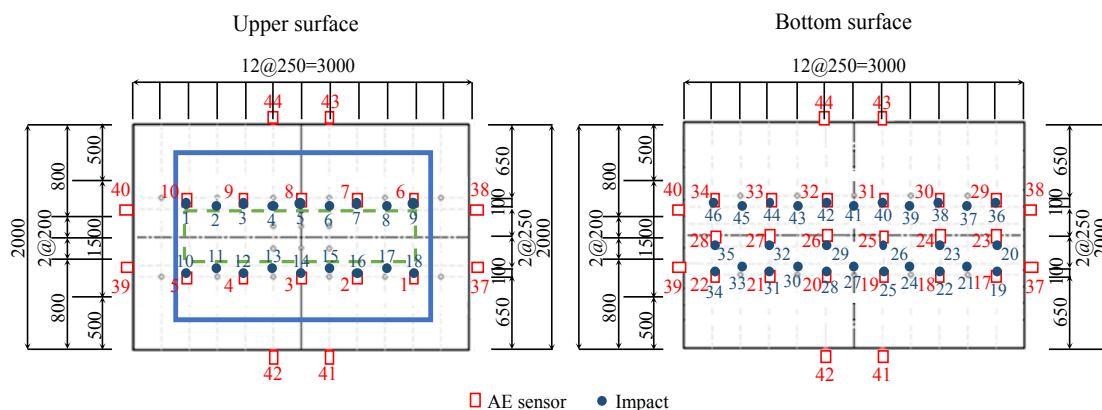
Figure 2. Locations of AE sensors and excitation points denoted by red squares and blue circles, respectively.

Arrangement of AE sensors and excitation locations are demonstrated as in Fig. 2. 36 AE sensors of 60 kHz resonance are arranged onto the specimen, namely 10 for top, 18 for bottom and 8 for sides. For elastic wave tomography, excitations are made by a 35 mm dia. steel ball for 18 points on the top as to avoid the loading area depicted by a green broken rectangle, and 28 points on the bottom. Measurement of elastic wave excitations are conducted six times: before loading, after second, after 3k, after 100k, after 200k load applications, and after failure. Detected signals by the sensors are amplified by 40 dB at preamplifier and acquired by the monitoring system of 48-channel Express-8 (Physical Acoustics Corp) with a 1 MHz sampling rate. 17 displacement-meters are set at the bottom. Seven electric strain gauges for detecting the vertical deformation are embedded inside the concrete.
