# SHearography for the Inspection of Composites – Phase 2 (SHIC2)

## PIPELINE BONDED JOINTS ASSEMBLY AND OPERATION HEALTH MONITORING WITH EMBEDDED FBG SENSORS

Authors: Thiago Destri Cabral\*, Antonio Carlos Zimmermann, Daniel Pedro Willemann, and Armando Albertazzi Gonçalves Jr.

Presented at: **7th International Electronic Conference on Sensors and Applications (ECSA-7)**

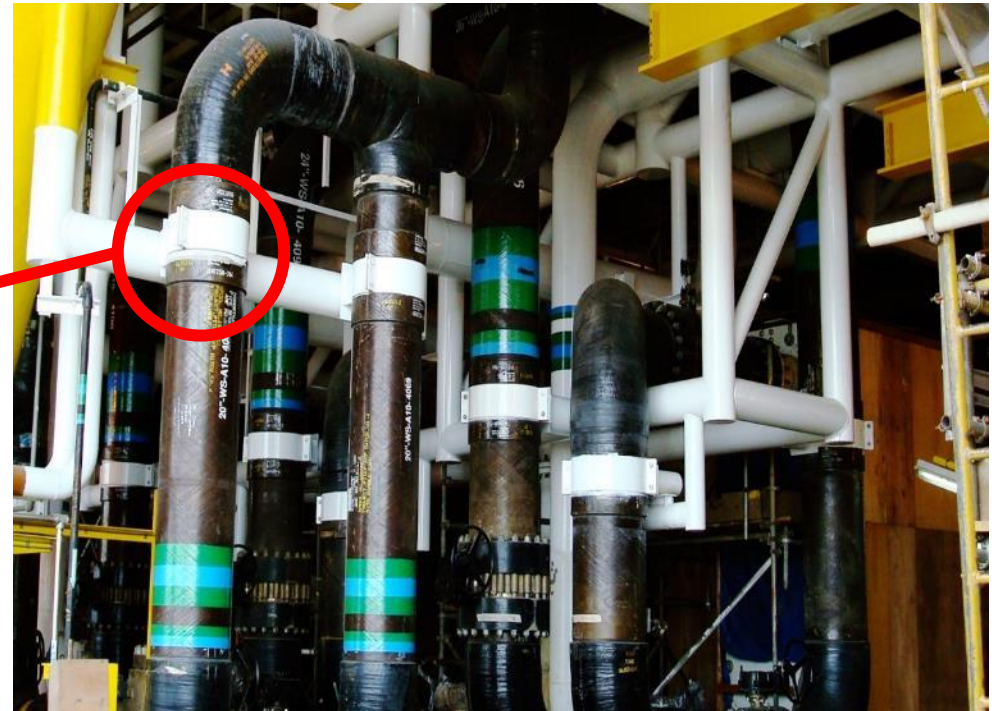
**CEMENTED BELL & SPIGOT ADHESIVE JOINT**

- Produced water in offshore oil platforms, gas lines, etc.;
- Joint failure disrupts operation causing significant financial losses and, possibly, severe environmental contamination.

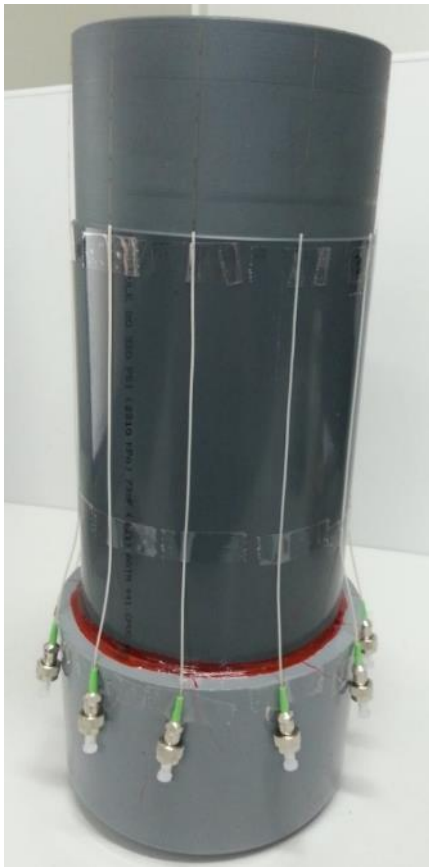
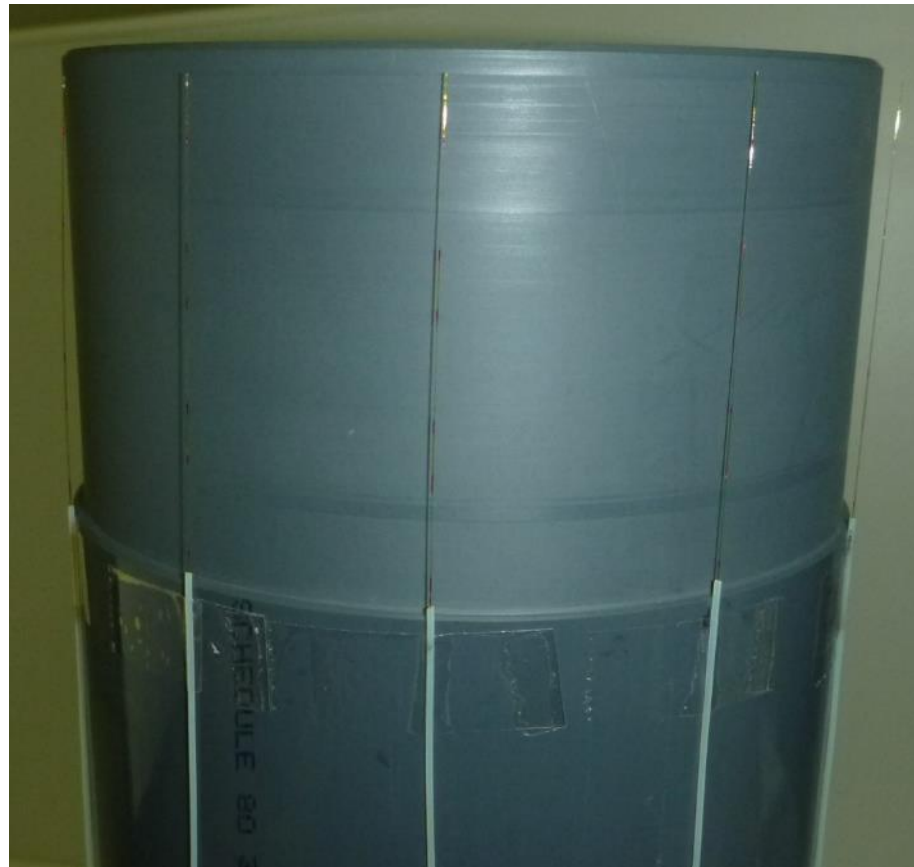
Firstly the sensing fibers are pre-positioned using adhesive tape, note that FBG1 will be the one embedded the deepest into the bonded joint, with FBG 3 closer to the exit point from the adhesive layer:

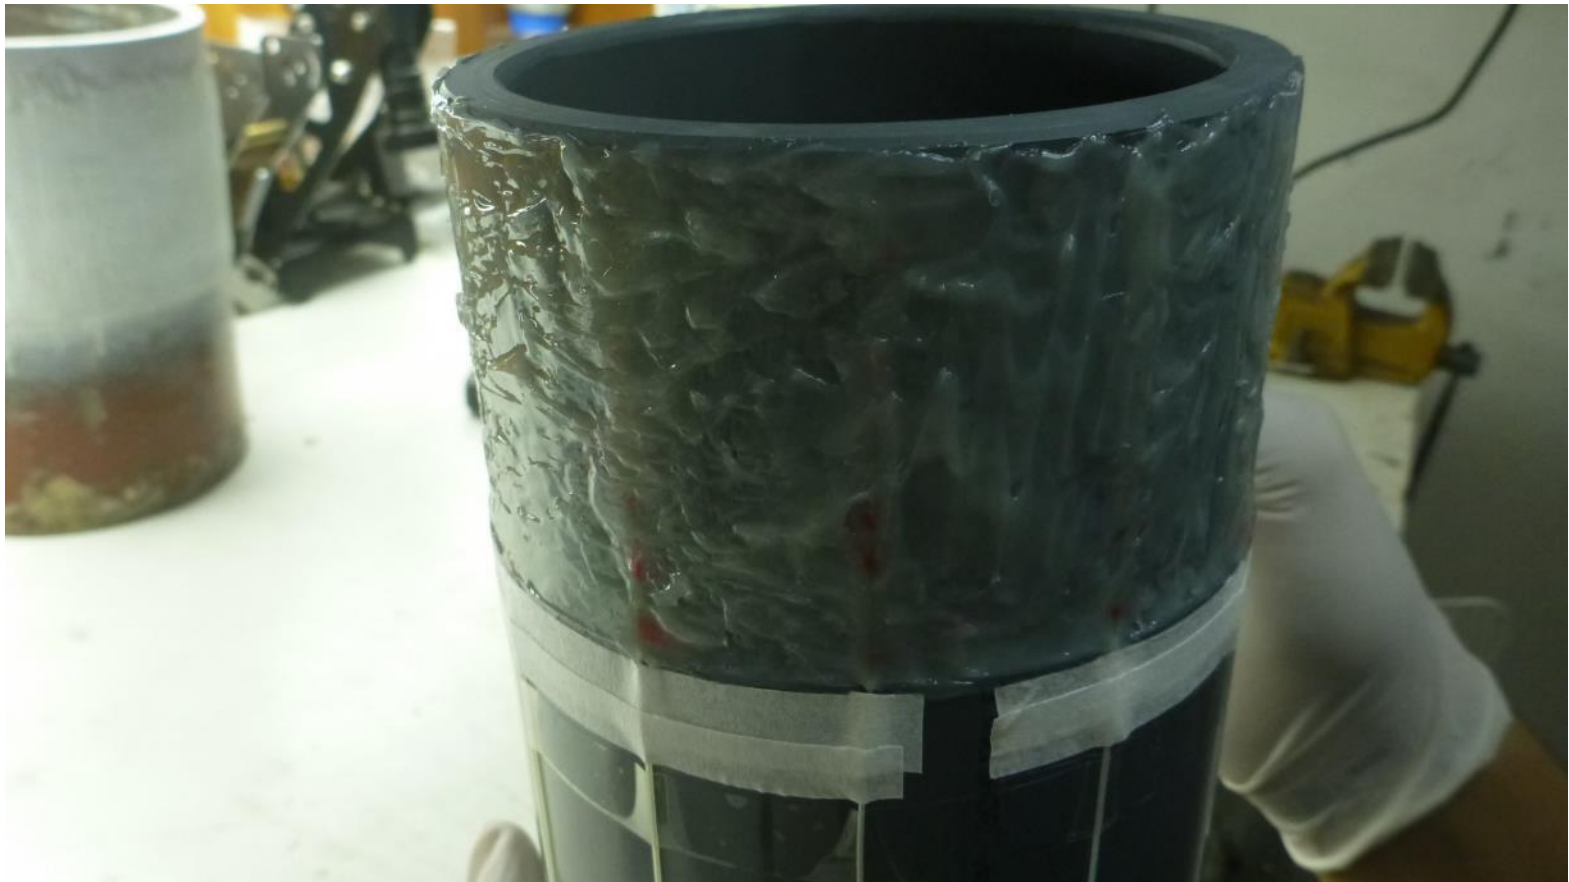
And then applied liberally to the whole area to be inserted into the sleeve:

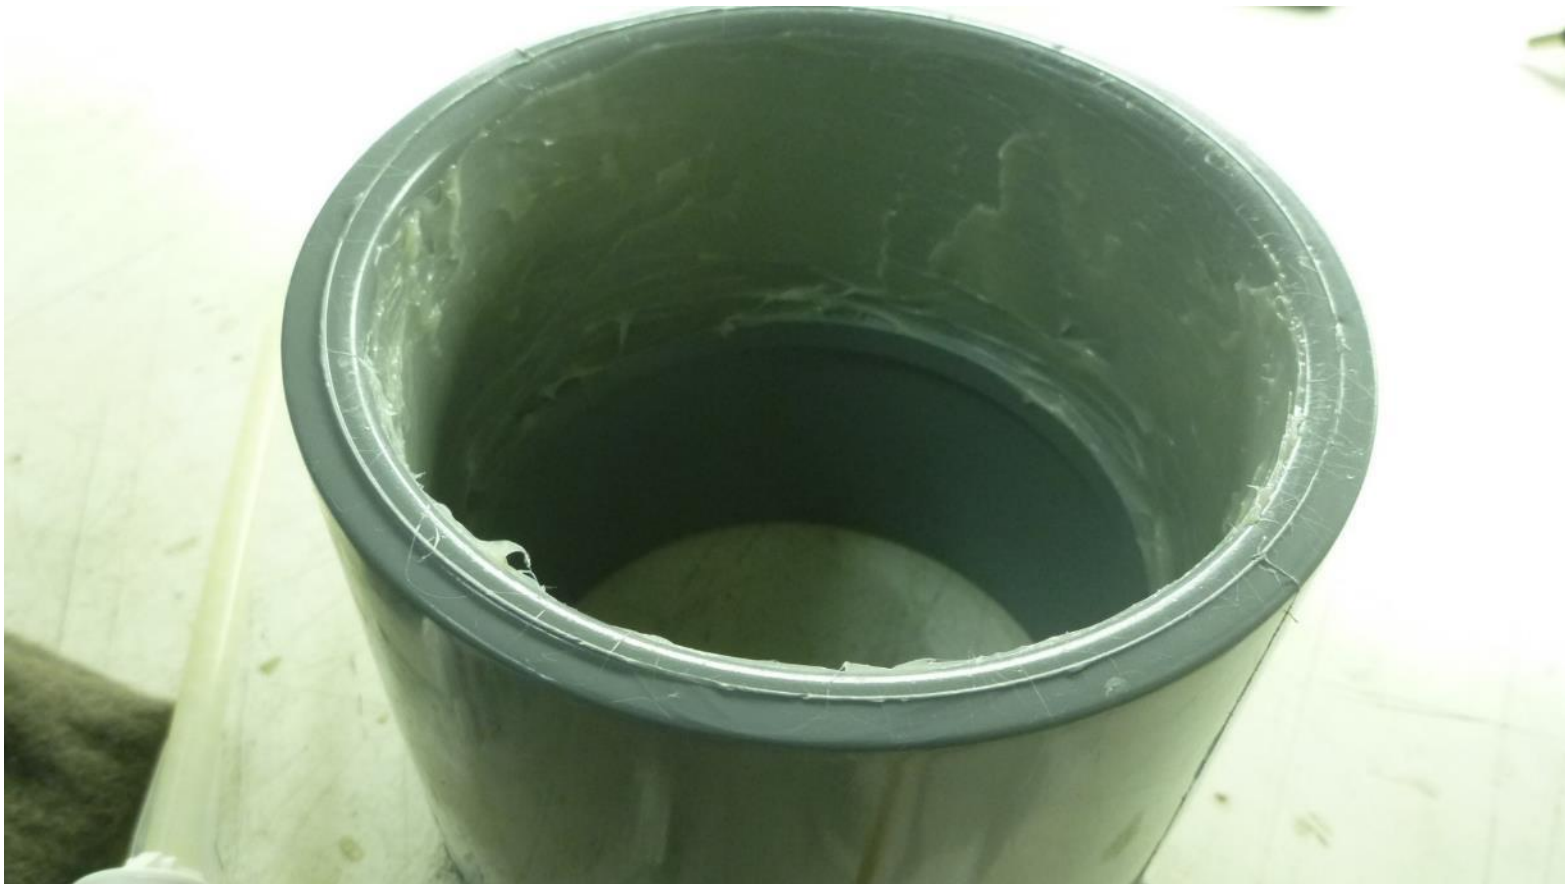
Adhesive is also applied to the inner side of the sleeve:

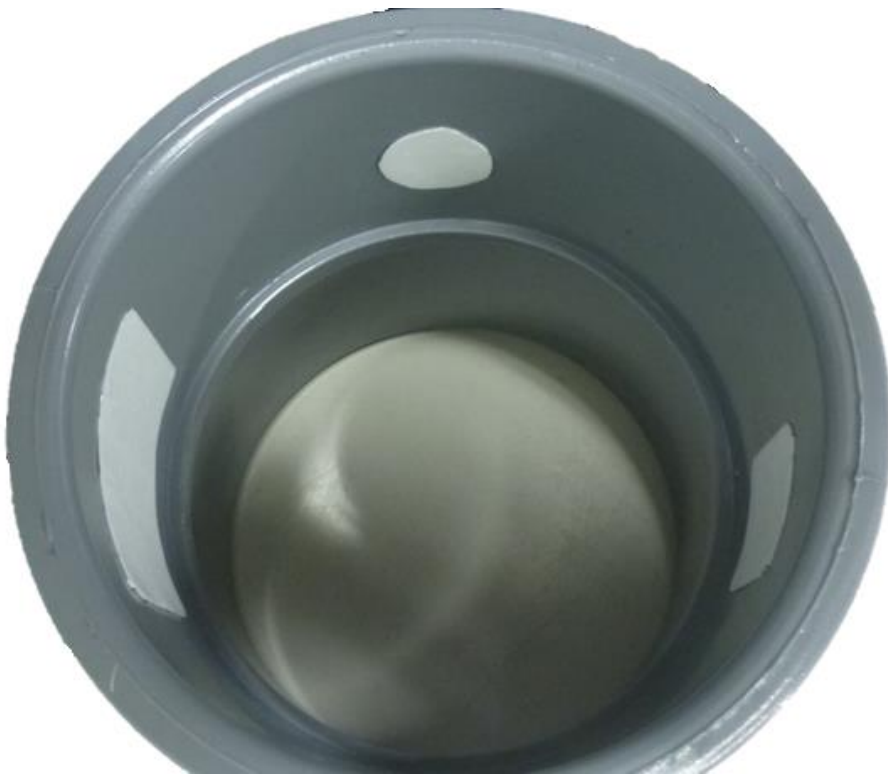
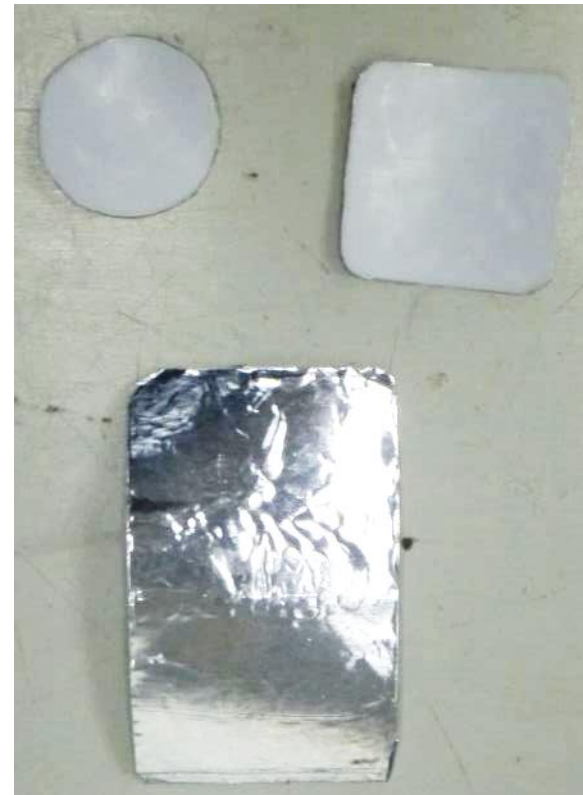
Intentional defects were introduced in one of the test specimens using Teflon sheets with aluminum tape (to increase detectability by tomography), which prevents proper adhesion and load transfer between the pipe and the sleeve:

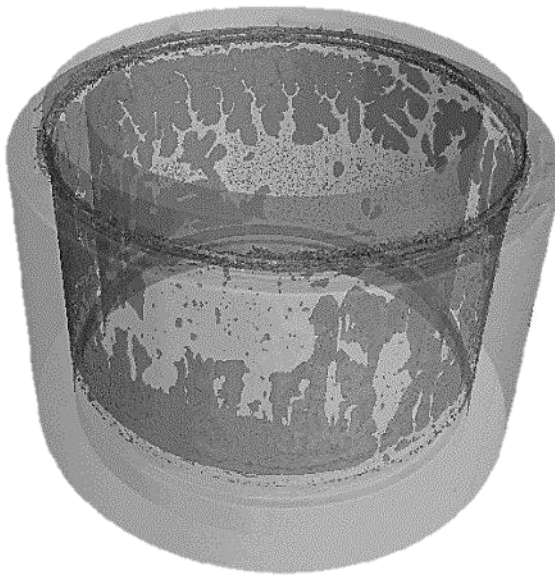
S1

- Widespread lack of adhesive (darker areas) in S1;
- No major defects, but the presence of porosity (darker spots) in S2;
- Some porosity (darker spots) in S3, with the intentionally embedded defects clearly outlined (arrows);

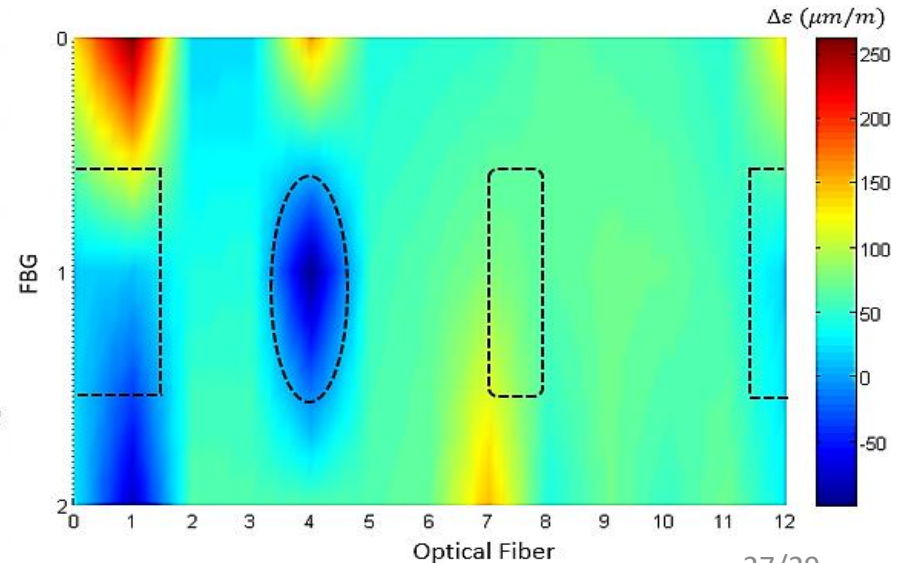
Hydrostatic strain data for S3 ( $\Delta P = 7$  bar) is shown below:

- Position of intentional defects is outlined by the black dashed lines in the color map (stretching is caused by image aspect ratio);
- Interesting strain artifacts can be observed in the position of the circular defect and around the larger rectangular defect;
- The smaller square defect, positioned in between fibers, as opposed to the other 2 defects placed on top of FBGs, did not cause a large enough disturbance in the strain field to be observable.

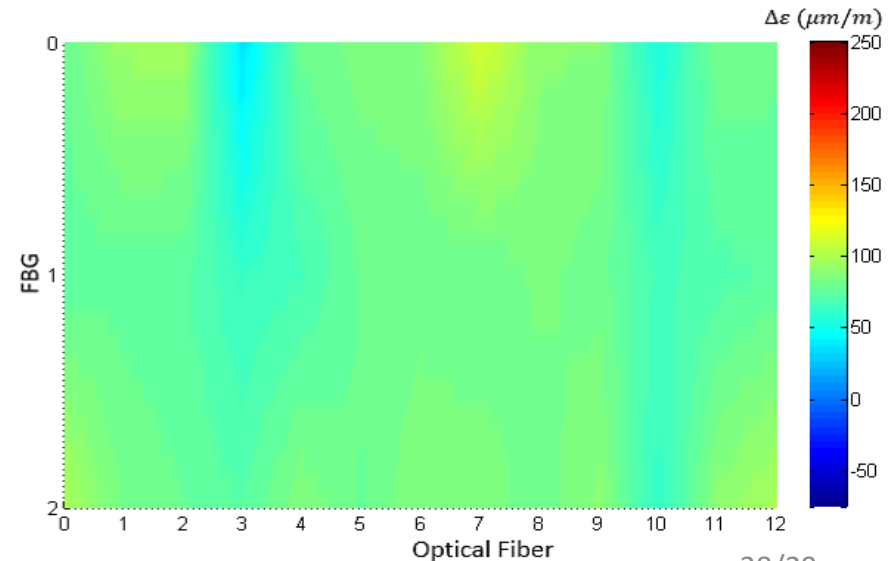
Hydrostatic strain data for S2 ( $\Delta P = 7$  bar) is shown below:

- Only tensile strain is observed;
- While some fluctuation in the strain level is observed, it is relatively small (mean strain =  $79.5 \mu\epsilon$ , standard deviation =  $13.4 \mu\epsilon$ );
- The fluctuations are mostly likely caused by porosity around the FBG sensors, as observed in the tomography reconstruction of S2's bonded joint;
- To better illustrate how small these fluctuations are compared to the ones caused by larger defects like in S3, the color bar for the colormap of S2 below has been rescaled to match that of S3.
