Assessment of Partial Discharges Evolution in Bushing by Infrared Analysis [†]

[†] Presented at the 8th International Electronic Conference on Sensors and Applications, 1–15 November 2021;

Keywords: partial discharges; bushing; insulation systems; infrared sensors; monitoring systems

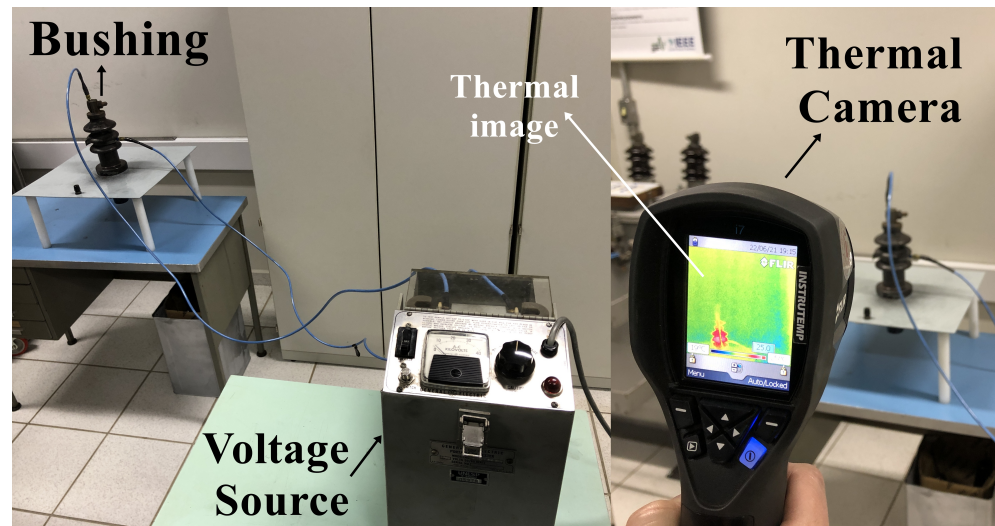
Figure 1. Experimental Setup.

In real-life scenarios, insulation systems are constantly contaminated with dust, which can promote PD activity. Therefore, a transformer's bushing was contaminated with powdered graphite to emulate this condition. Additionally, a high voltage AC source (0–40 kV) was connected to the extremities of the component to induce partial discharges.

One of the most relevant steps for the improvement of maintenance planning is the PD evolution assessment. Due to material deterioration, the electrical charges produced by the failure increase. Based on this behavior, the PD evolution was carried out by increasing the voltage level for the same contamination pattern. The PD started at 13 kV, and, after that, the voltage was increased by a step of 2 kV up to 23 kV, totaling six different flow levels. For each level, 20 images were taken using a thermal camera (FLIR—Instrutemp i7). Additionally, 20 more images were taken when the insulator was without PD activity (0 kV) to assess the effectiveness of thermal analysis for PD evolution. Figure 1 shows the experimental setup.

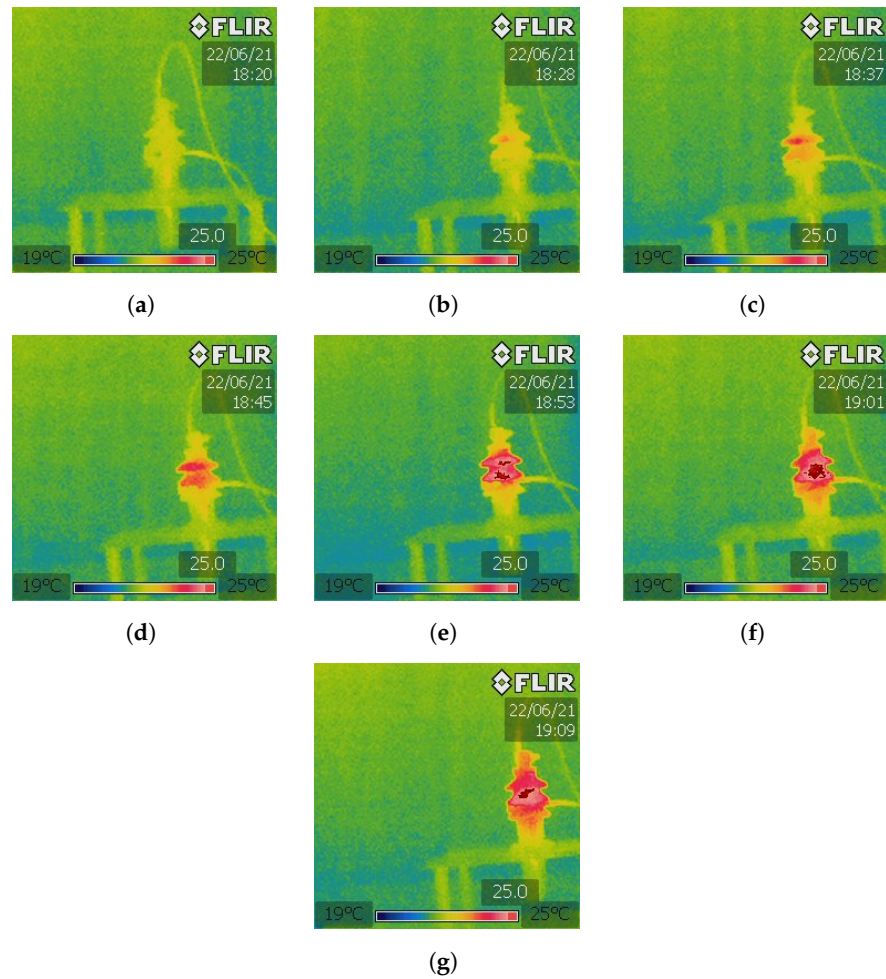
Figure 2. Thermal imaging of bushings subjected to (a) no discharge; and discharge levels generated by: (b) 13 kV; (c) 15 kV; (d) 17 kV; (e) 19 kV; (f) 21 kV; (g) 23 kV.

Figure 2 presents the thermal images taken for all PD levels. It can be noted that the thermal analysis is suitable to perform PD evolution detection since the temperature increases with the PD activity. By Figure 2a, when the failure is not present at the component, the average temperature was 22 C. After the PDs started, it can be observed hot spots promoted by failure heat emission. However, the visual analysis was not enough to perform a quantitative estimation of PD evolution. Also, in some figures, the effects of the faults in the thermography are too subtle (e.g., Figure 2b) and may not be detected without the development of a specific index. In the other hand, in Figure 2e–g, it is hard to define which one represents the highest PD level, reiterating the creation of new imaging processing approaches. A basic analysis of the maximum temperature value is not sufficient to assess the PD evolution since the maximum temperature spot of the image remains at 25 C for PDs higher than 17 kV, as shown in Figure 3.

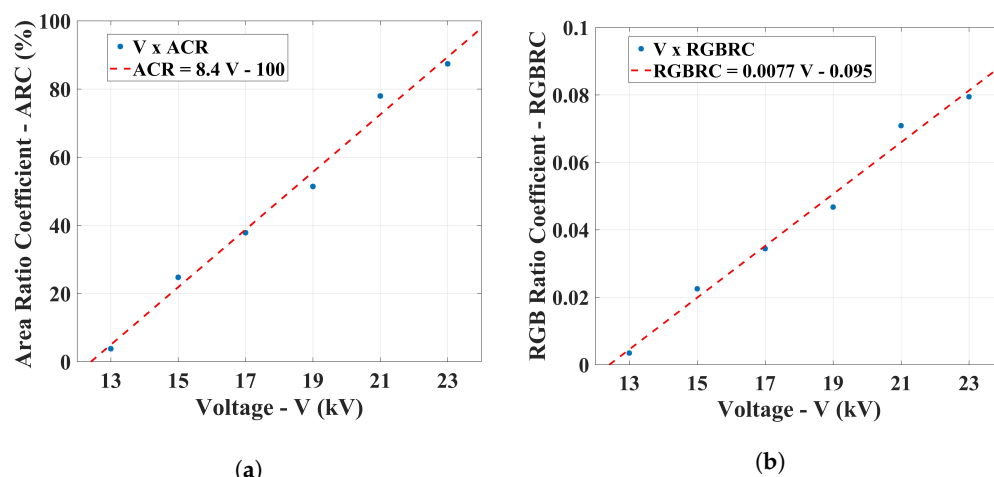
Figure 4. (a) ARC per PD level. (b) RGBRC per PD level.

Therefore, based on these issues, the feature extraction of PD evolution was achieved by the novel indexes ARC and RGBRC, according to Figure 4. By analyzing the results, it can be noted that ARC and RGBRC indexes increase with the PD evolution. The strong correlation between the voltage levels and the indexes allows a linear regression. Then, the regression equations presented in Figure 4a,b can be applied to estimate the PD level based on the thermal images.

The ARC increased from 0 to 80%, which means that the intensity of the PD activity can change the thermal pattern in the whole insulator. Besides, the relation between the high-temperature pixels and the total number of pixels can be a promising tool to detect the failure evolution once the red and orange patterns increased as presented in Figure 4.

$$ARC = \frac{A_{hs}}{A_T}. \quad (1)$$

$$RGBRC = \frac{P_{ro}}{P_T}. \quad (2)$$
