A Study of Analysis Method for the Surface Roughness on the Inner Bore of Diesel Engines Before and After Running-in Operations [†]

[†] Presented at the 4th International Electronic Conference on Applied Sciences; Available online: <https://asec2023.sciforum.net/>.

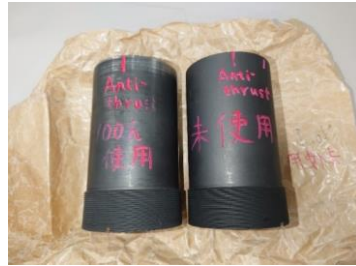
Figure 1. Engine cylinder liner.

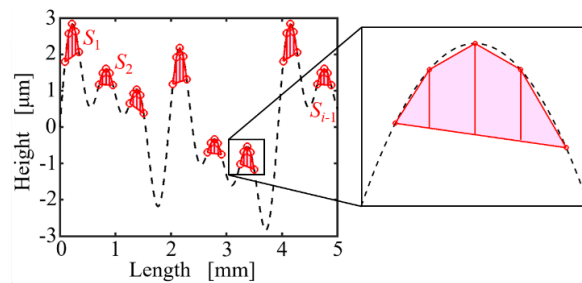
The volume near the peak is considered to potentially affect the anchoring effect and intermolecular forces. Based on this, a new parameter, pPsm, is developed. The procedure for calculating pPsm is as follows. (1) Detect the peak point of surface profile. (2) As shown in Fig. 3, after detection, five points are detected: two points in front of the detected peak and two points behind it. (3) As shown in Fig. 3, the volume, S_i , is calculated between the five detected points using trapezoidal integration. (4) Finally, the total volume calculated in step (3) is divided by the total number of peaks, n_m , to obtain an average. This is pPsm as in Eq. (1).

Figure 3. Schematic diagram of calculation method on pPsm.

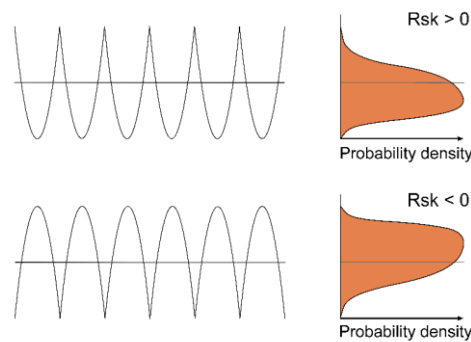
Rsk and Rku are described effective parameters for evaluating the wear on part surfaces according to ISO standards [3]. Figure 5 is a schematic diagram of Rsk. The parameter Rsk evaluates the symmetry of the peaks and valleys of the surface profile. Rsk takes a value of zero in the case of a normal distribution and shows a negative value in the case of a worn surface. Rsk is calculated as follows Eq. (3) [3]. The parameter Rku evaluates the sharpness of the peaks and valleys of the surface profile. Figure 6 is a schematic diagram of Rku. Rku takes a value of three in the case of a normal distribution. Rku is calculated as shown in Eq. (4) [3].

Figure 5. Schematic diagrams of Rsk.

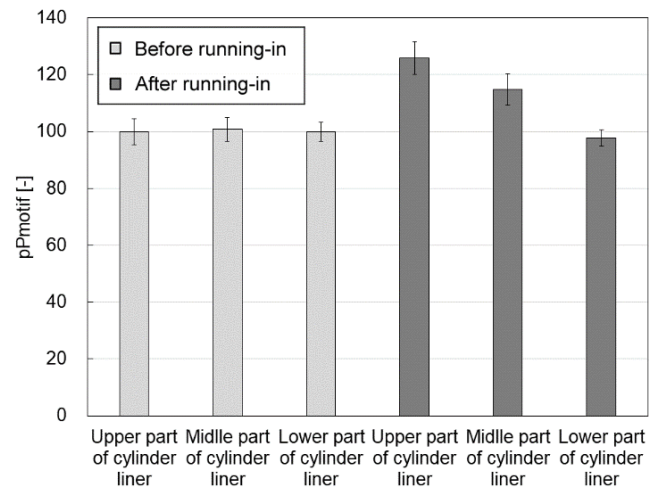
Figure 8 shows the calculation results of pPmotif. As shown in Fig. 8, pPmotif exhibits a constant value in all parts of the cylinder liner before running-in. Additionally, after running-in, the value of pPmotif is the highest at the top of the cylinder liner and decreases in the middle and bottom, in that order. These results are similar to the changes in the cylinder liner surface profile before and after running-in shown in Fig. 2. Therefore,

pPmotif is considered a suitable parameter for quantifying the differences in the surface of the cylinder liner before and after running-in. However, the pPmotif cannot characterize differences in the surface profiles of all parts because the error bars overlap between the upper and middle parts of the cylinder liner after running-in. Therefore, since pPmotif has problems of accuracy, further improvements are required.

Figure 8. Results of pPmotif.

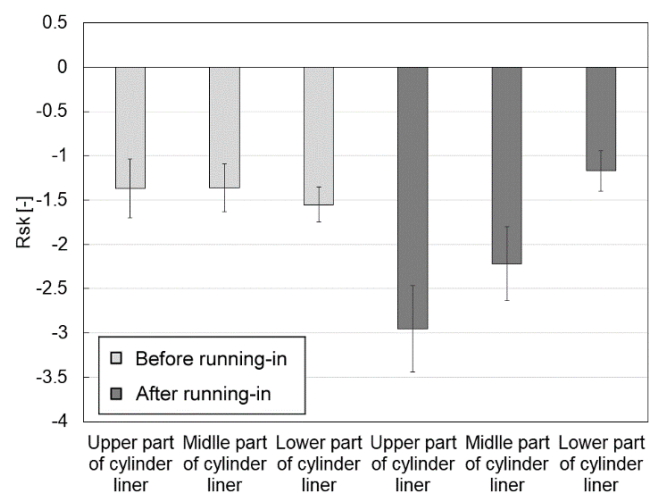
Next, the result of pPmotif is compared with those of Rsk and Rku. Figures 9 and 10 present the calculation results of Rsk and Rku, respectively. From Figs. 9 and 10, Rsk and Rku show results that are almost similar to those of pPmotif. However, both Rsk and Rku have more overlap of error bars than pPmotif in all parts of the cylinder liner after running-in. Therefore, the effectiveness of Rsk and Rku is considered lower than that of pPmotif, although they are possible to quantify the differences in the cylinder liner surface before and after running-in. In conclusion, pPmotif is considered highly effective for quantifying the surface texture of the cylinder liner before and after running-in.

Figure 9. Results of Rsk.
