# Long-term in-situ study of stress corrosion cracking kinetics in a carbonate-rich solution

**Abstract:** A long-term SCC crack growth kinetics study, using precracked WOL samples, was performed. The samples were exposed in a mild steel storage tank containing a solution with high levels of ammonium and carbonate ions. Some samples were fully immersed in the tank content, while in other cases, intermittent drying took place in the tank upper regions. At short times, the highest (intergranular) crack growth rates were obtained at immersed regions and initially, the region with intermittent drying showed considerably slower growth rates. With pronounced exposure times, the trend however reversed and the growth in the intermittent drying region accelerated while the samples in the immersed location experienced a retardation in the SCC growth velocities. It was found that the SCC mechanism progressed through a process where small cracks first formed at the fatigue crack front and thereafter merged to form a continuous SCC crack front.

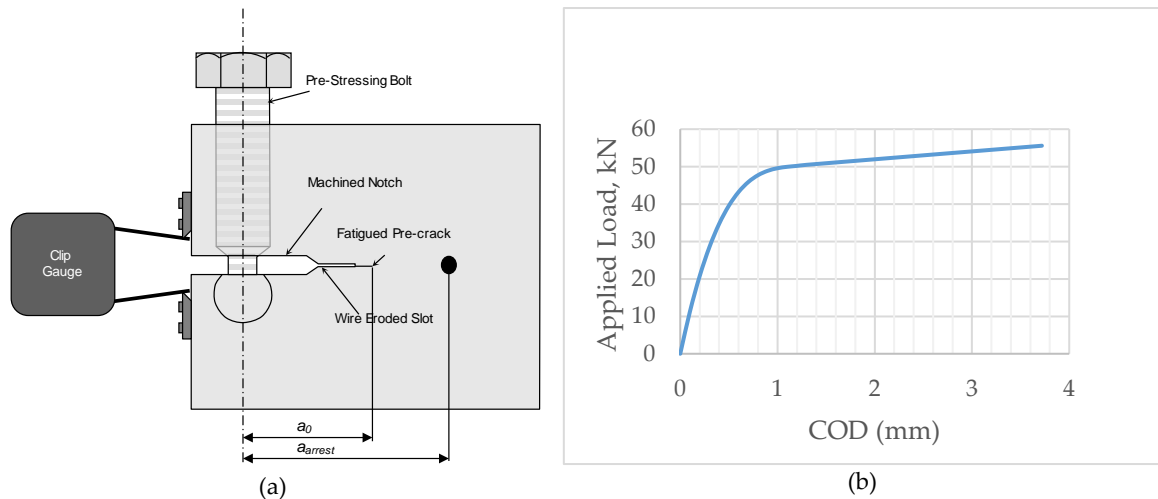
**Figure 1.** a) A schematic of the self-stressed WOL samples utilized in this study. The sample thickness,  $B$ , was 16.8 mm and the width,  $W$  was 38.0 mm. The dimension,  $a_0$ , was 17.7 mm. b) A calibration curve used for the preloading of the samples for immersion. The initial stress intensity was mostly in the order of  $71 \text{ MPam}^{0.5}$  (38.7 kN). Samples were taken with crack orientations both parallel (TL according to ASTM A 399) and transverse (LT) to the rolling direction.

Laboratory precracked (in fatigue) and self-stressed WOL (Wedge Opening Loading) were used (Fig 1a). After the exposure to the medium, average (at nine positions, to BS 7448) and maximum SCC crack depths were determined by fracturing the samples cooled to liquid nitrogen temperatures. Metallographic evaluation of etched samples were performed on the polished sides of the samples. Manufacture of the WOL samples was performed from steel plate with similar chemistry to that of the strakes, as recorded in Table 2.

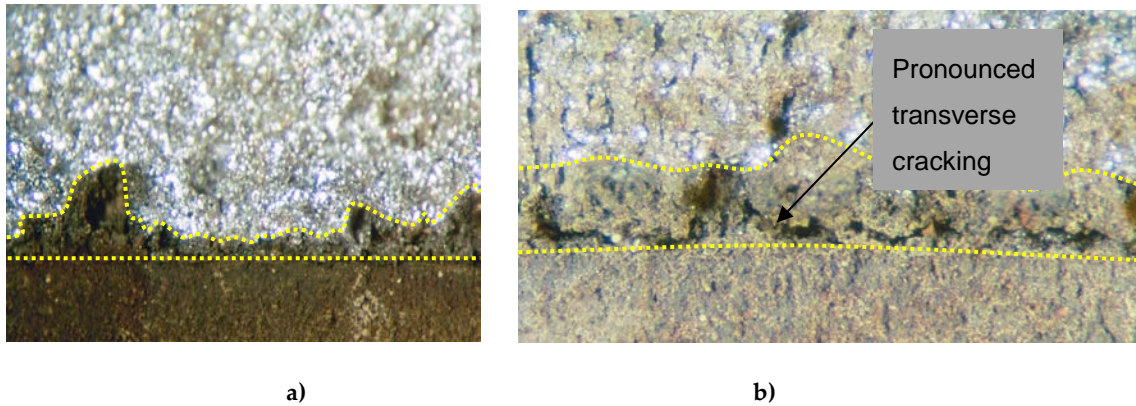
**Figure 2.** Fracture surface after laboratory fracture of WOL specimens, immersed at the floor level for 670 hours. Fatigue crack front is indicated with yellow hyphenated line, and the in-plane SCC crack front by the irregular hyphenated line. The bright fracture surface is the fresh (cryogenic) fracture (a) Notch longitudinal (TL orientation) showing in-plane SCC cracking; (b) Notch transverse (LT orientation) showing SCC cracking both in the plane of the fatigue crack and normal to it. Metallography demonstrated that cracking was intergranular in all cases.

The first samples were removed after an exposure period of 670 hours. The SCC crack depths were determined and are reported in Table 3 and shown in Figure 2. It was observed that the first steps of SCC propagation was the development of single small cracks from the fatigue crack tip, as seen in the case of the “vapour zone” sample.

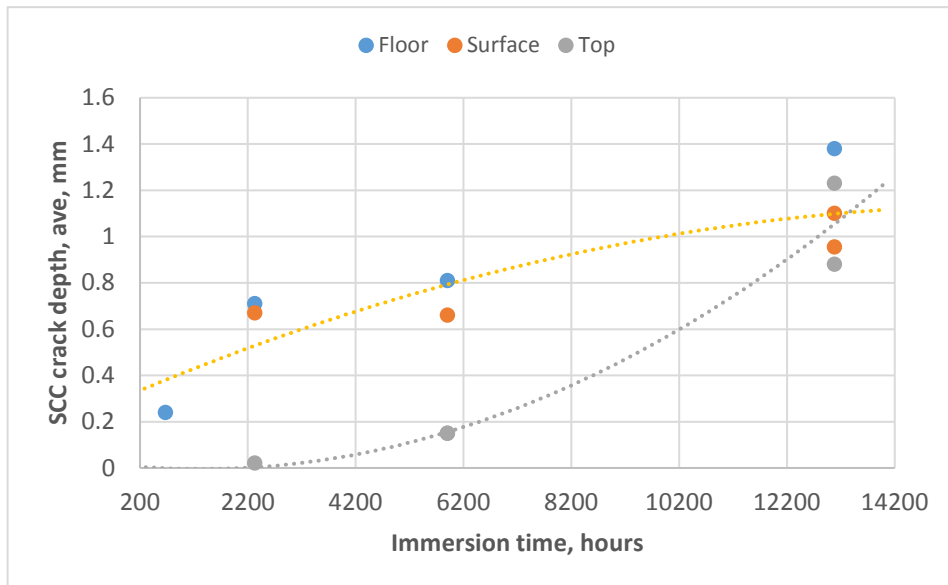
**Figure 3.** SCC crack depths, average, as a function of immersion time for the three tank locations

As the exposure times increased, the individual cracks merged and formed continuous crack fronts with reduced  $a_{max}/a_{ave}$  ratios (after 5904 hours, the ratios ranged from 1.24 to 1.38). The average crack depths over time are shown in fig. 3.

For most of the immersion times, it was found that samples at the floor level and those at the “surface level” (see 4.1) behaved similarly in terms of SCC growth, with the floor level average growth rates being slightly higher than those at the “liquid level”, where some intermittent drying occurred. The samples in the top zone, however, initially showed slow growth rates, with growth rates rapidly increasing after exposure times of 5940 hours.

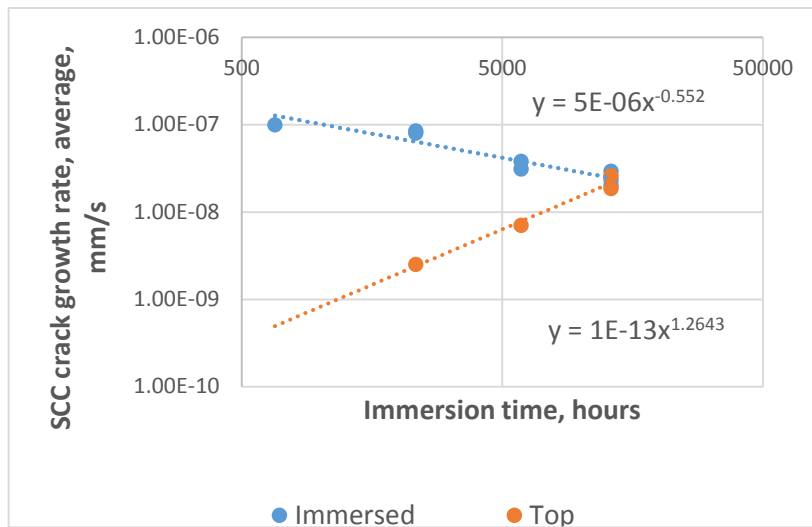
**Figure 4.** Average crack growth rates for the immersed samples (floor and “surface level” samples grouped together) and top (“vapour zone”) samples, showing decreasing growth rates for the immersed samples and acceleration of the vapour zone samples.

The average growth rates for the “immersed” (floor and surface) and “vapour zone” (top) samples are shown in Figure 4. The plot demonstrates the distinctly different growth behavior for the two classes of samples, with the governing power law equations for the two classes given in Figure 4. This difference was especially noticeable in the fourth exposure period (5941 – 13080 hours), when the incremental growth rate for the period was 3.3 times higher for the vapour (top) zone compared to that of the samples in the immersed zone ( $3.50 \text{ E-}08$  vs.  $1.06\text{E-}08$  mm/s).

The decline in growth rate with increasing time for the immersed samples, is in keeping with that expected in Stage 2 of the Parkins model, where initiation of multiple small cracks reduce the effective strain rate and growth velocity at the individual crack tips. In the case of frequent drying

events and low immersion of the “vapour zone” samples, however, an increase in growth rate was experienced with increasing exposure time. In this case, increasing crack numbers with time can also be expected. The increasing growth rate for this zone must therefore be due to another factor, and is likely to be related to the destruction of the inhibiting films during the regular and long dry periods.
